# EAGLE CREEK PRELIMINARY HYDROGEOLOGICAL RECONNAISSANCE, SANTA CRUZ COUNTY, CALIFORNIA: SUMMER OF WATER YEARS 2018 – 2020

February 2021

Balance Hydrologics, Inc.

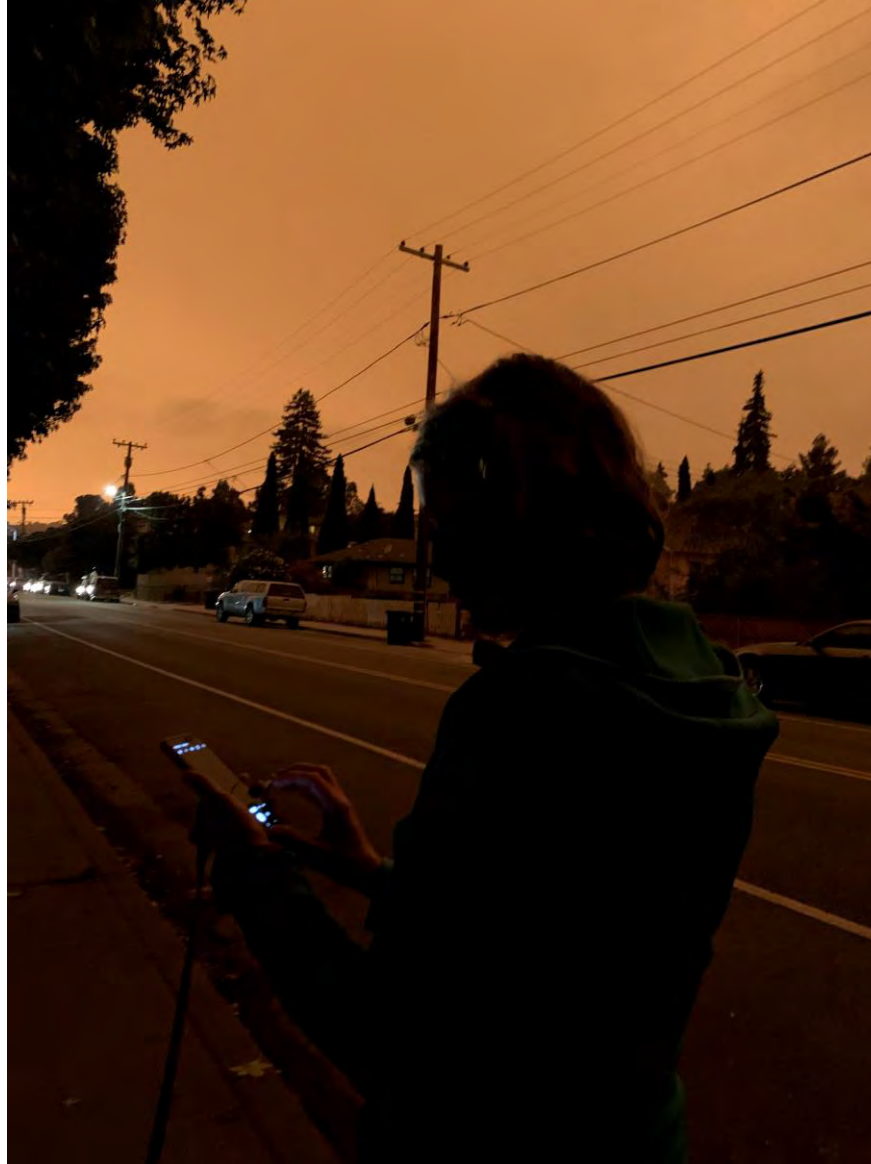
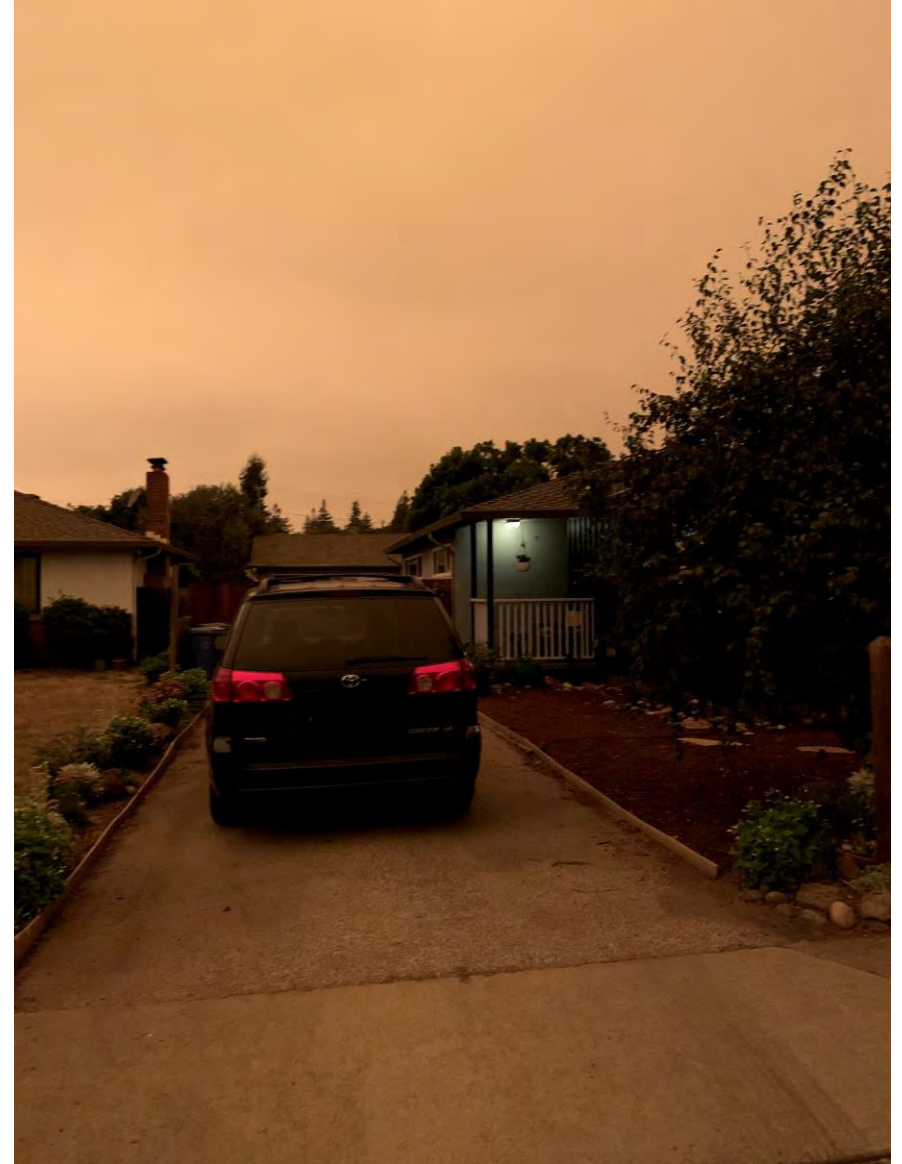
On September 9, smoke from this and other fires as far north as Oregon and Washington obscured sunlight throughout the Bay and Monterey Bay areas in an event sharply noted to nearly all observers (see **Figure 11**). Drivers used headlights throughout the day, and lights were on continuously in nearly all residences. Effects gradually attenuated over the following week. The smoke blocked sunlight lowering the air temperature as well as evapotranspiration rates. The gage instrumentation showed (a) an increase in flow and (b) a decrease in the daily fluctuation range. The daily flow minima were suppressed on September 9 and for several subsequent days. Smoke appears to have raised flows intermittently by suppressing evapotranspiration (ET) for two- or three-weeks following September 9, and (more locally) for several days between August 18 and Sept. 8. A full range of daily flow fluctuations effectively re-established by the heat spell on October 1 through 3. Flows increased seasonally during the first two weeks in October with reduced ET as temperatures diminished and as leaf-drop proceeded, followed by the first runoff event of the season.

Cars are using headlights and streetlights are on at 4:30 pm. Sunset is at 7:30 pm.

**Figure 11:**  
September 9, 2020 Smoke obscured skies due to multiple fires in Northern California. Photo in Santa Cruz near Emeline Ave. approximately 3 miles SE of Eagle Cr.

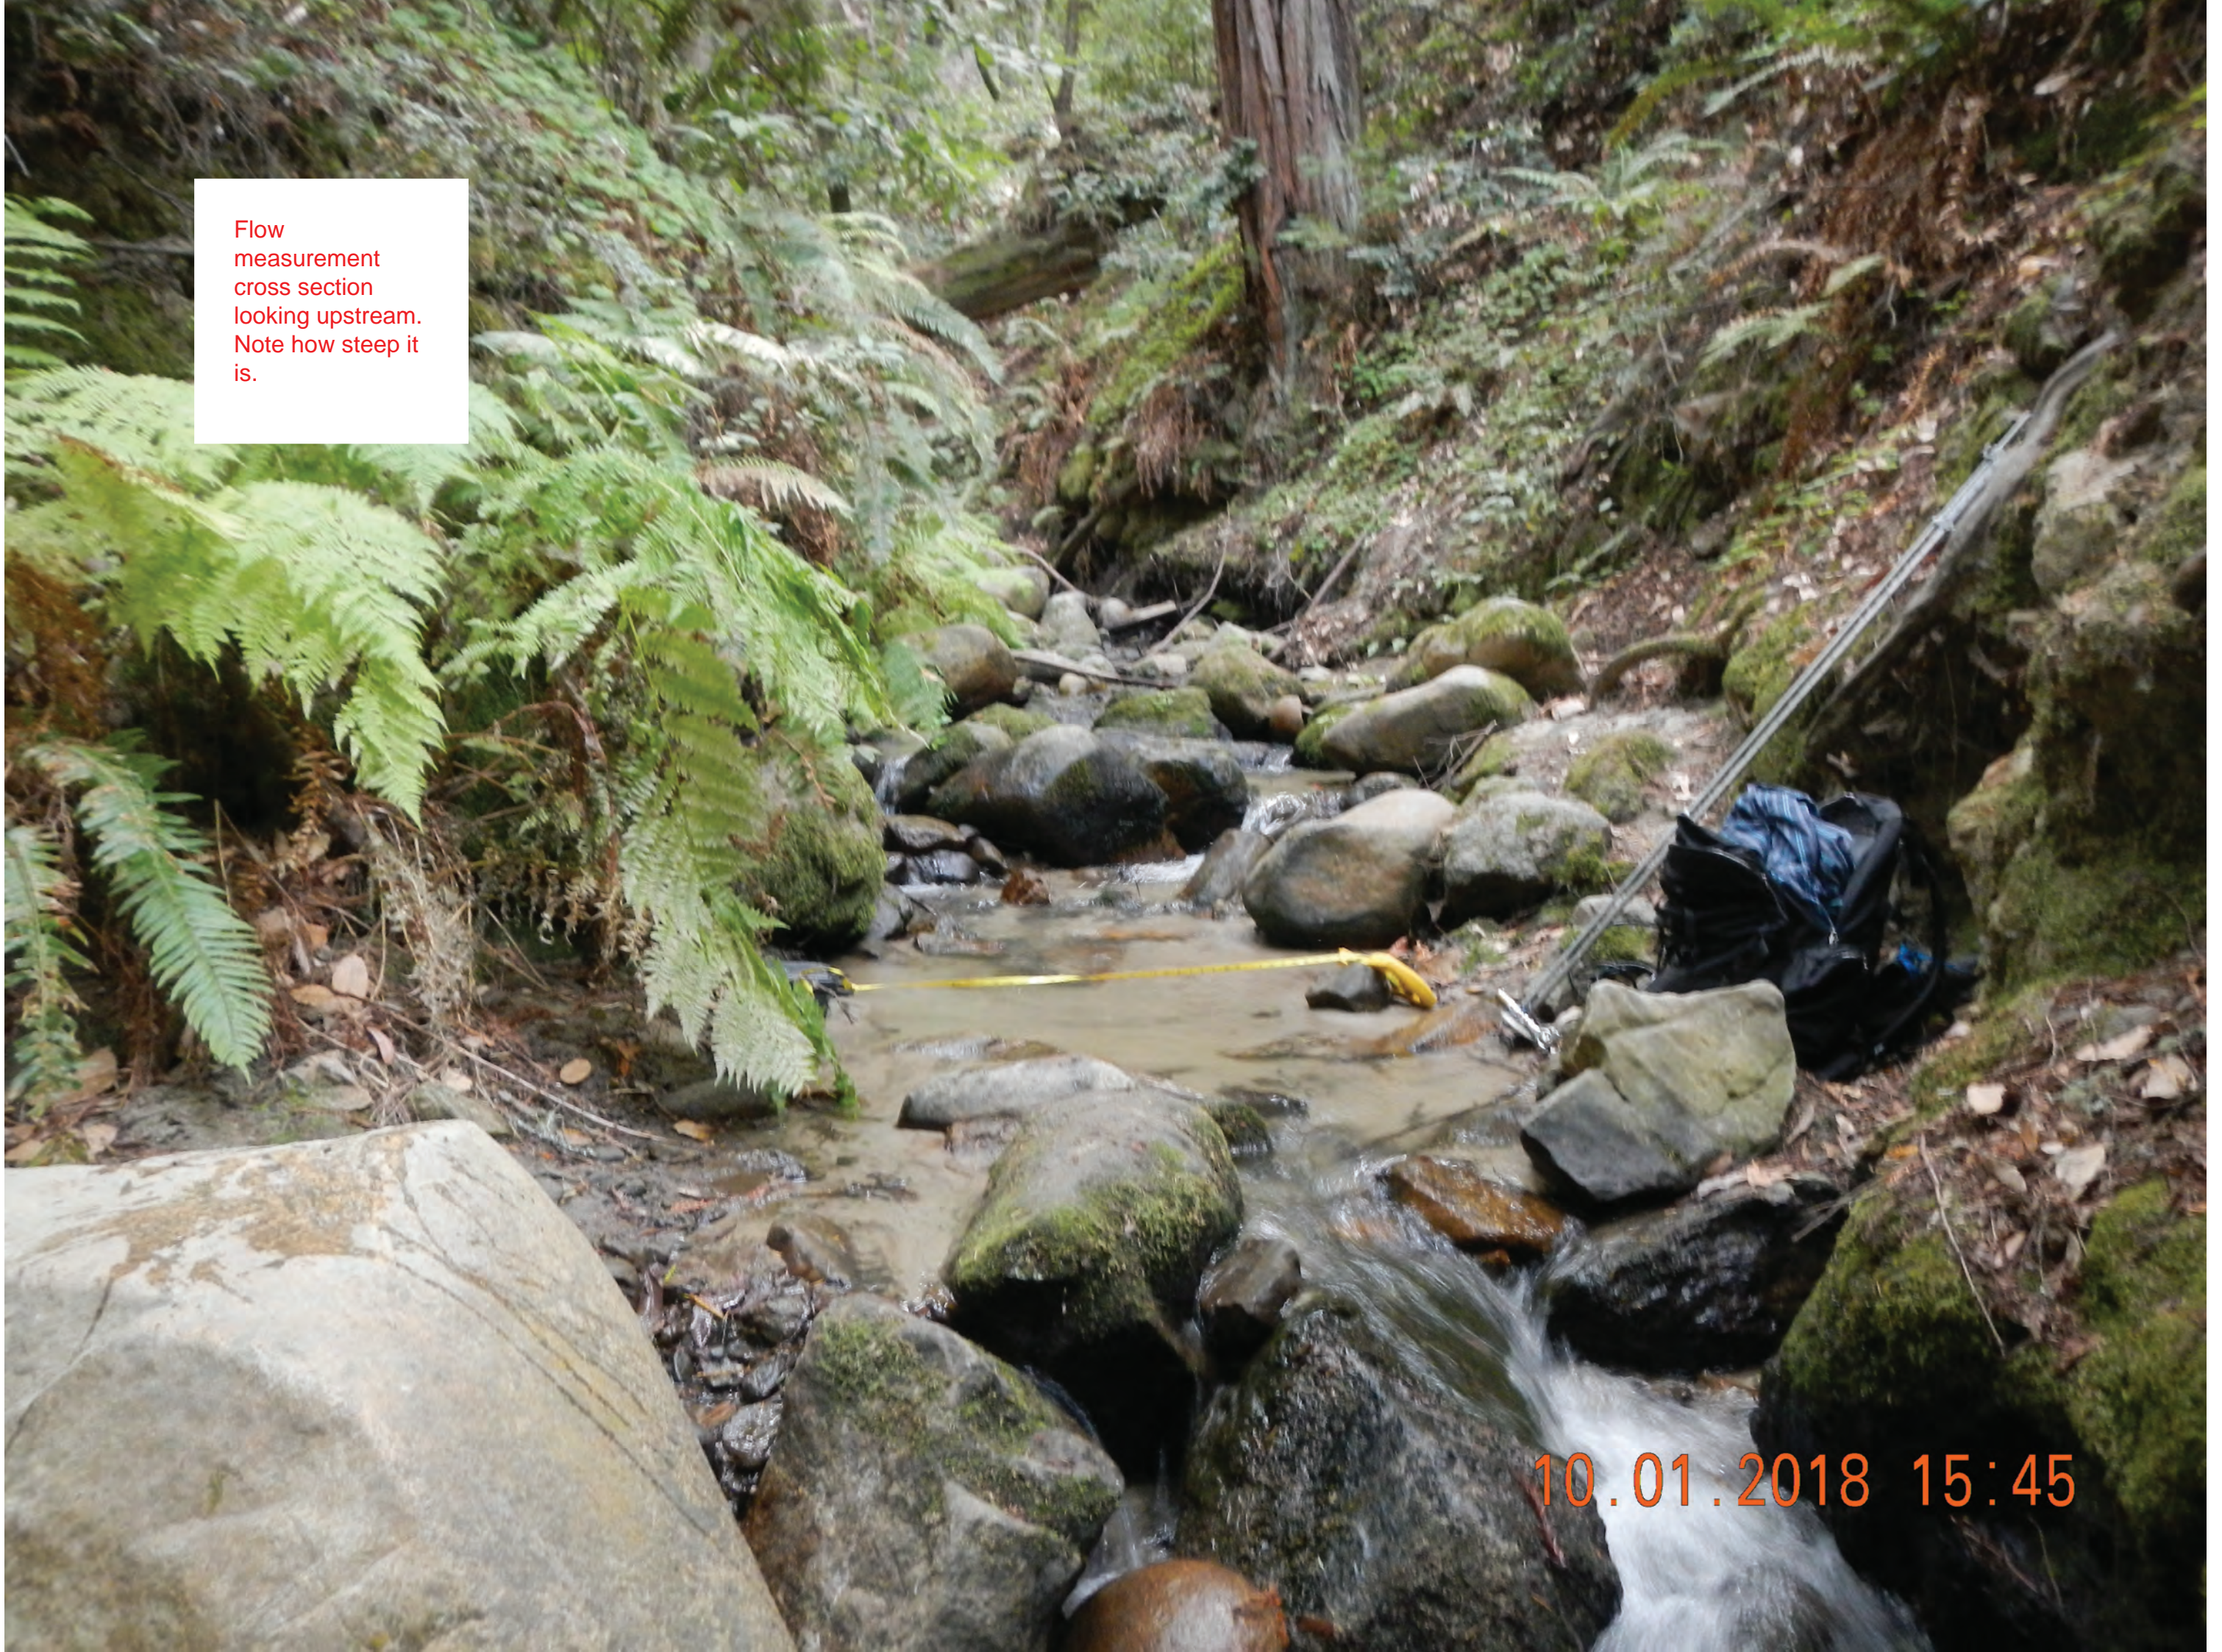
Flow  
measurement  
cross section  
looking upstream.  
Note how steep it is.

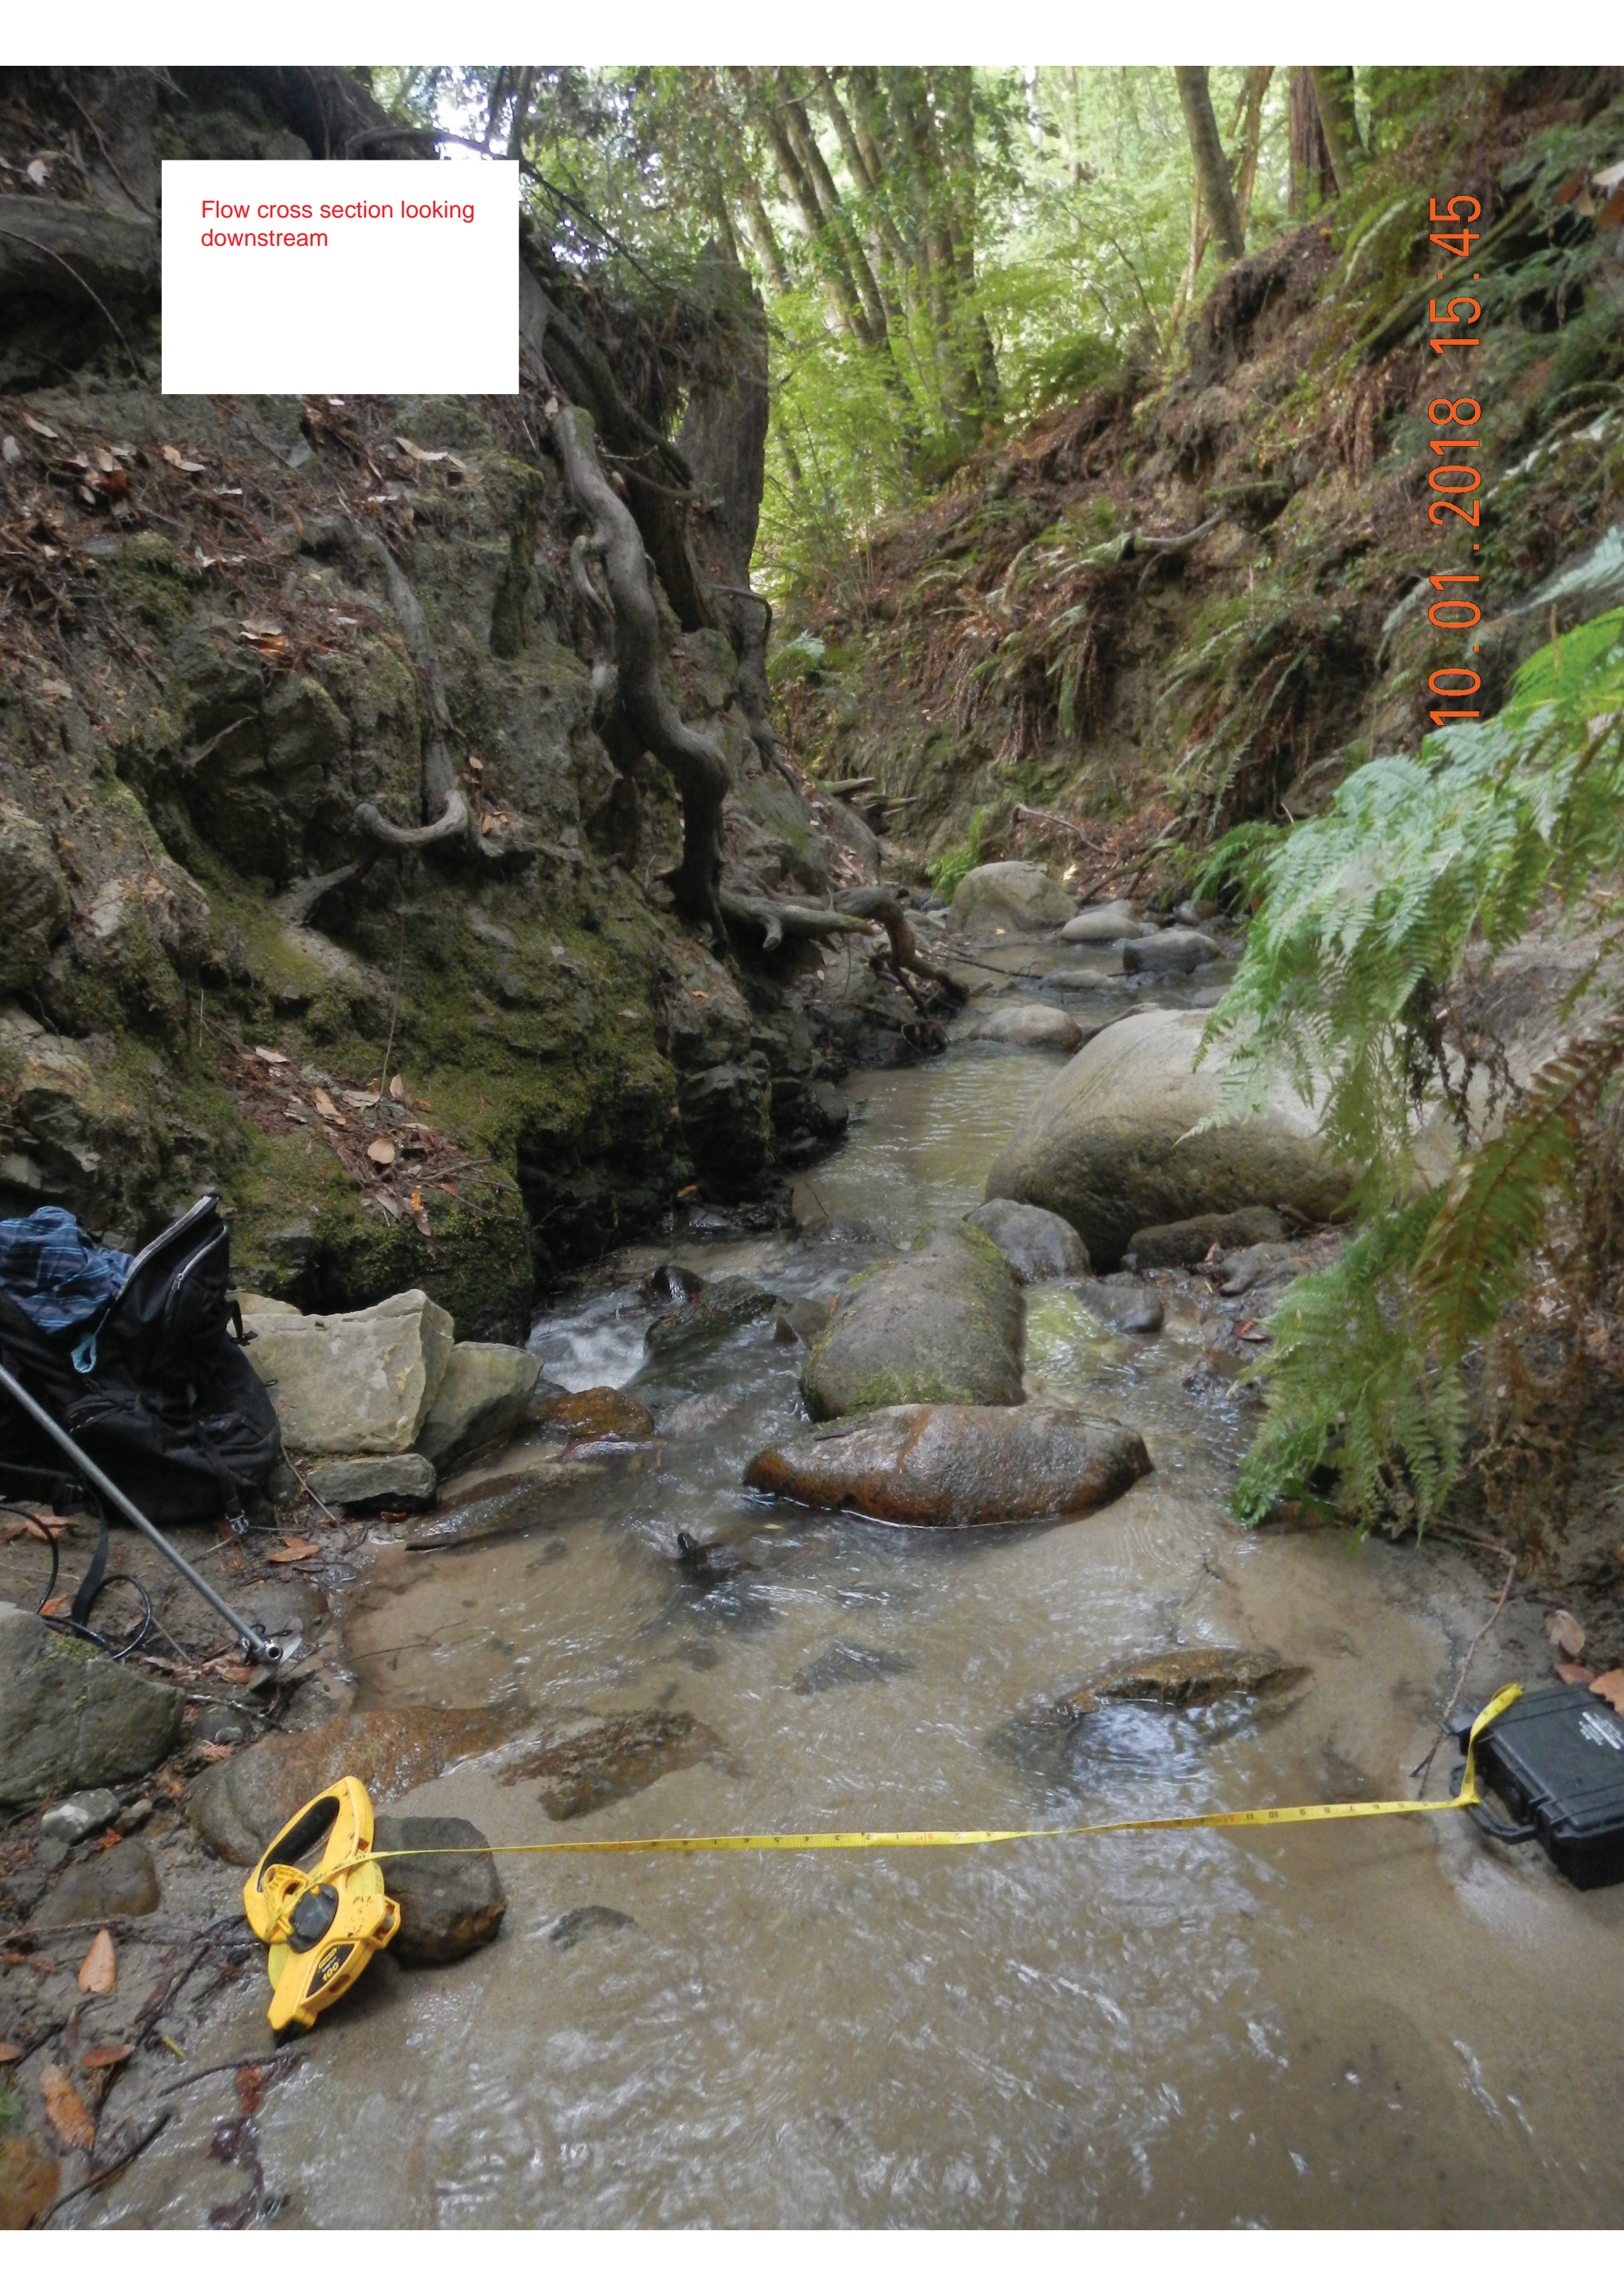
Flow cross section looking  
downstream

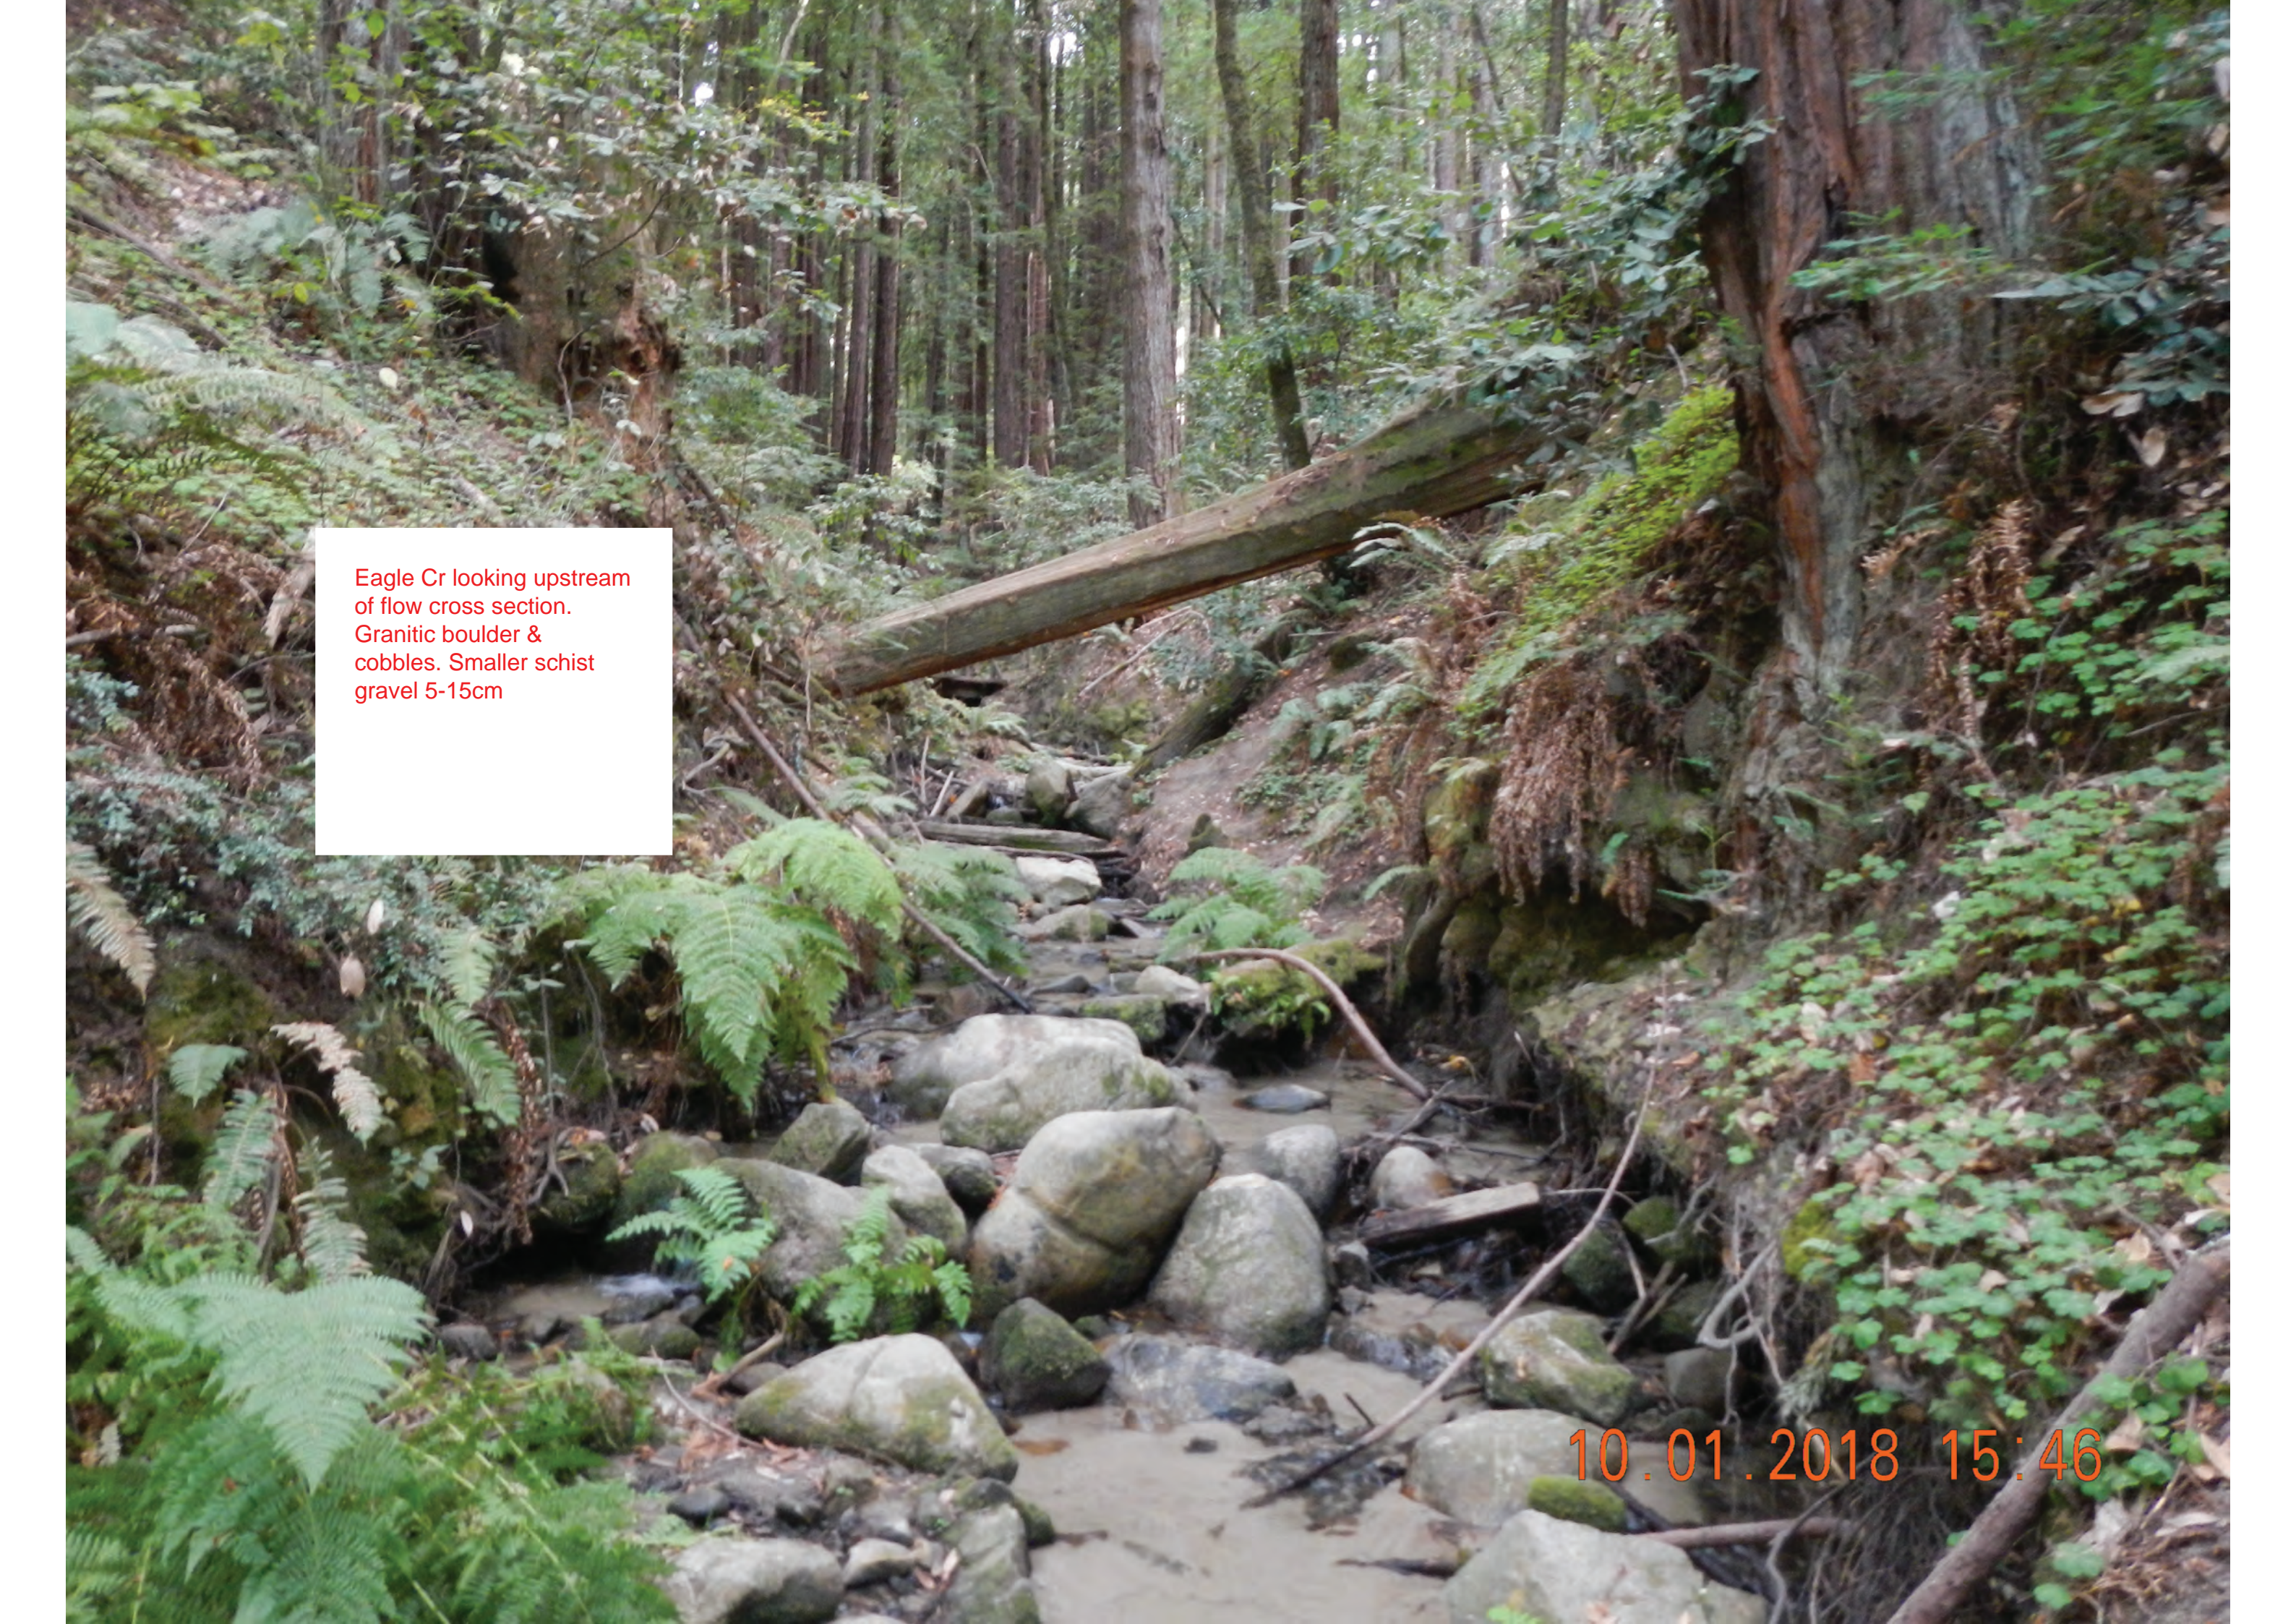
Eagle Cr looking upstream  
of flow cross section.  
Granitic boulder &  
cobbles. Smaller schist  
gravel 5-15cm

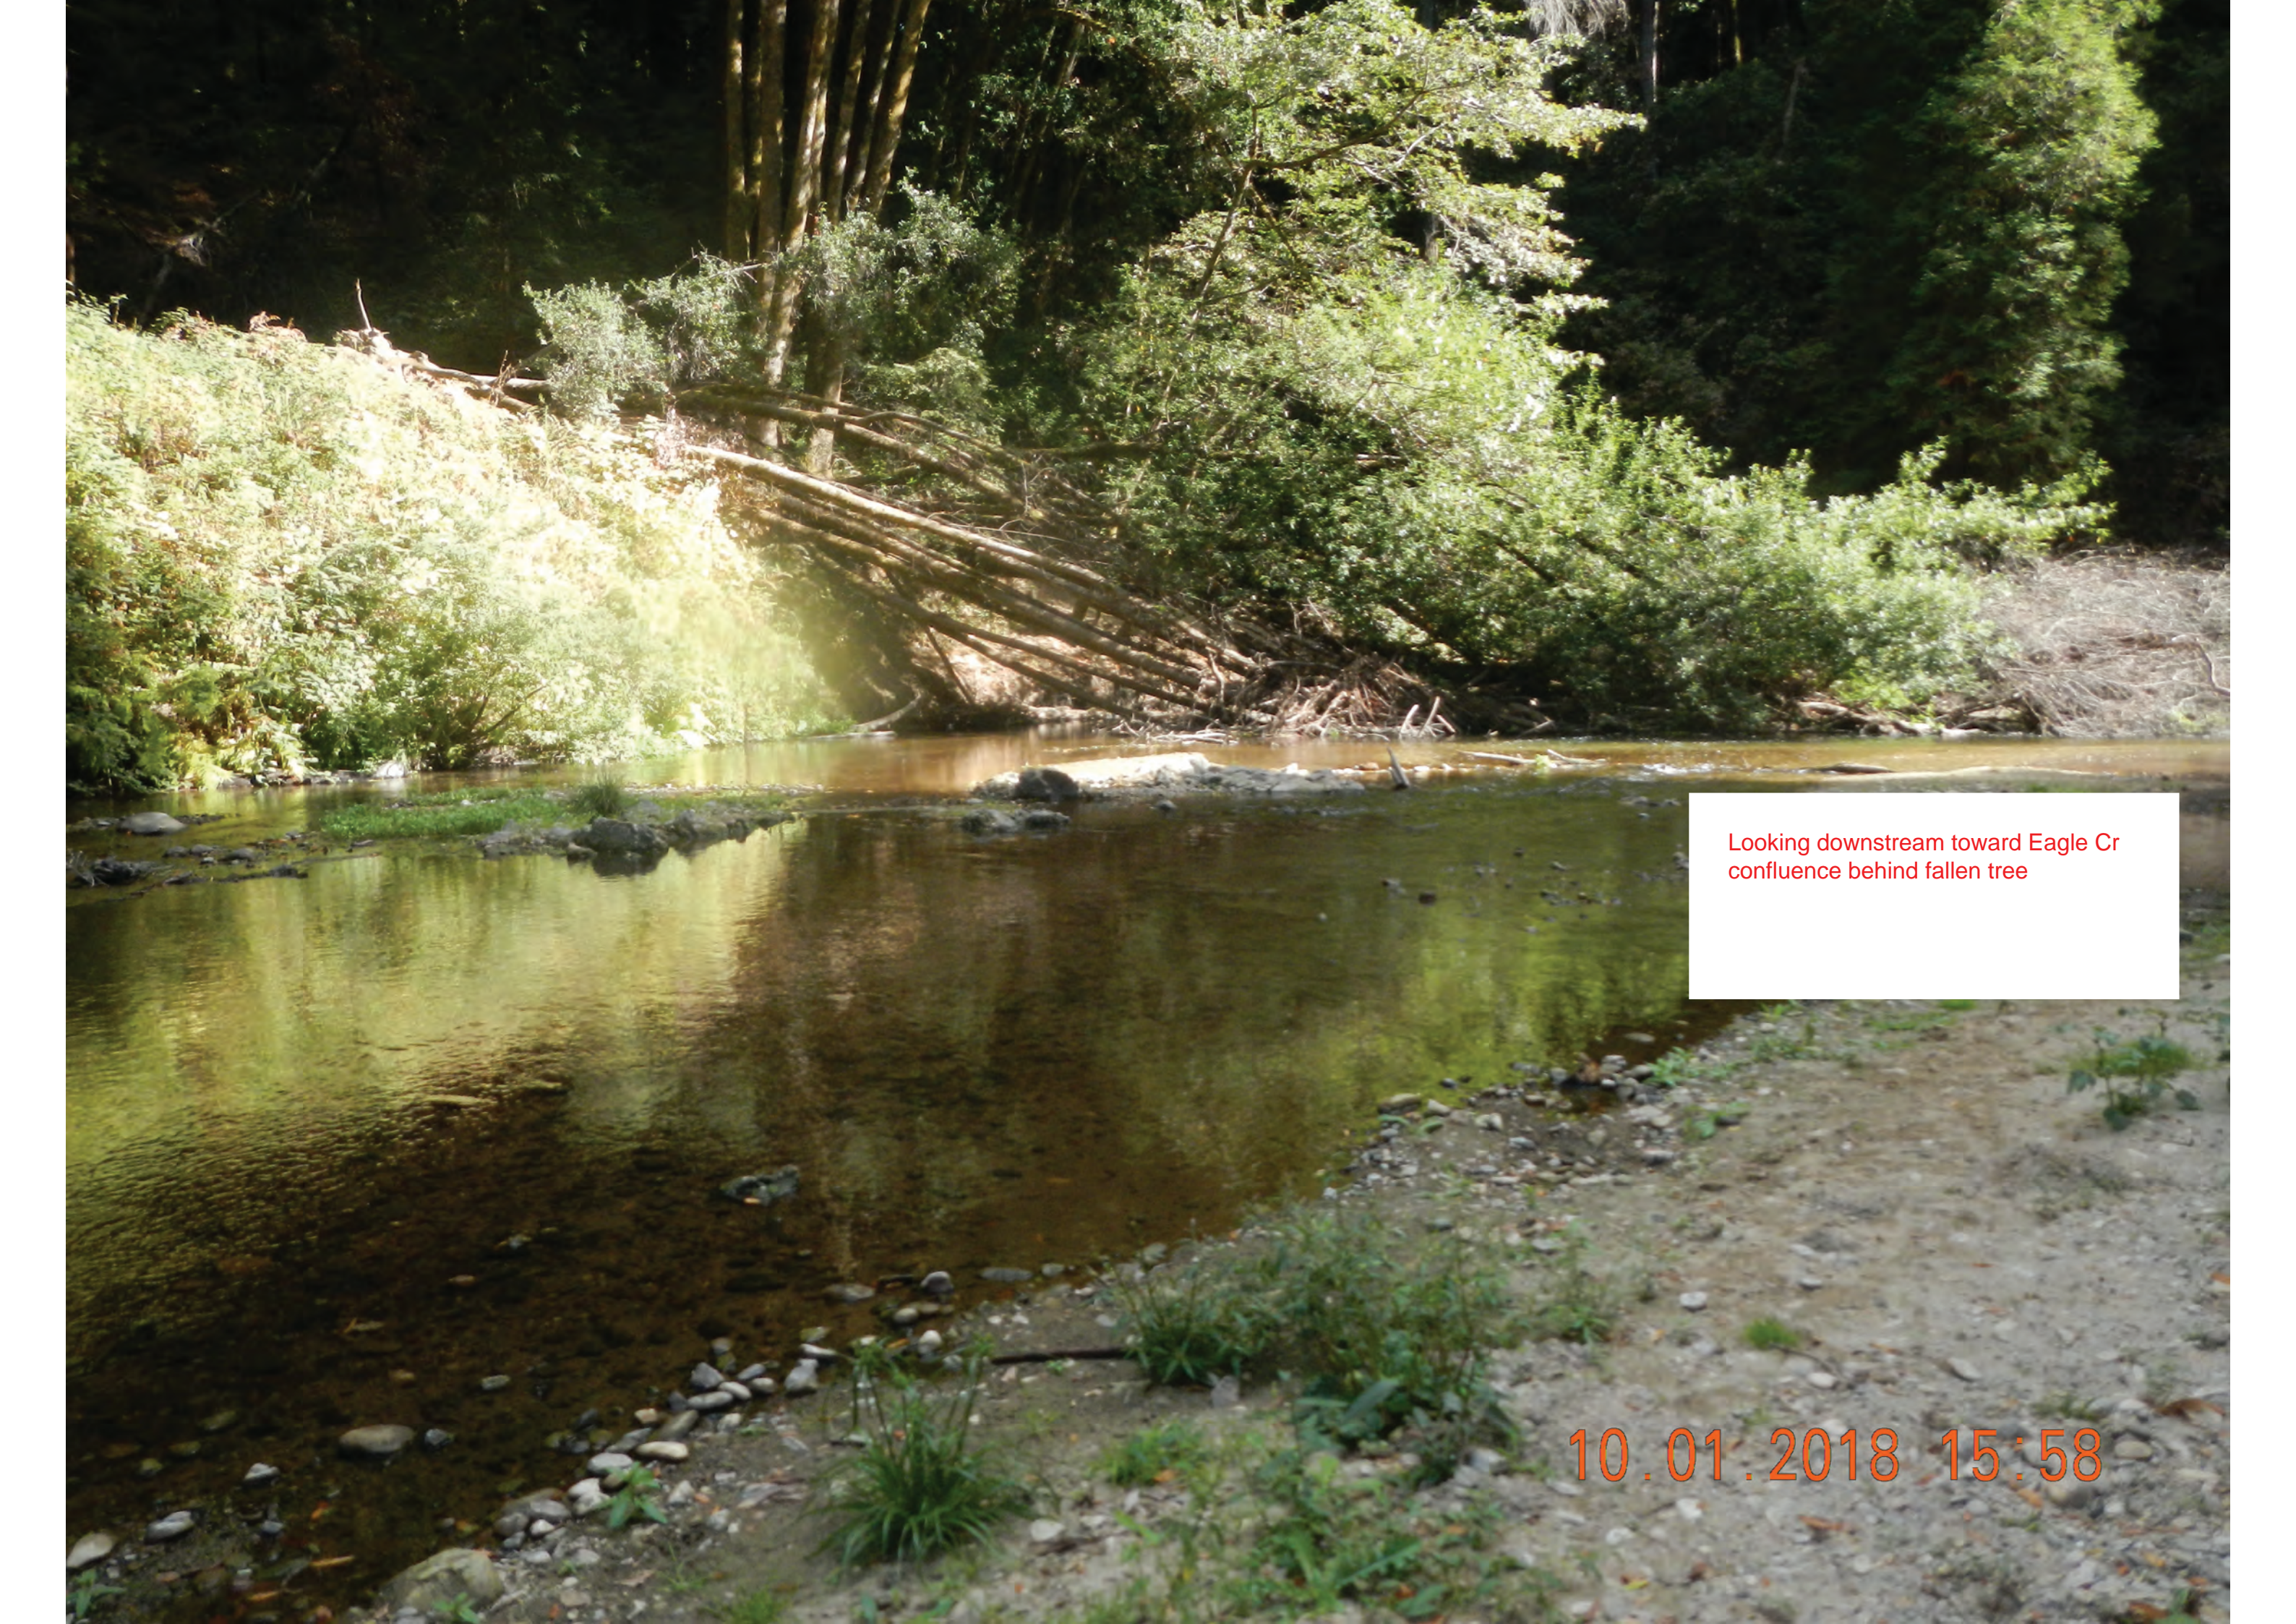
Alluvial fan at the outlet of Eagle Cr into the SLR.  
This fan has probably not been scoured by the higher flow of the SLR due to the fallen tree just upstream of the confluence creating a velocity shadow.
