San Lorenzo River Longitudinal Accretion and Hydrochemistry Reconnaissance

Prepared for:
County of Santa Cruz, Health Services—Environmental Health
700 Ocean Street, Room 312
Santa Cruz, California 95062

© 2022 Balance Hydrologics, Inc.
Project Assignment: 209153

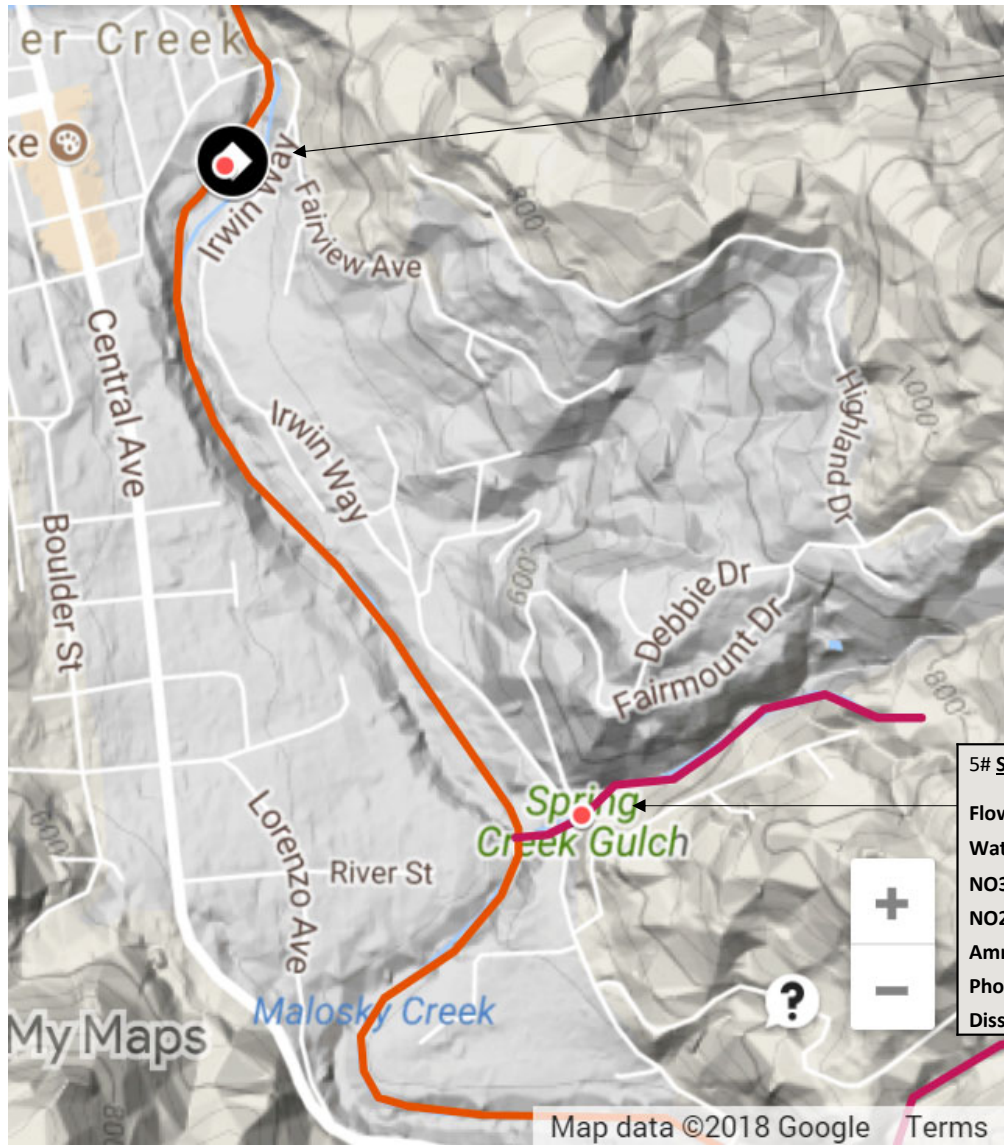
Figure 3: Sample locations and results: Irwin Way Reach

4# SLR, downstream of Boulder Cr at seasonal gage

Flow (cfs)	5.38
Water temp. °C, SCT at 25°C	17.4, 500
NO3 (mg/L)	0.27
NO2 (mg/L)*	0.33
Ammonium (mg/L)*	0.03
Phosphate (mg/L)*	0.54
Dissolved silica (mg/L)*	33.61

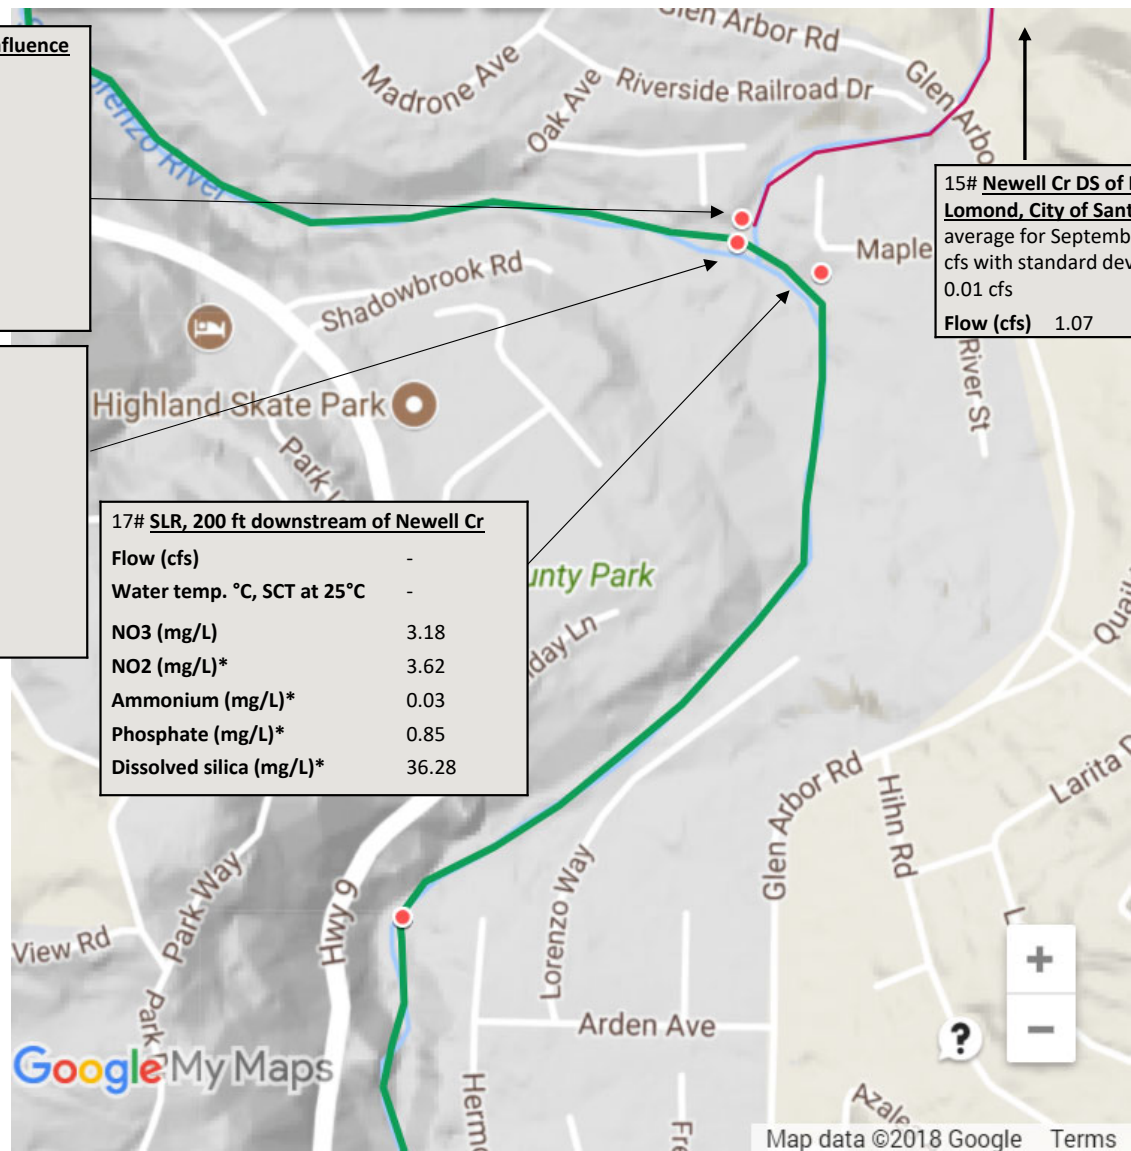
Figure 10: Sample locations and results: Glen Arbor Reach (2 of 2)

15# Newell Cr DS of Loch Lomond, City of Santa Cruz gage.
average for September was 1.07 cfs with standard deviation of 0.01 cfs

Flow (cfs)	1.07
------------	------

14# Newell Cr at Rancho Rio Bridge. Follow-up measurement 9/19/18 after main water quality sampling.

Flow (cfs)	1.25
Water temp. °C, SCT at 25°C	15.7, 355
NO3 (mg/L)	0.98
NO2 (mg/L)*	1.09
Ammonium (mg/L)*	0.01
Phosphate (mg/L)*	0.51
Dissolved silica (mg/L)*	33.43
