**SAN LORENZO RIVER LONGITUDINAL
FLOW ACCRETION AND HYDROCHEMISTRY
RECONNAISSANCE,
SUMMER OF WATER YEAR 2019
SANTA CRUZ COUNTY, CALIFORNIA**

**ALSO CONTAINS THE HYDROLOGIC SUMMARY FOR STREAM GAGES, 2017-2019, FOR BEAN CREEK
ABOVE ITS MOUTH AT MOUNT HERMON CAMP, ZAYANTE CREEK AT WOODWARDIA, AND NEWELL
ABOVE ITS MOUTH.**

Balance Hydrologics, Inc.

June 8, 2022

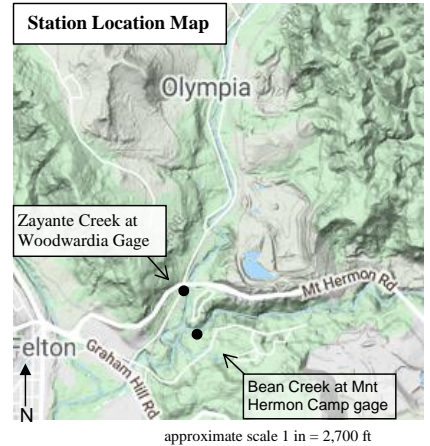
Form 2. Annual Hydrologic Record, WY2018

Station Location
 Latitude: 37° 03' 19.85" N, Longitude: 122° 03' 36.69" W (WGS84), Santa Cruz County, CA. Gage is located on the upstream side of the concrete weir just upstream of the Woodwardia Bridge 0.47 miles up E. Zayante Rd from the intersection with Graham Hill Rd. Site is almost directly under Mount Hermon Bypass bridge. Land use is primarily rural residential. Drainage area is approximately 16.76 sq. mi.

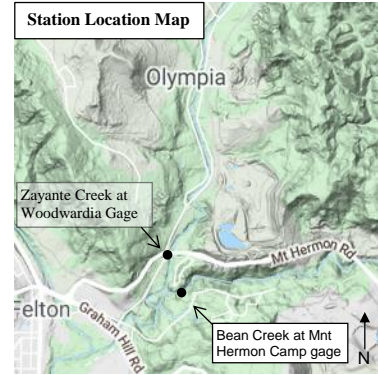
Latitude: 37.05246, Longitude: -122.05971 (WGS84), Santa Cruz County, CA.
 Gage is located approximately 80 feet upstream of the abandoned foot bridge on the right bank. Previously located (WY09-12) downstream of the current gage approximately 150 feet or about 70 feet downstream of the abandoned foot bridge on the left bank (facing downstream). Drainage area is approximately 9.64 square miles.

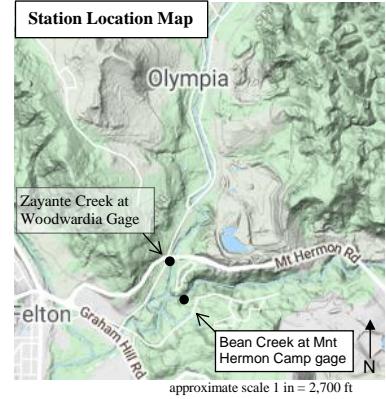
Form 5. Annual Hydrologic Record, WY2018

Station Location
 Latitude: 37.05246, Longitude: -122.05971 (WGS84), Santa Cruz County, CA.
 Gage is located approximately 80 feet upstream of the abandoned foot bridge on the right bank. Previously located (WY09-12) downstream of the current gage approximately 150 feet or about 70 feet downstream of the abandoned foot bridge on the left bank (facing downstream). Drainage area is approximately 9.64 square miles.

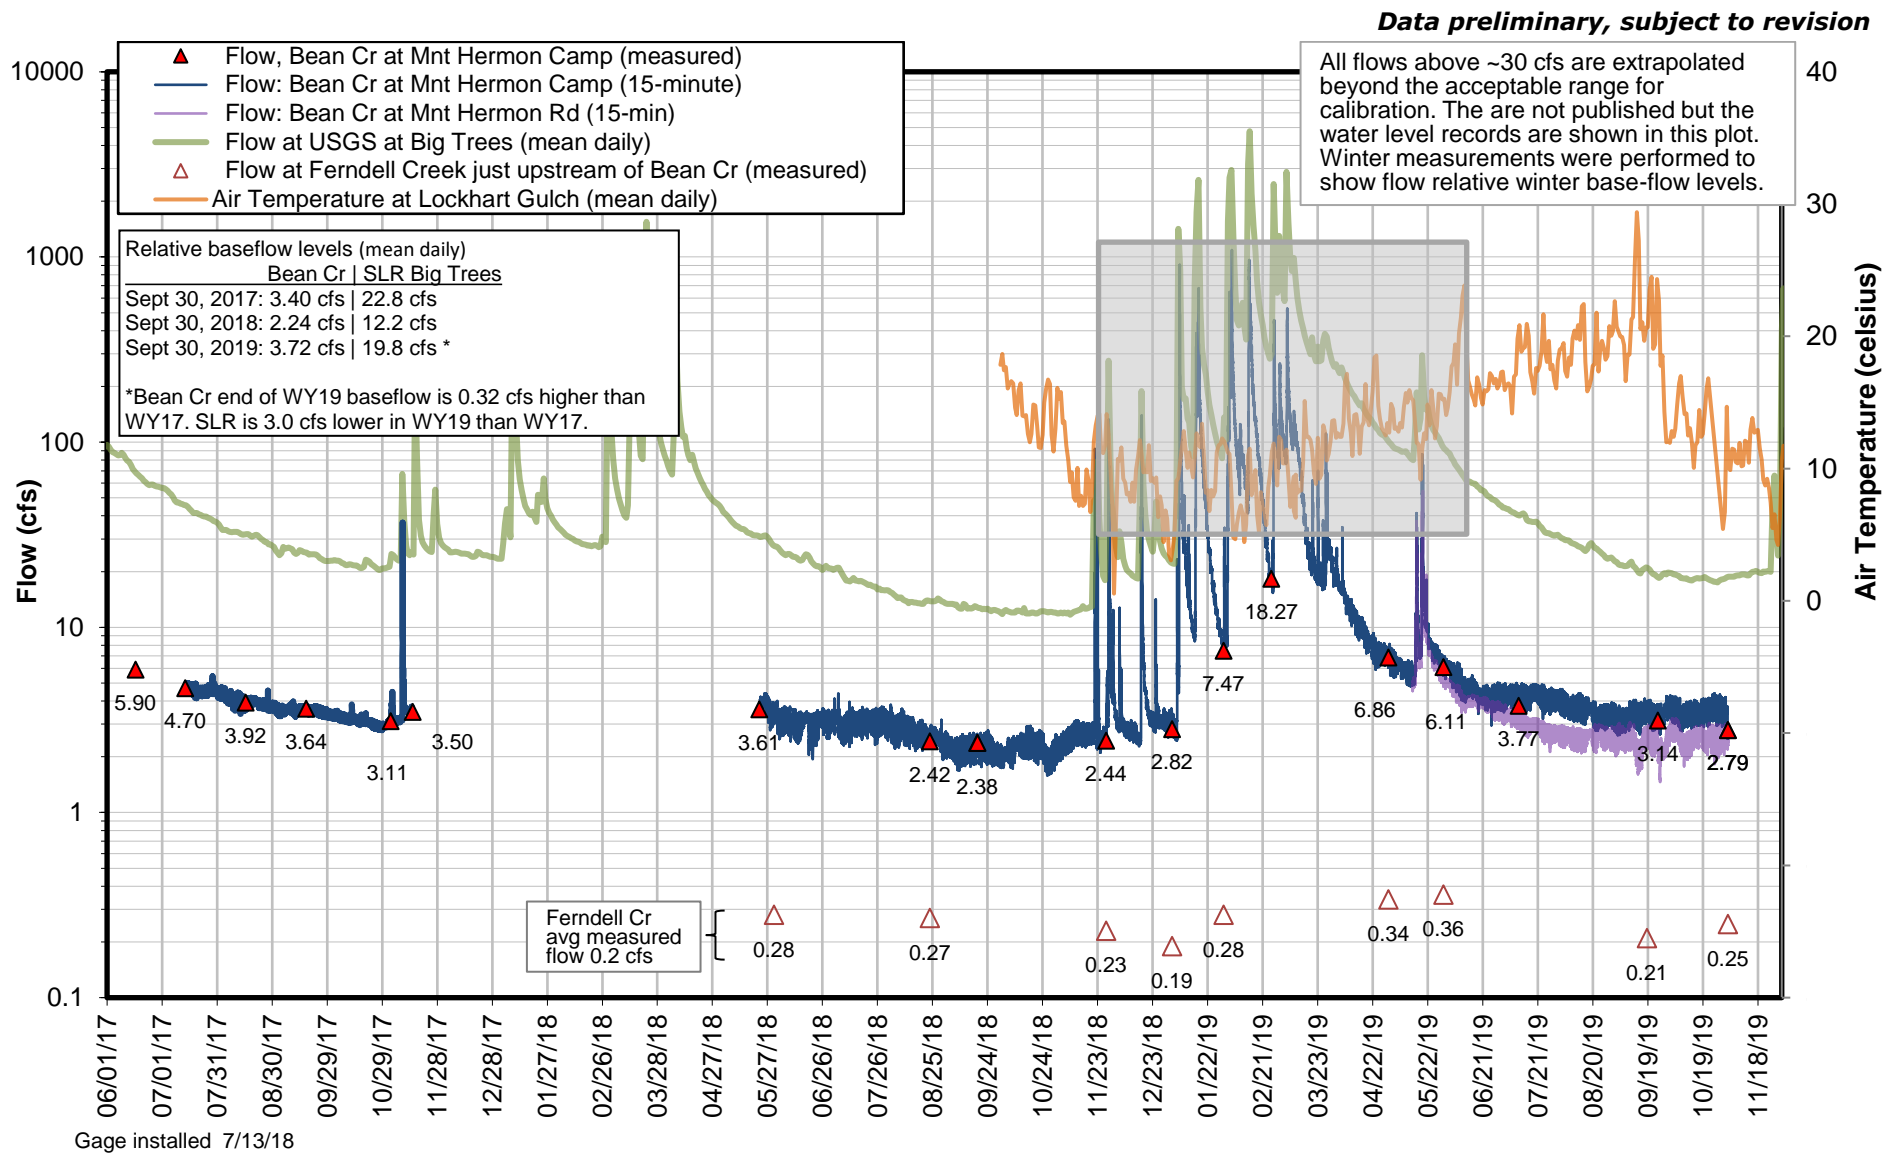
Figure 12. Flow: Bean Creek above mouth at Mount Hermon Camp, Santa Cruz County, California. June 1, 2017 through November 28, 2019

Diurnal fluctuations at the Mnt Hermon Road and Mnt Hermon Camp are about 0.5 cfs. The general rate of baseflow decline appears to behave independently of hot spells at both gages. weather station: wunderground.com, KCASCOTT9

Flow conditions for lower Bean Creek at Mount Hermon Camp, Zayante Creek at Woodwardia, and Newell Creek at its mouth (150 feet upstream of the San Lorenzo River) for water years 2017 to 2019 can respectively be seen in the hydrograph figures 12, 14, and 16 for as well as in the **Tables 1 through 8**.

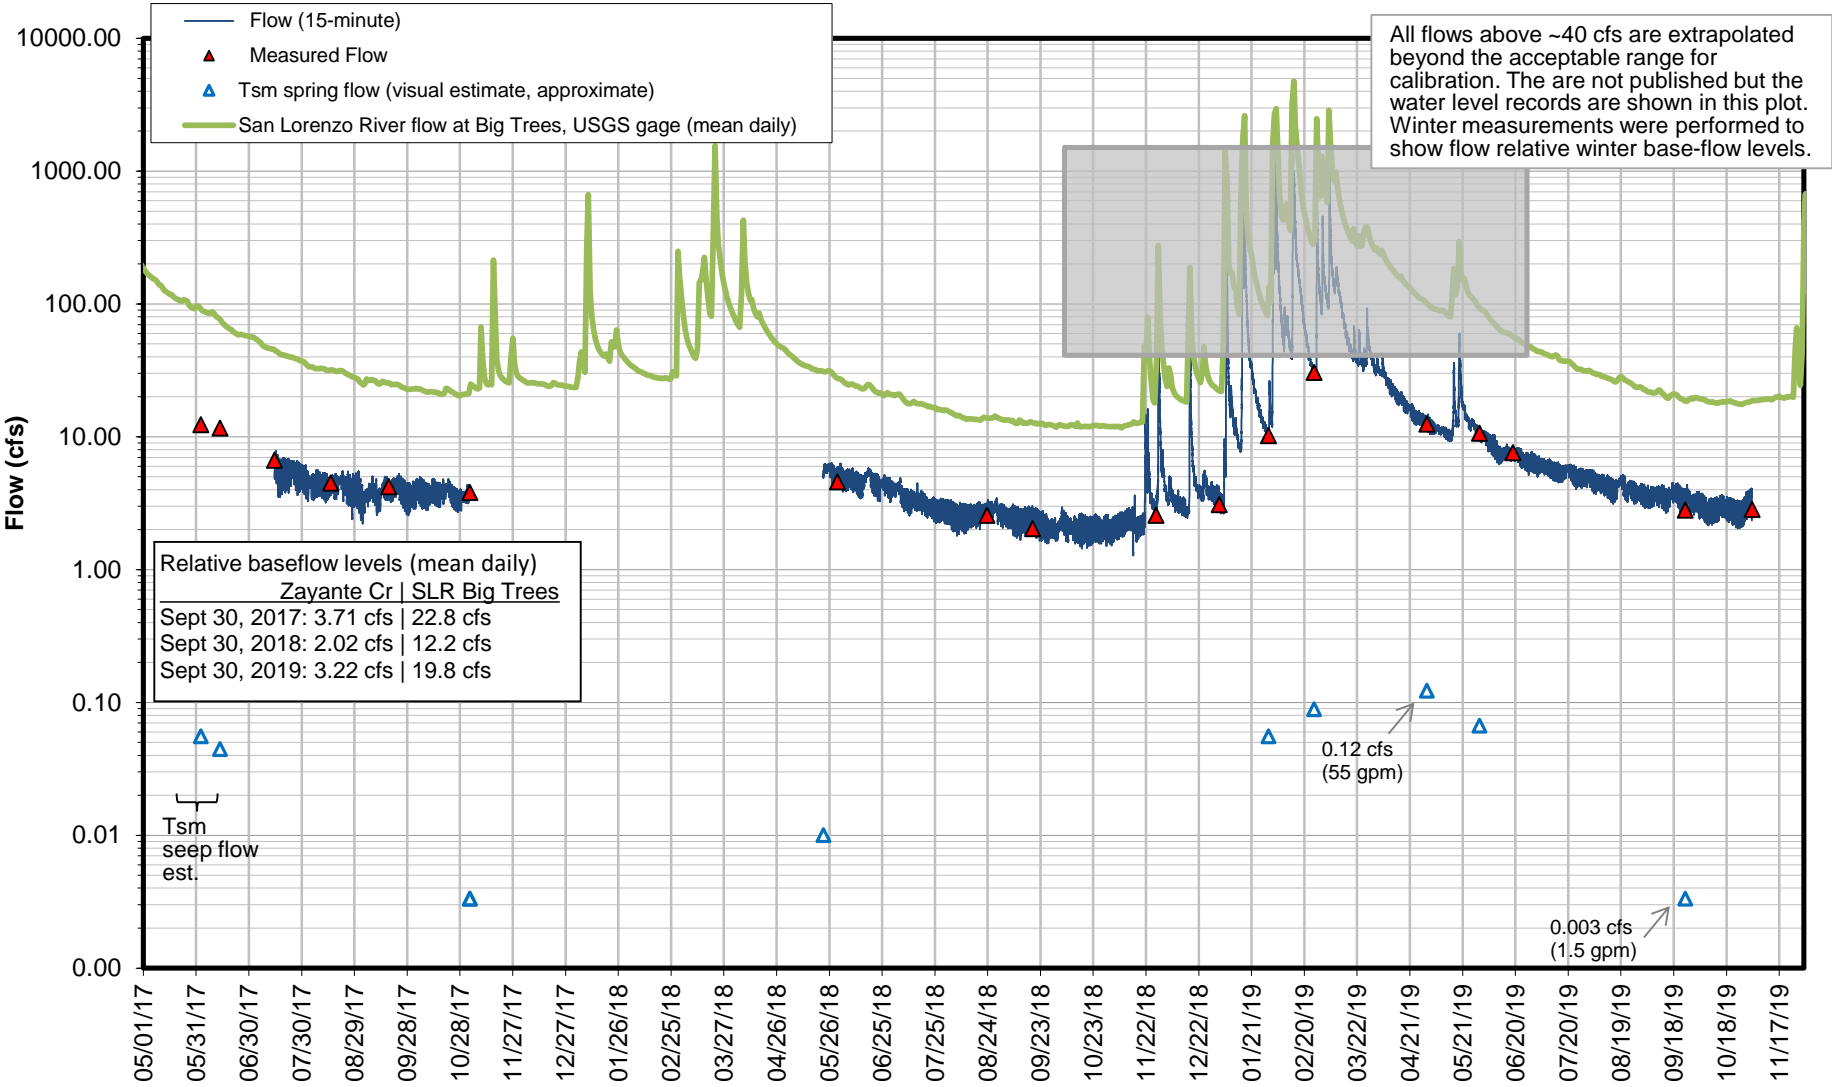
Figure 14. Flow: Zayante Creek at Woodwardia weir, Santa Cruz County, California, June 2, 2017 through November 1, 2019

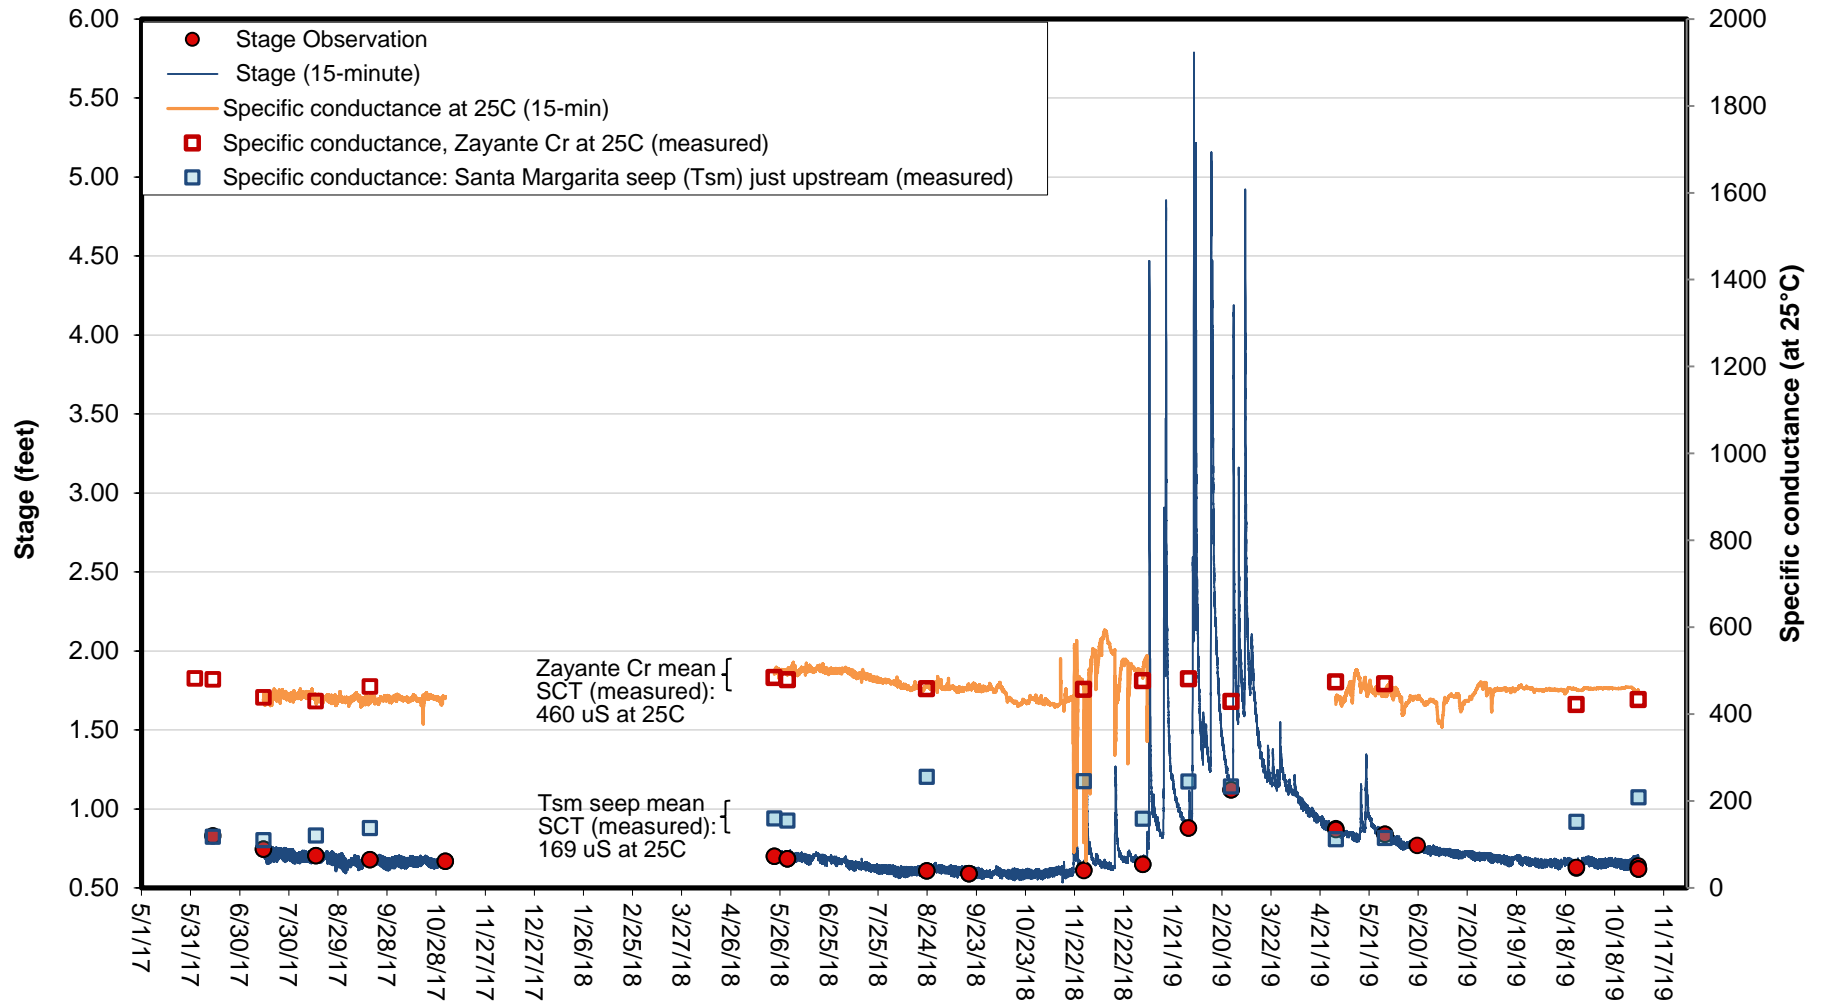
Figure 15. Stage and specific conductance: Zayante Creek at Woodwardia weir, Santa Cruz County, California, June 2, 2017 through November 1, 2019

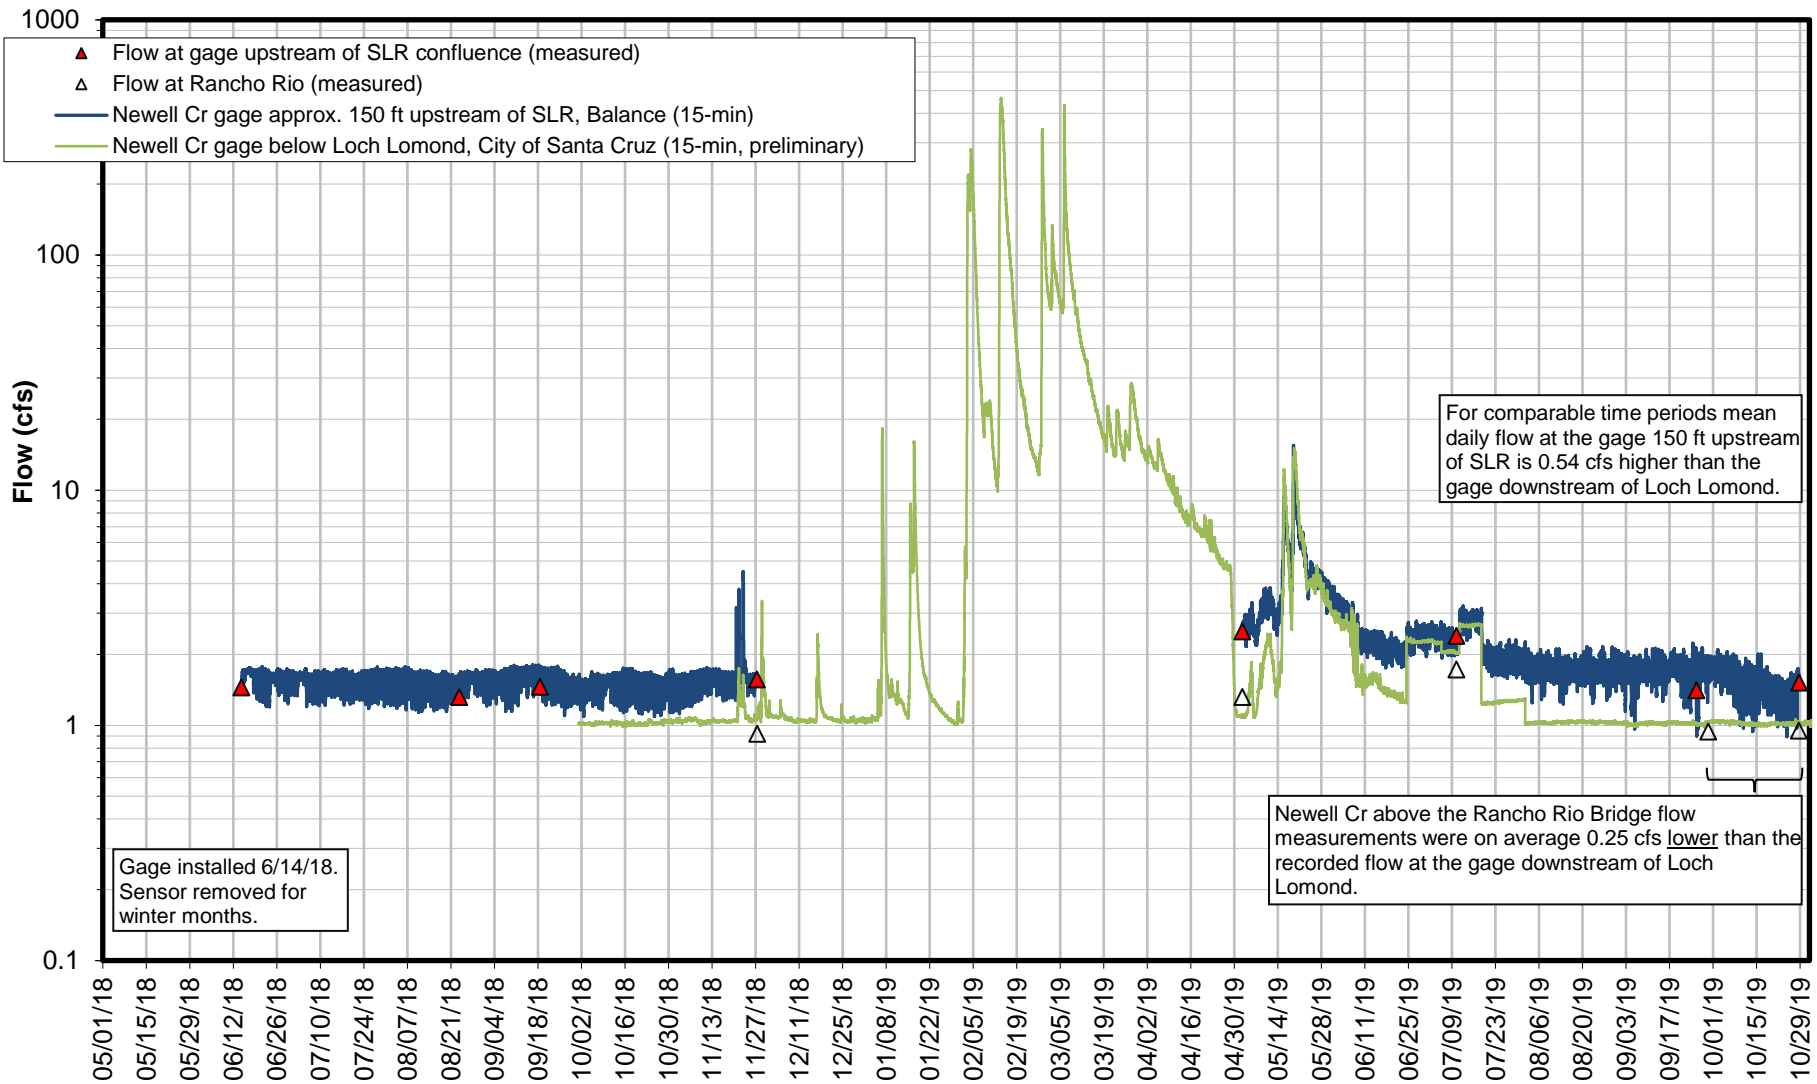
Figure 16. Flow: Newell Creek approximately 150 feet upstream from the San Lorenzo River, Santa Cruz County, California, June 14, 2019 through October 28, 2019

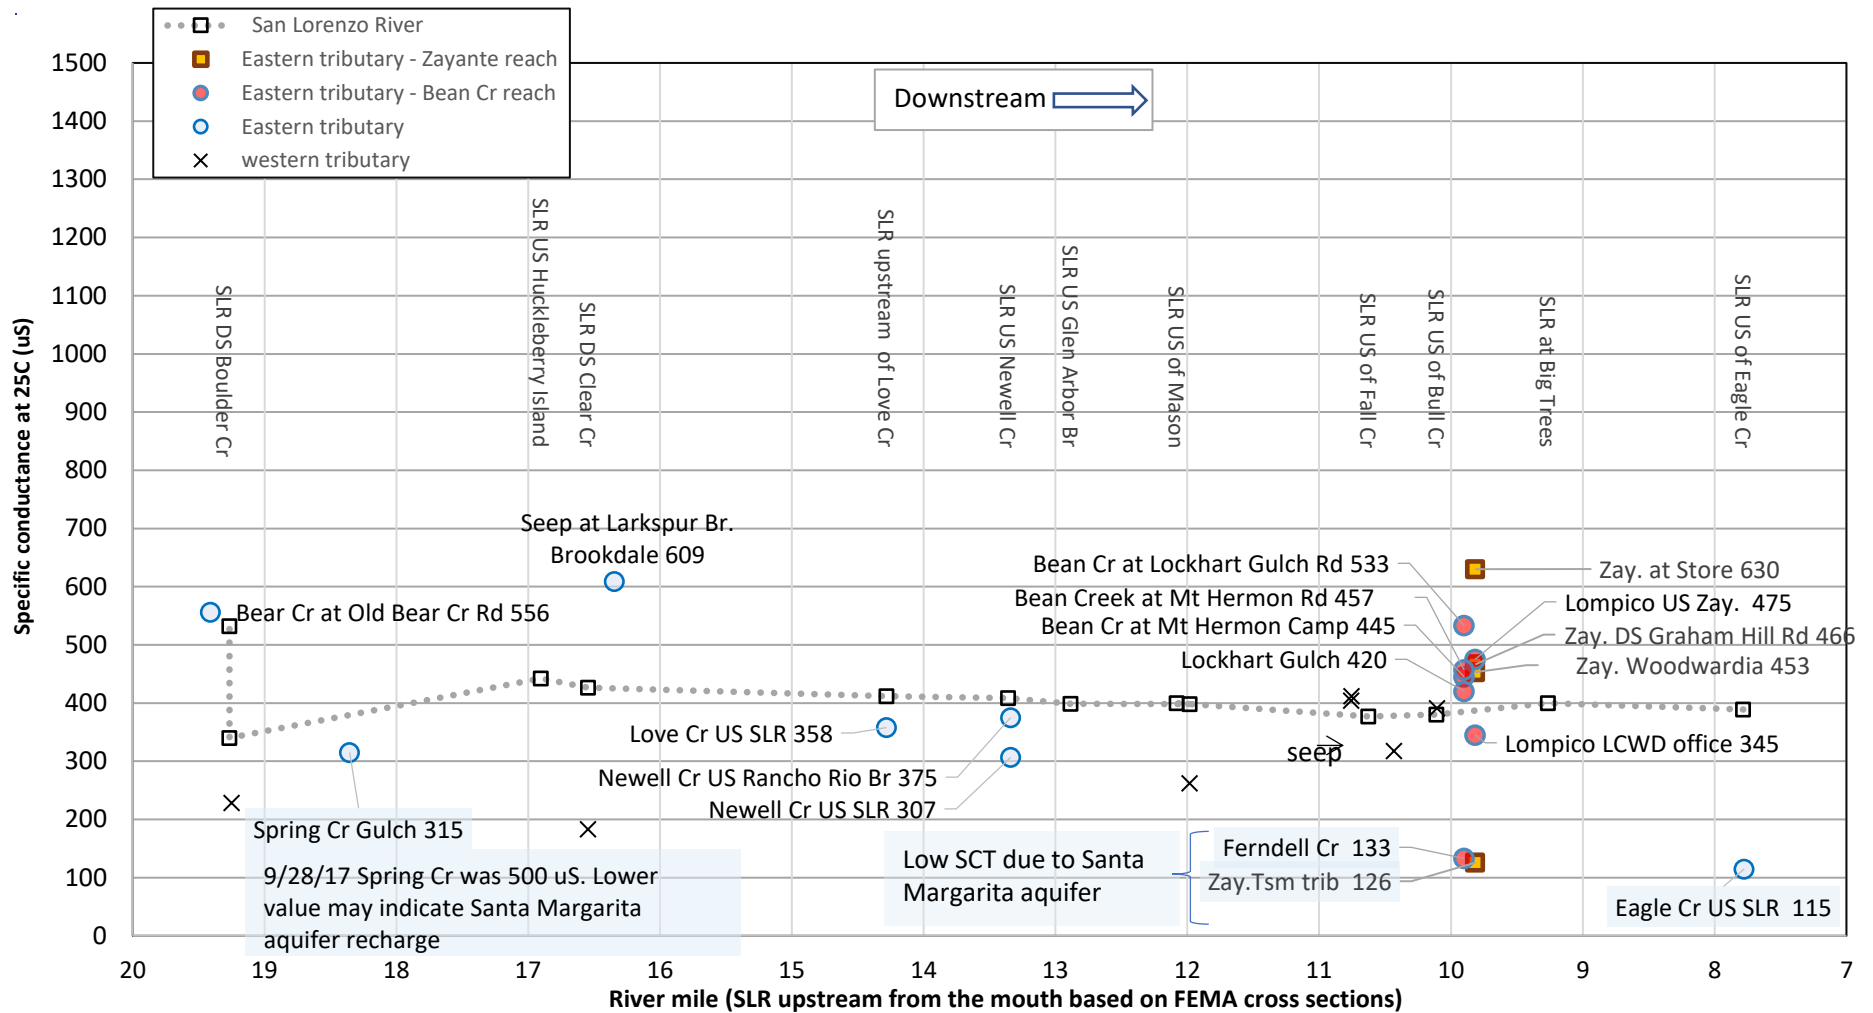
Figure 20: San Lorenzo River watershed, downstream changes in specific conductance, June 16, 2019, Santa Cruz County, CA. San Lorenzo River data points are connected to illustrate the influence of downstream contributions. Bear Cr and Zayante reach at same river mile.

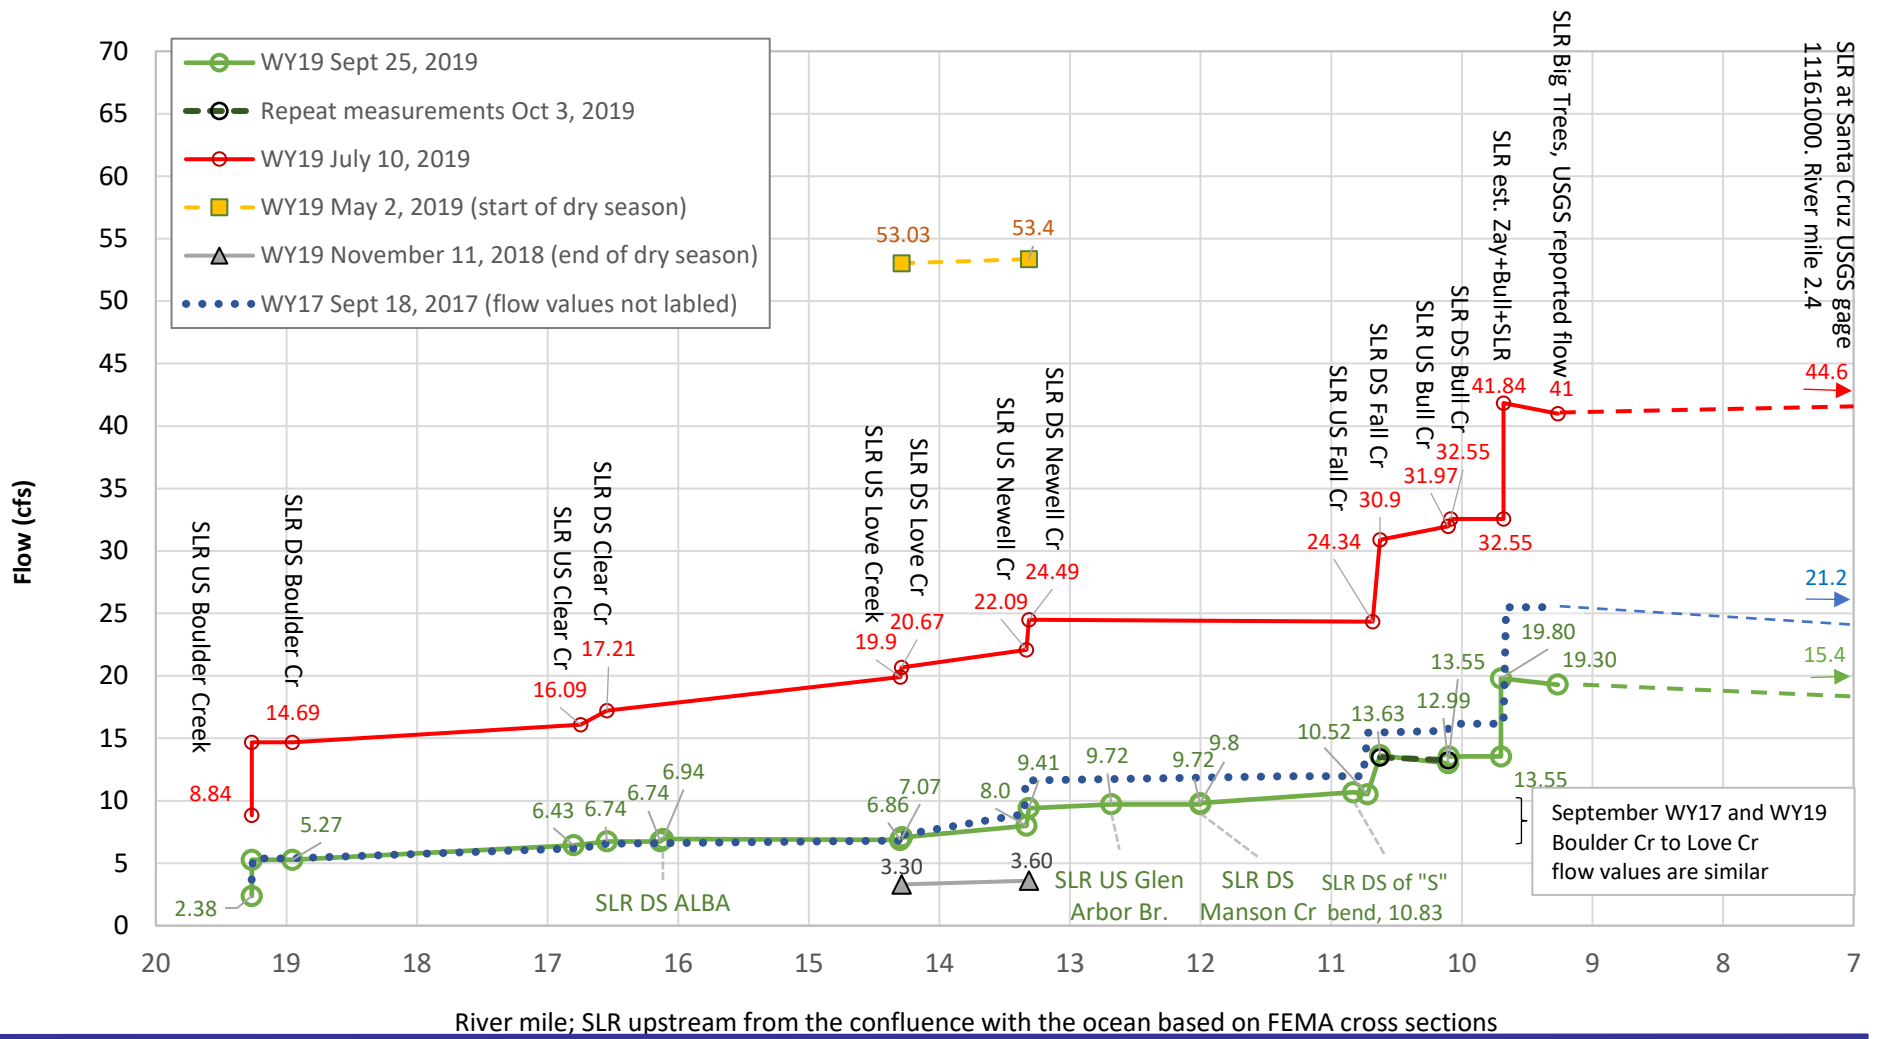
Figure 21: San Lorenzo River downstream changes in flow, water years 2017 to 2019, Santa Cruz County, CA. Points are based on measured or estimated flow values on the San Lorenzo River and tributaries.
