**SANTA MARGARITA BASIN
STREAMFLOW MONITORING,
DRY SEASON OF 2021**

Report prepared for:
County of Santa Cruz, Environmental Health Services

Balance Hydrologics, Inc.

May 2022

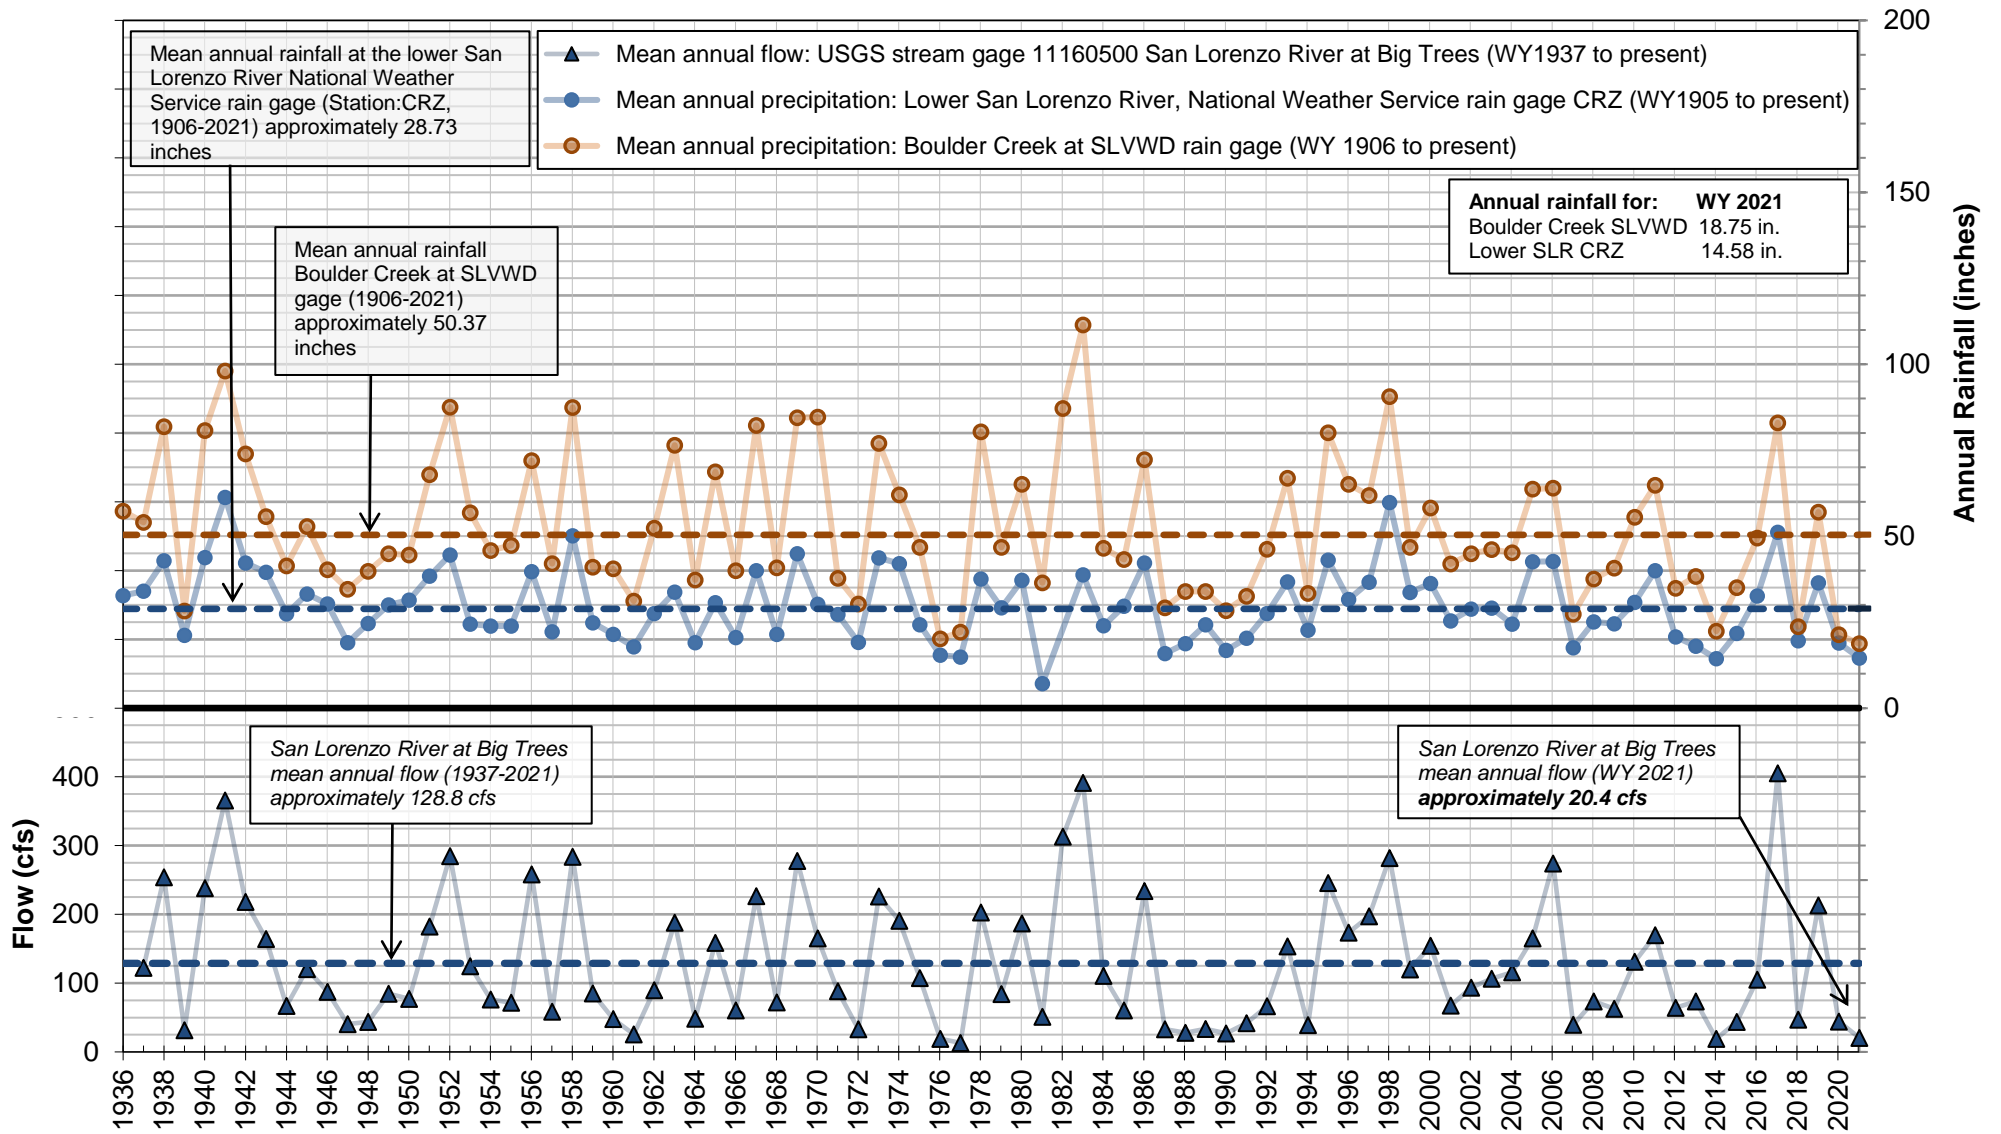
Figure 2. Comparison of historic annual rainfall in San Lorenzo Basin to annual streamflow at USGS Gage 11160500, San Lorenzo River at Big Trees, Santa Cruz County, CA

Water year 2021 can be characterized as a critically dry year, with below-average annual precipitation, which resulted in lower-than-average flows (**Figure 2**). The San Lorenzo Valley Water District rain gage in Boulder Creek received 18.75 inches of rain (approximately 37% of the long-term average) and the CDEC rain gage in Santa Cruz (CRZ) received 14.58 inches of rain (approximately 51% of the long-term average) This is the second consecutive below average rainfall year. During water year 2020 in Boulder Creek received 21.40 inches of rain (approximately 42.5% of the long-term average) and the CDEC rain gage in Santa Cruz (CRZ) received 18.94 inches of rain (approximately 66% of the long-term average). The resulting runoff during water year 2021 from the San Lorenzo River was approximately 20.4 cfs or 16% of the long-term average, as measured at the USGS Big Trees stream gage. Streamflow during water year 2020 was 44.4 cfs or 35% of the long-term average at the Big Trees gage. See **Figure 1** for gage locations.

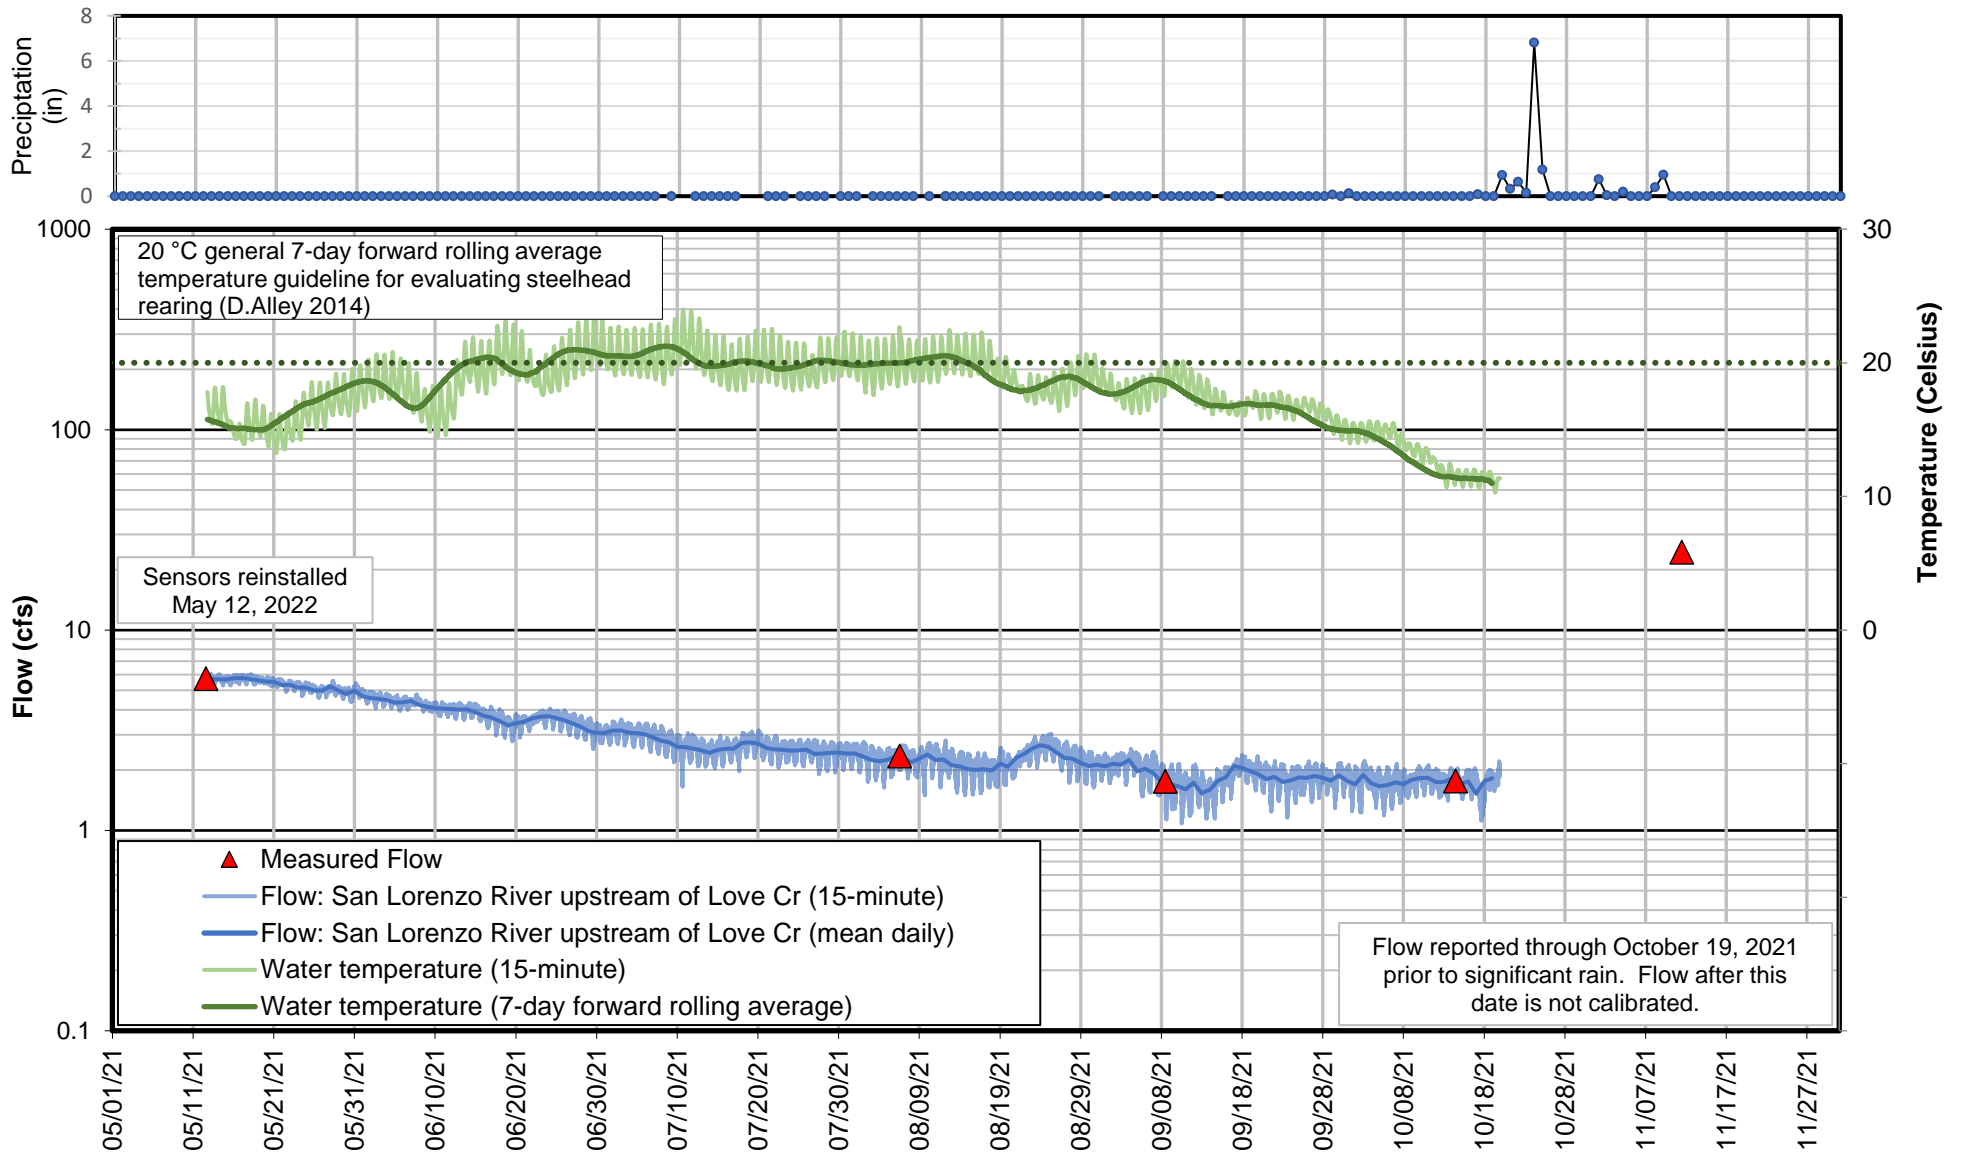
Figure 3. Flow and water temperature at the San Lorenzo River upstream of Love Creek, dry season 2021, Santa Cruz County, CA Precipitation data from SLVWD downtown Boulder Creek gage

Hydrographs of 15-minute flows and mean daily values for gaged seasonal flows for San Lorenzo River above Love Creek, Newell, Zayante, and Bean Creeks, are shown on **Figures 3 – 6**. Water temperature and precipitation were also plotted to compare natural fluctuations at the gages. Plots of specific conductance and temperature for each gage are shown in **Figures 7 -10**. Measurements and observations for each gage are shown in **Tables 1 – 4** and a summary of daily mean flow for each gage are shown in **Forms 1 – 4**.

The mean daily seasonal baseflow recession at the San Lorenzo River upstream of Love Creek gage ranged from about 5.7 cfs down to about 1.5 to 1.8 cfs prior to the first rain in October (**Figure 3**). The slight rise in baseflow prior to rainfall is likely associated with reduced evapotranspiration.

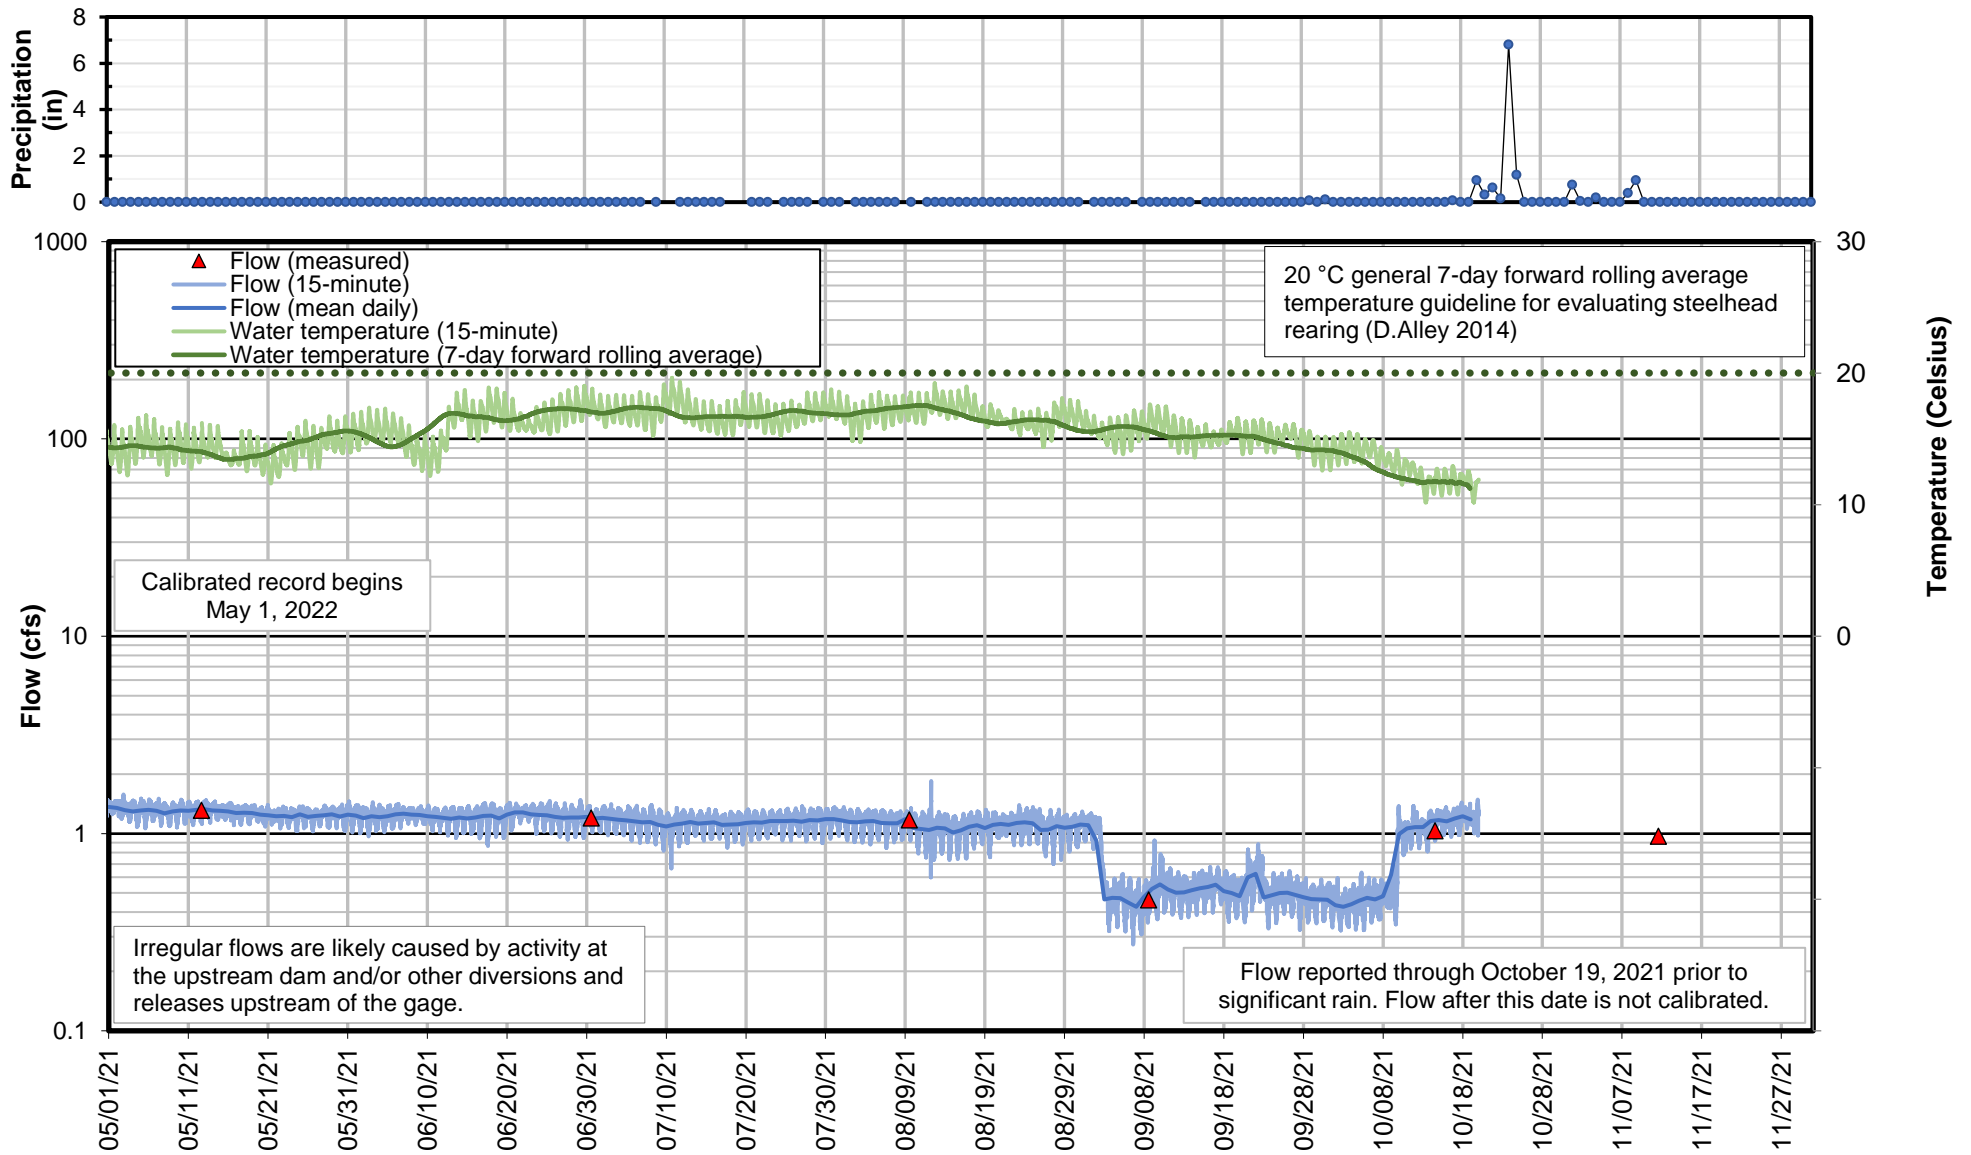
Figure 4. Flow and water temperature at Newell Creek approximately 120 ft upstream of the San Lorenzo River, dry season 2021, Santa Cruz County, CA. Precipitation data from SLVWD downtown Boulder Creek gage.

The seasonal baseflow at the Newell Creek upstream of the San Lorenzo River gage slowly decreased from mean daily flow of about 1.4 cfs to approximately 1.1 cfs from May through October, which is consistent with observed flow recessions during previous years (**Figure 4**). This site is downstream of the Loch Lomond Reservoir and is highly regulated. The City regularly releases 1.0 cfs from Loch Lomond to promote aquatic and riparian habitat in Newell Creek and the river. From September 2 through October 10, 2021, the City of Santa Cruz reduced the bypassed flow due to construction related activities at the reservoir. Mean daily flow at the gage during this time ranged between approximately 0.55 cfs to 0.43 cfs.

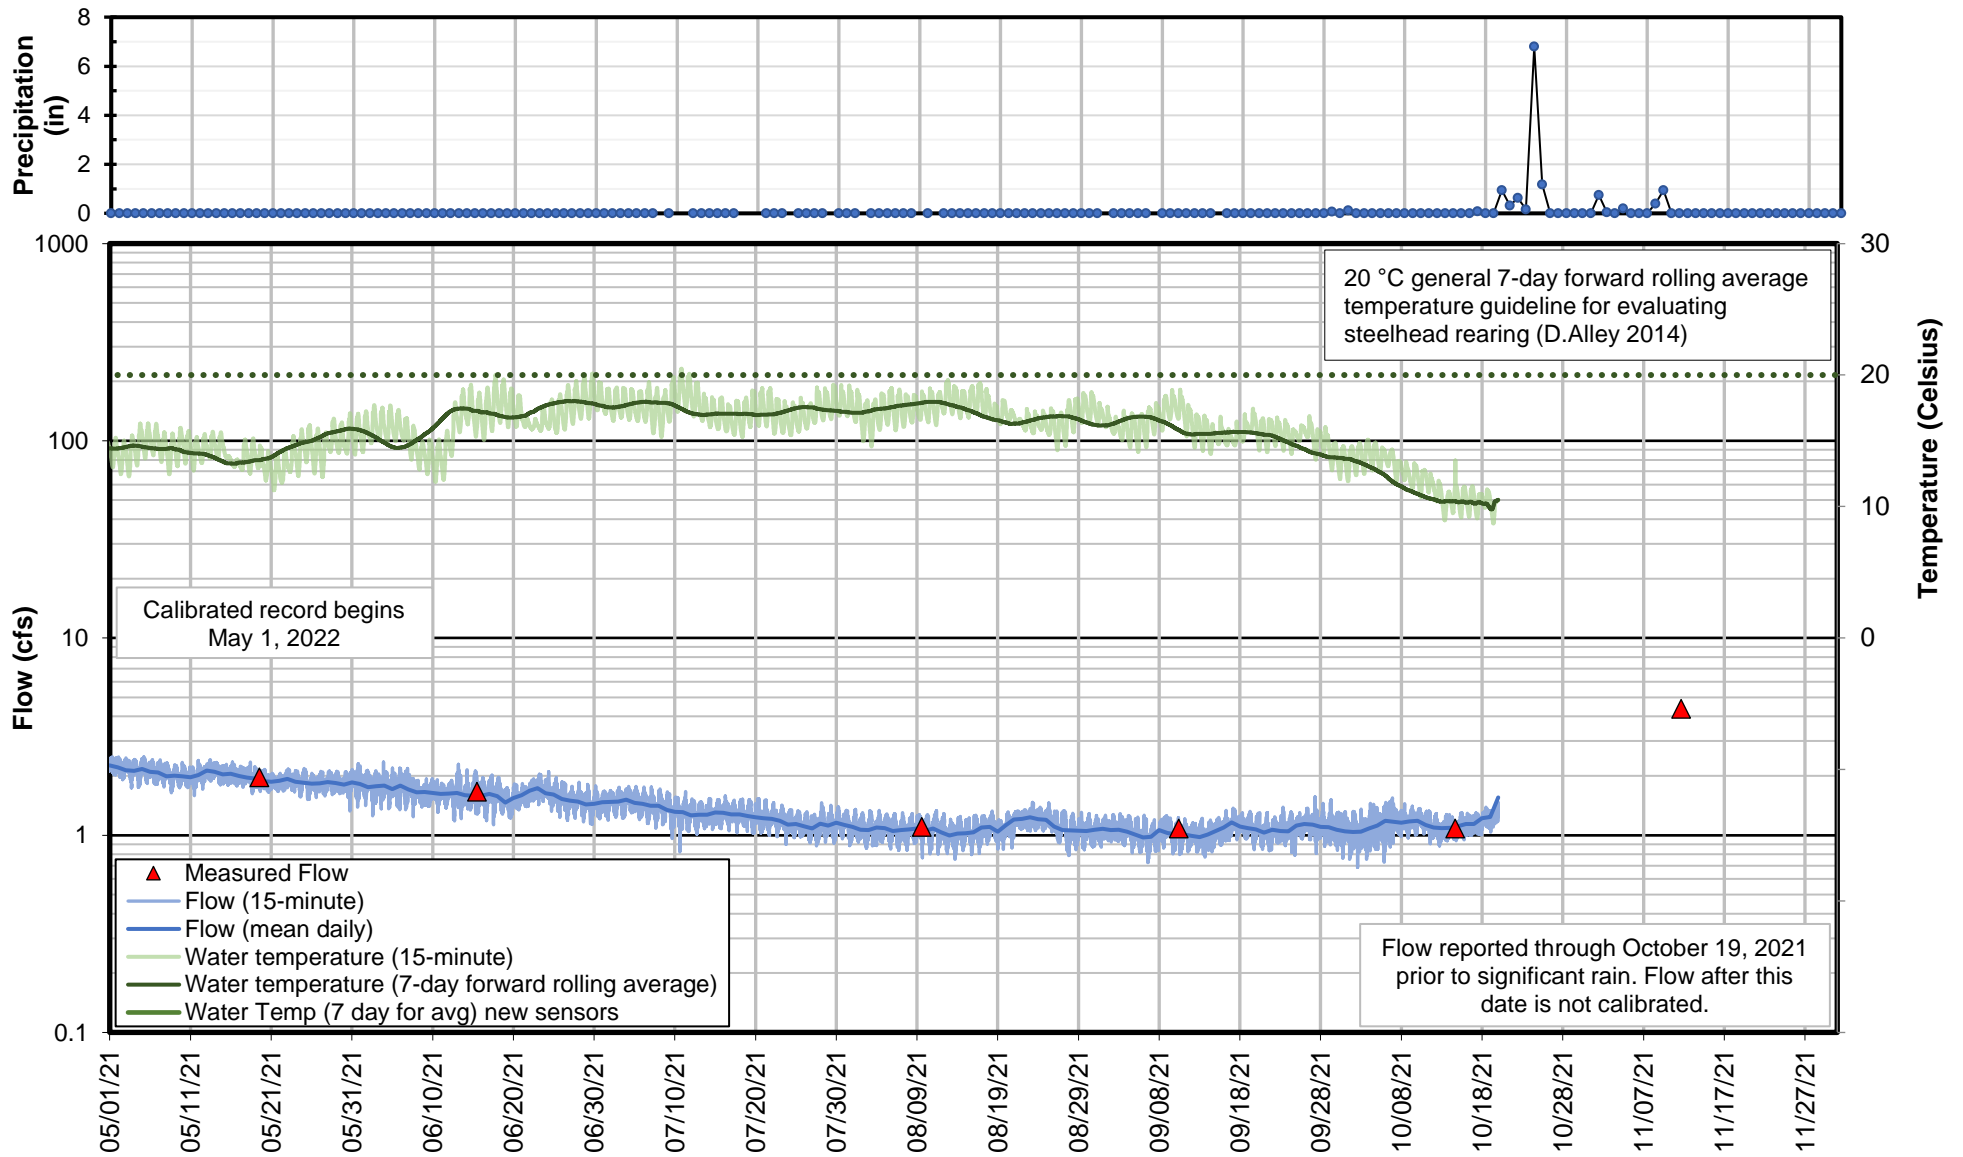
Figure 5. Flow and water temperature at Zayante Creek at Woodwardia, dry season 2021, Santa Cruz County, CA. Precipitation data from SLVWD downtown Boulder Creek gage.

The mean daily seasonal baseflow recession at Zayante Creek at Woodwardia Weir ranged from about 2.3 cfs in June down to just under or at 1 cfs in September/October 2021 (**Figure 5**). Water year 2020 base flow ranged between 3 cfs down to approximately 1 cfs from June to November. Baseflow for water years 2020-2021 were both lower than was observed during water 2017 and water year 2019, which were both above average years, and comparable to water year 2018, which was a dry year.

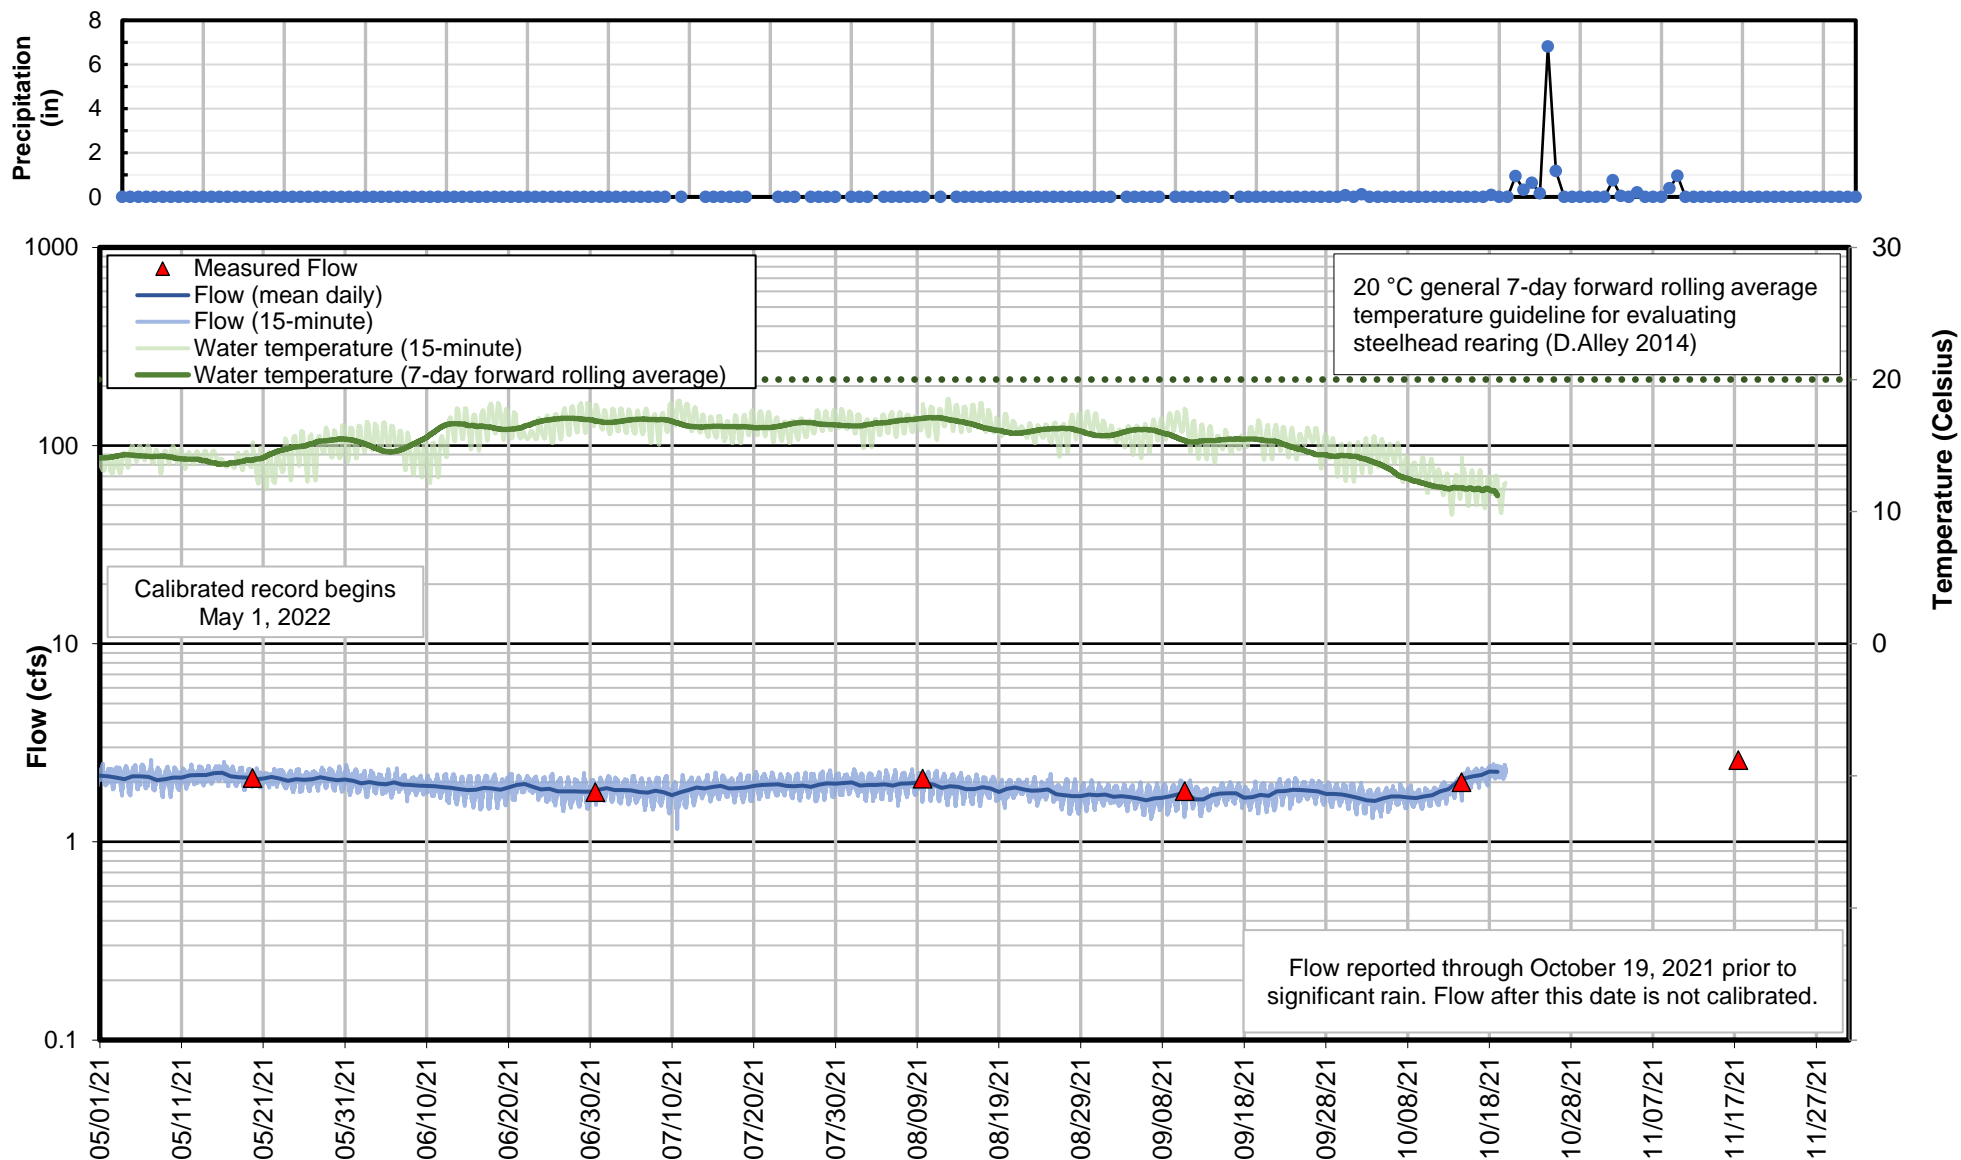
Figure 6. Flow and water temperature at lower Bean Creek above mouth at Mt. Hermon Camp, dry season 2021, Santa Cruz County, CA. Precipitation data from SLVWD downtown Boulder Creek gage.

The seasonal mean daily baseflow recession during water year 2021 at Bean Creek at Mount Hermon Camp ranged from approximately 2.2 to 1.6 cfs from May until the first significant rain in October (**Figure 6**). Similar to other gages, the slight rise in baseflow prior to rainfall is likely associated with reduced evapotranspiration. During water year 2020 at Bean Creek at Mount Hermon Camp was consistently around 2.5 to 2 cfs from June until the first runoff-producing rain in November.

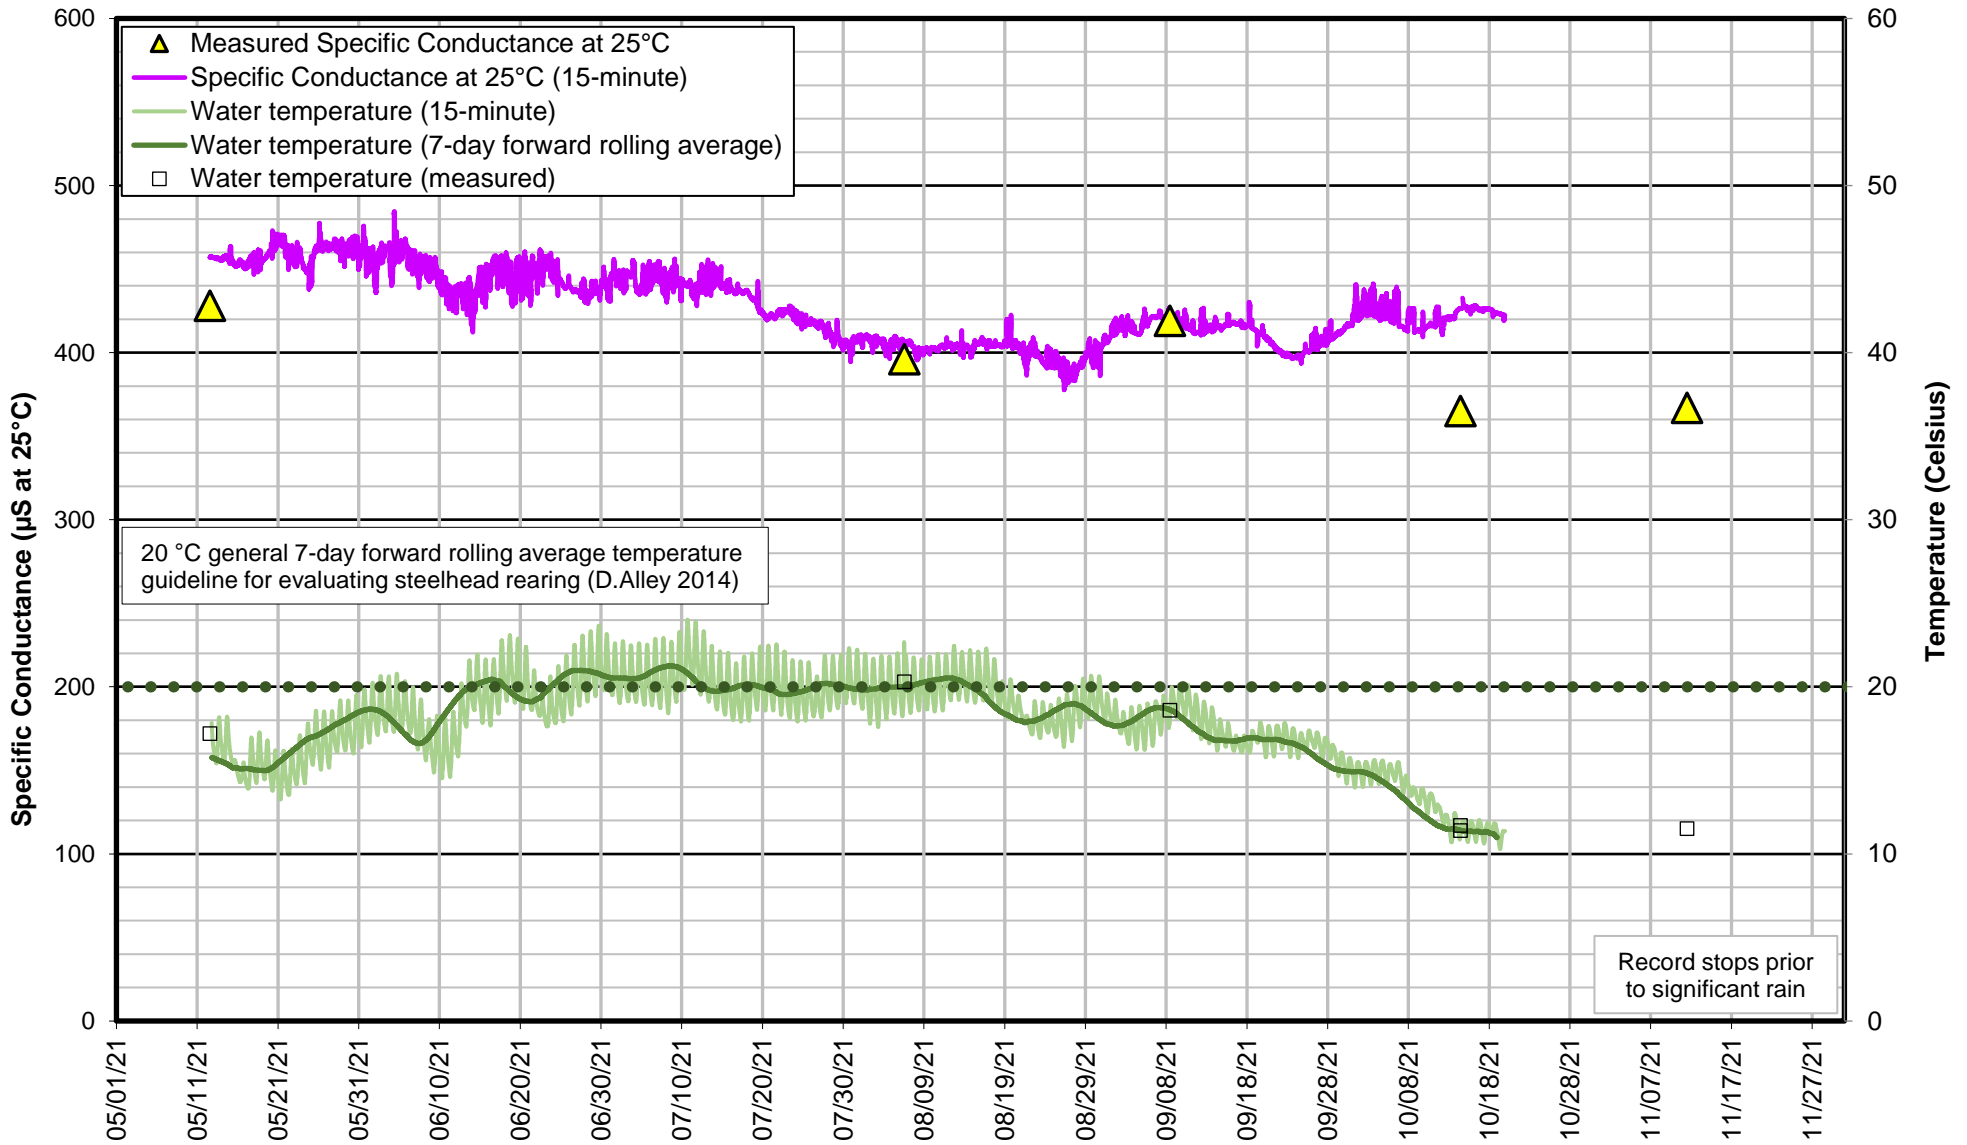
Figure 7. Specific conductance and water temperature in the San Lorenzo River upstream of Love Creek, dry season 2021, Santa Cruz County, CA

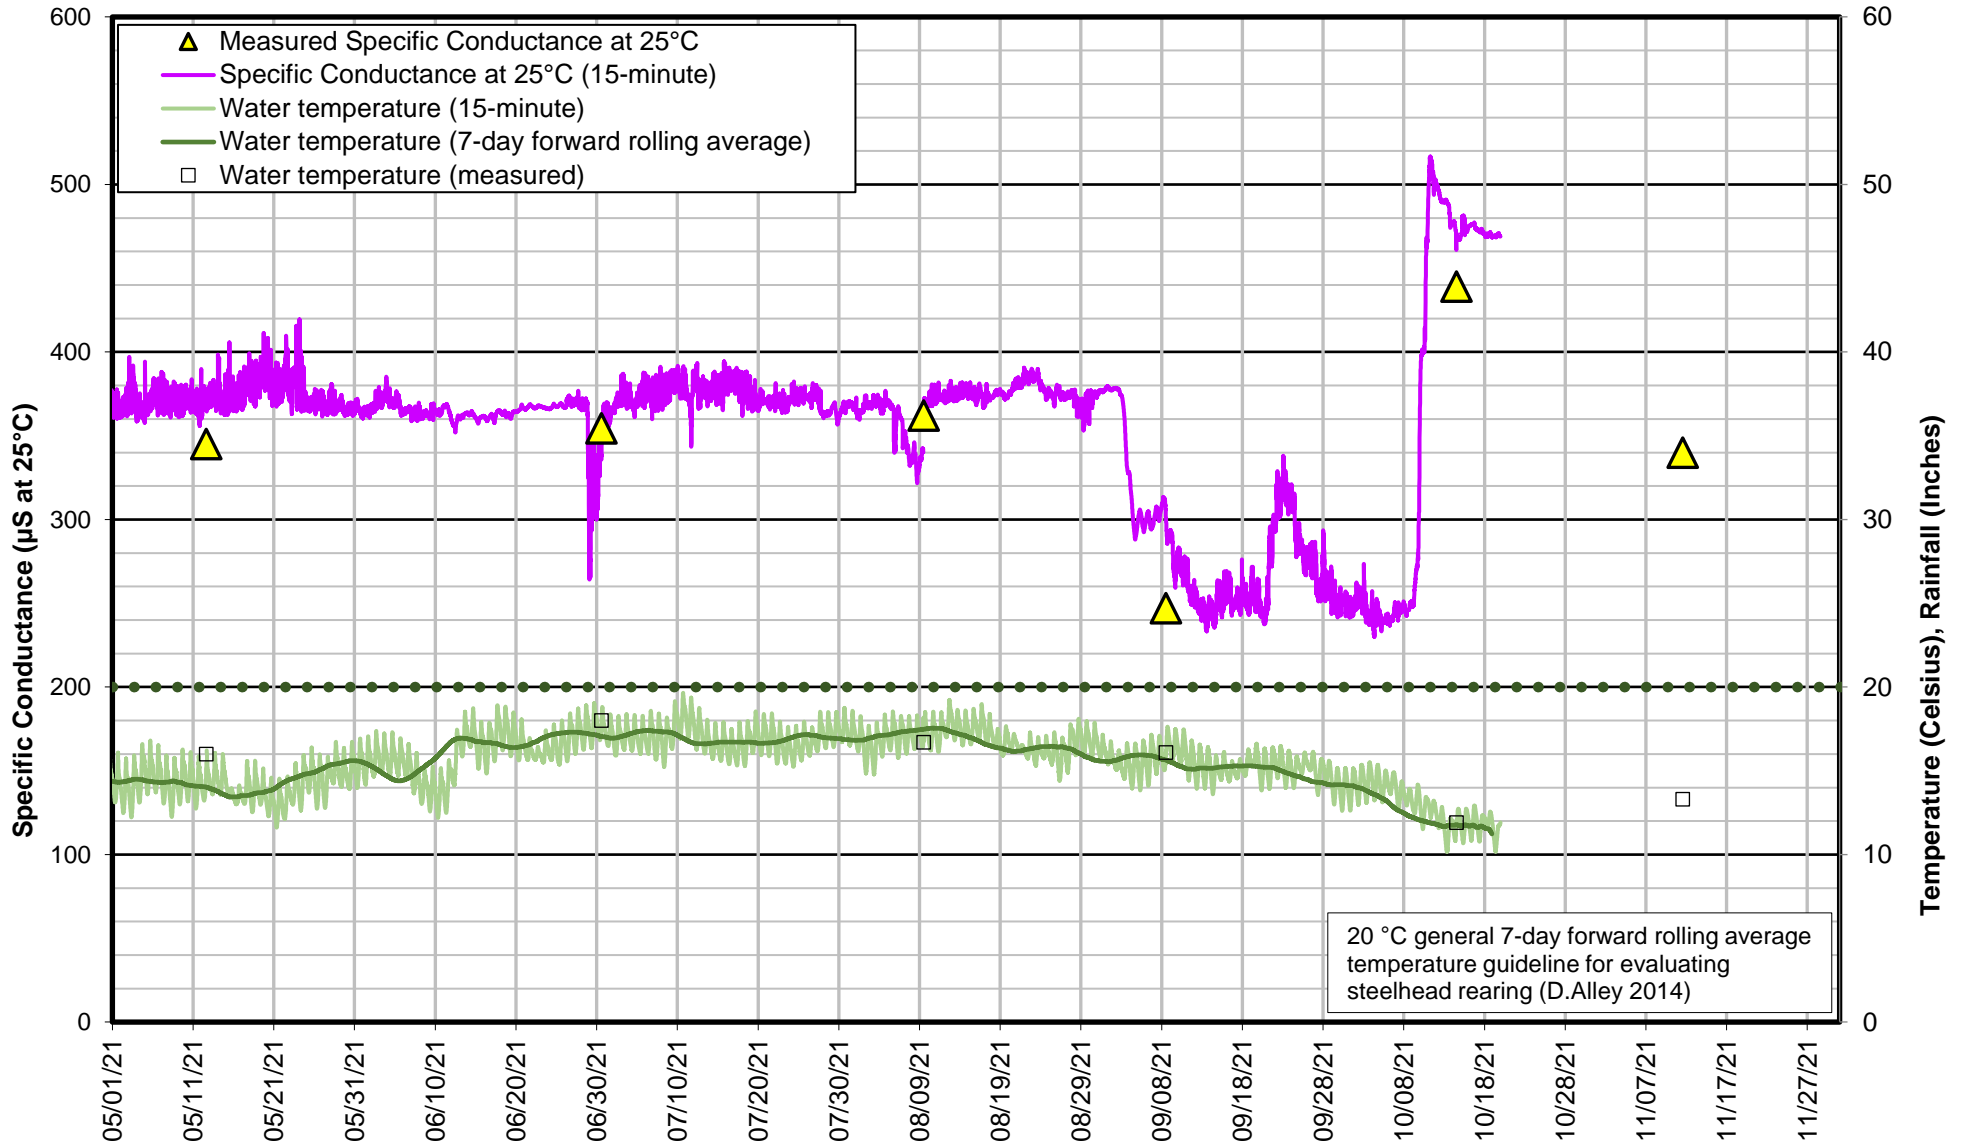
Figure 8. Specific conductance and water temperature in Newell Creek approximately 120 ft upstream of the San Lorenzo River, dry season 2021, Santa Cruz County, CA.

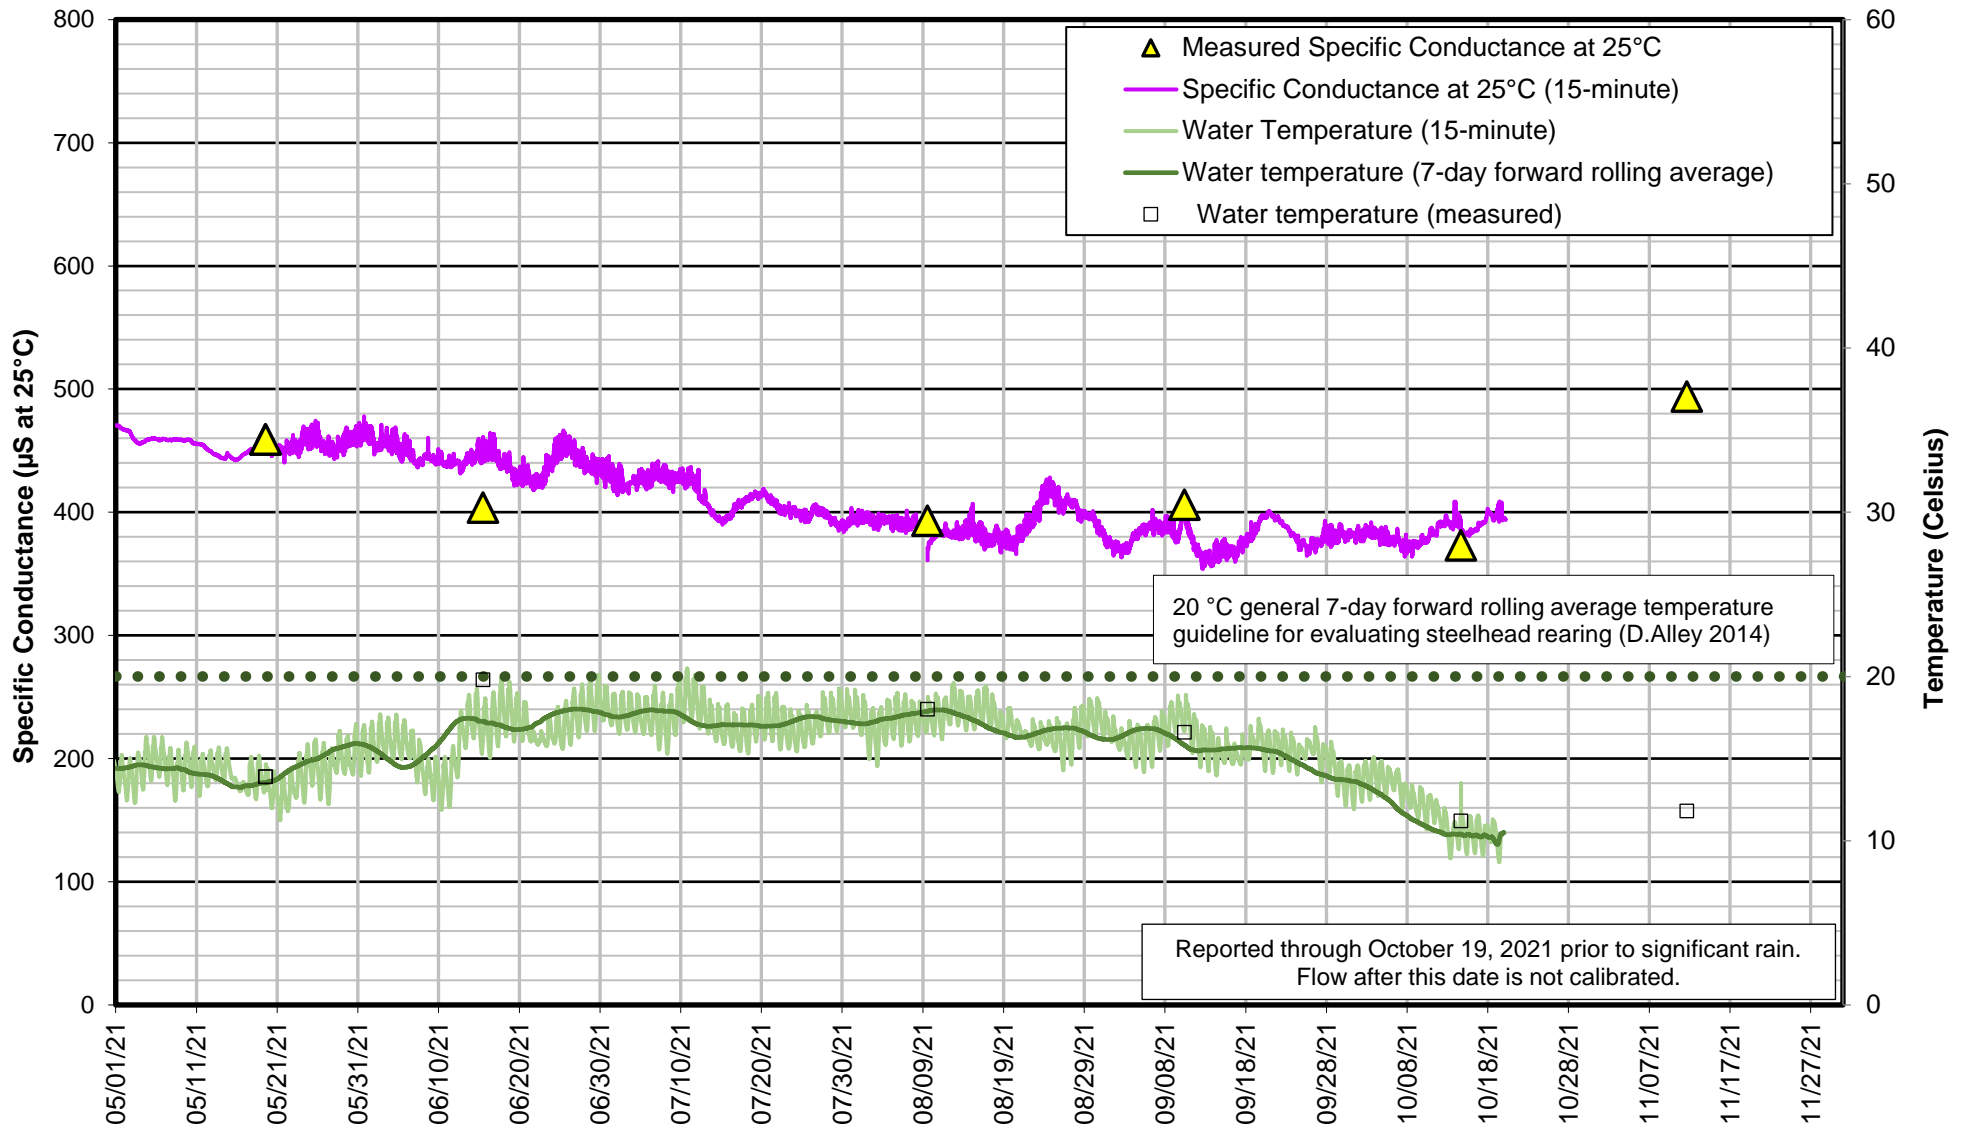
Figure 9. Specific conductance and water temperature in Zayante Creek at Woodwardia, dry season 2021, Santa Cruz County, CA.

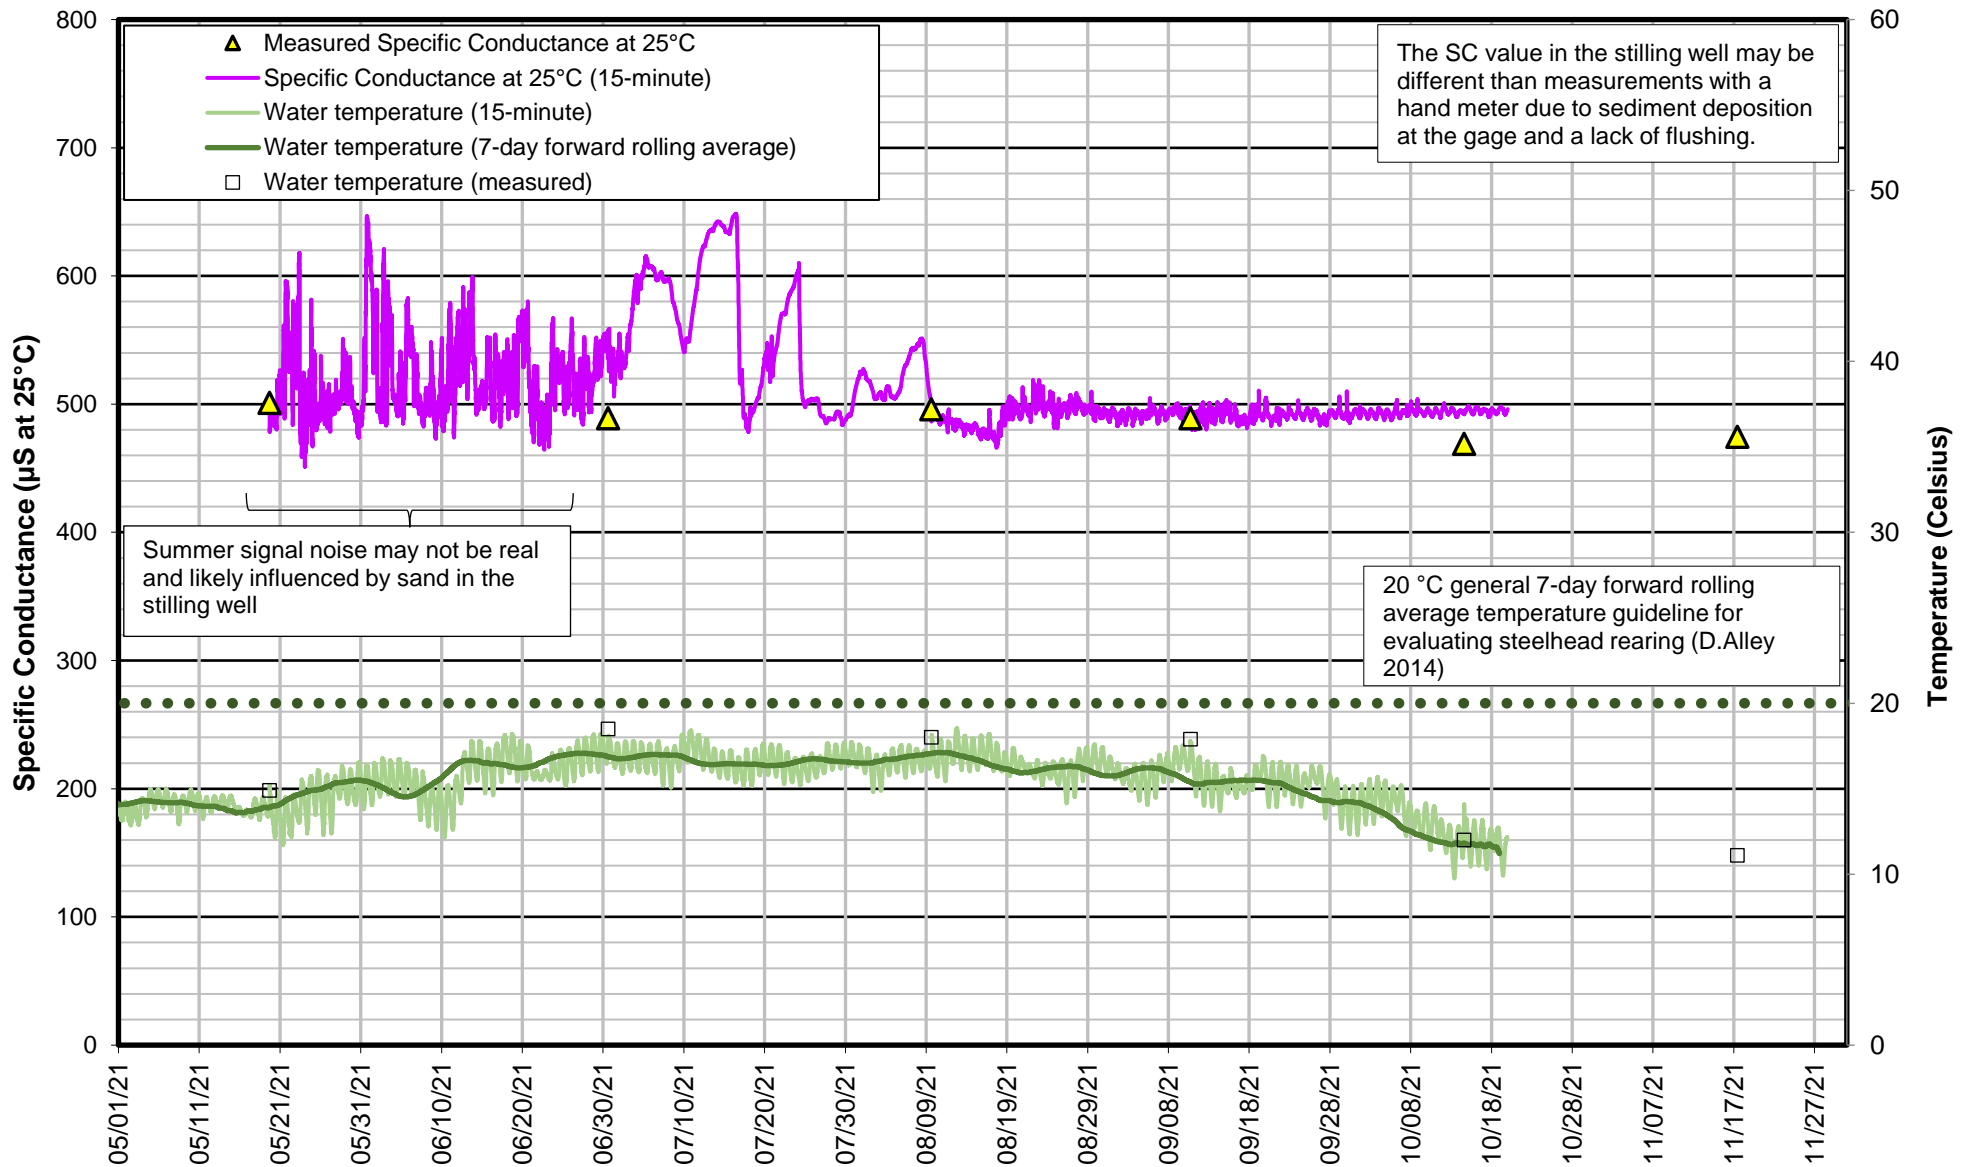
Figure 10. Specific conductance and water temperature in lower Bean Creek above mouth at Mt. Hermon Camp, dry season 2021, Santa Cruz County, CA
 Precipitation data from SLVWD downtown Boulder Creek gage.
