MEMO

Subject: Draft water year 2019 accretion assessment on Bean Creek and adjoining parts of lower Zayante Creeks

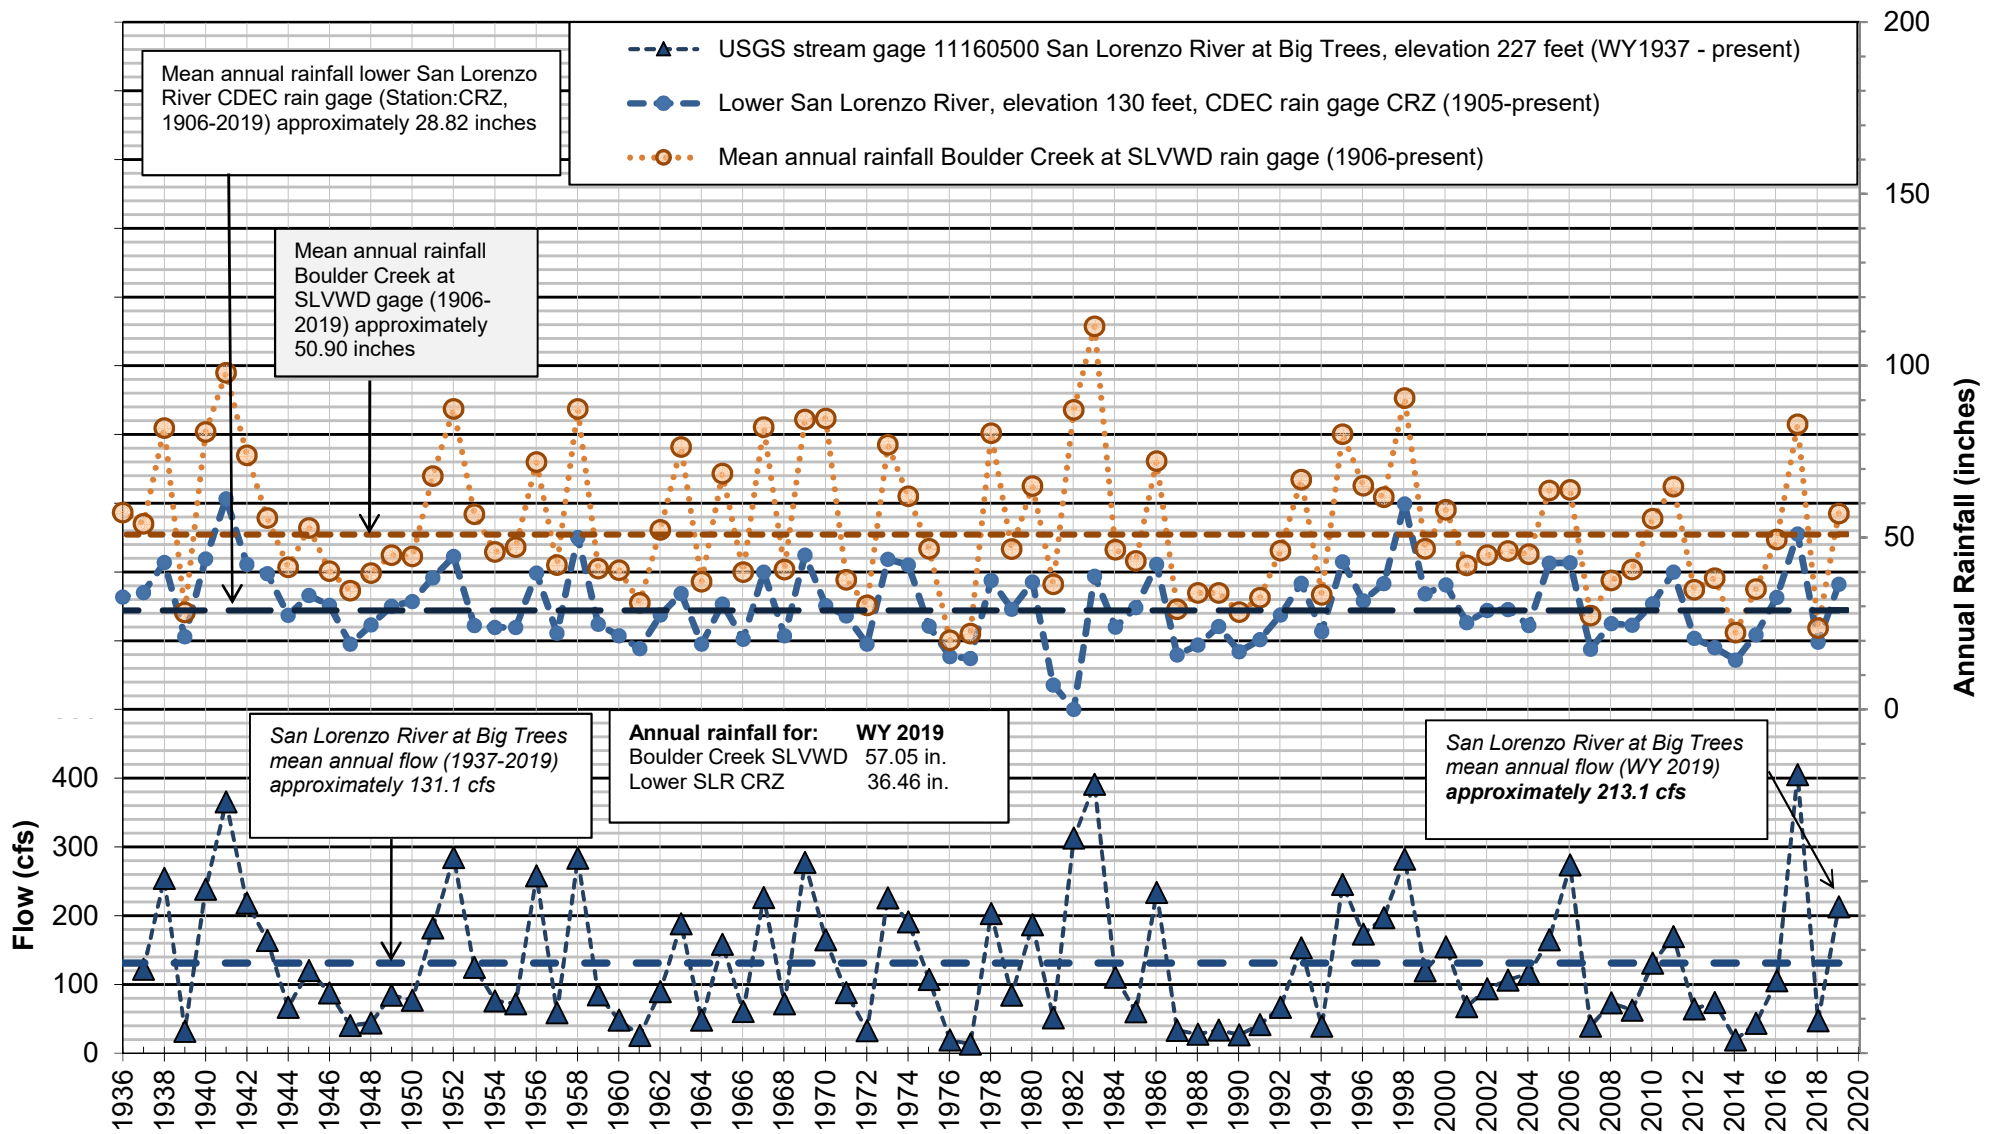
Figure 2. Comparison of historic annual rainfall in San Lorenzo Basin to annual streamflow at USGS Gage 11160500, San Lorenzo River at Big Trees, Santa Cruz County, CA

Water Year 2019 can be characterized as a wet year, with above-average precipitation rates (**Figure 2**). The San Lorenzo Valley Water District rain gage in Boulder Creek received 57.05 inches of rain (approximately 112% of the long-term average) and the CDEC rain gage in Santa Cruz (CRZ) received 36.46 inches of rain (approximately 127% of the long-term average) (see **Figure 1** for gage locations). The resulting runoff from the San Lorenzo River was approximately 60% above average, as measured at the USGS Big Trees stream gage (**Figure 2**).

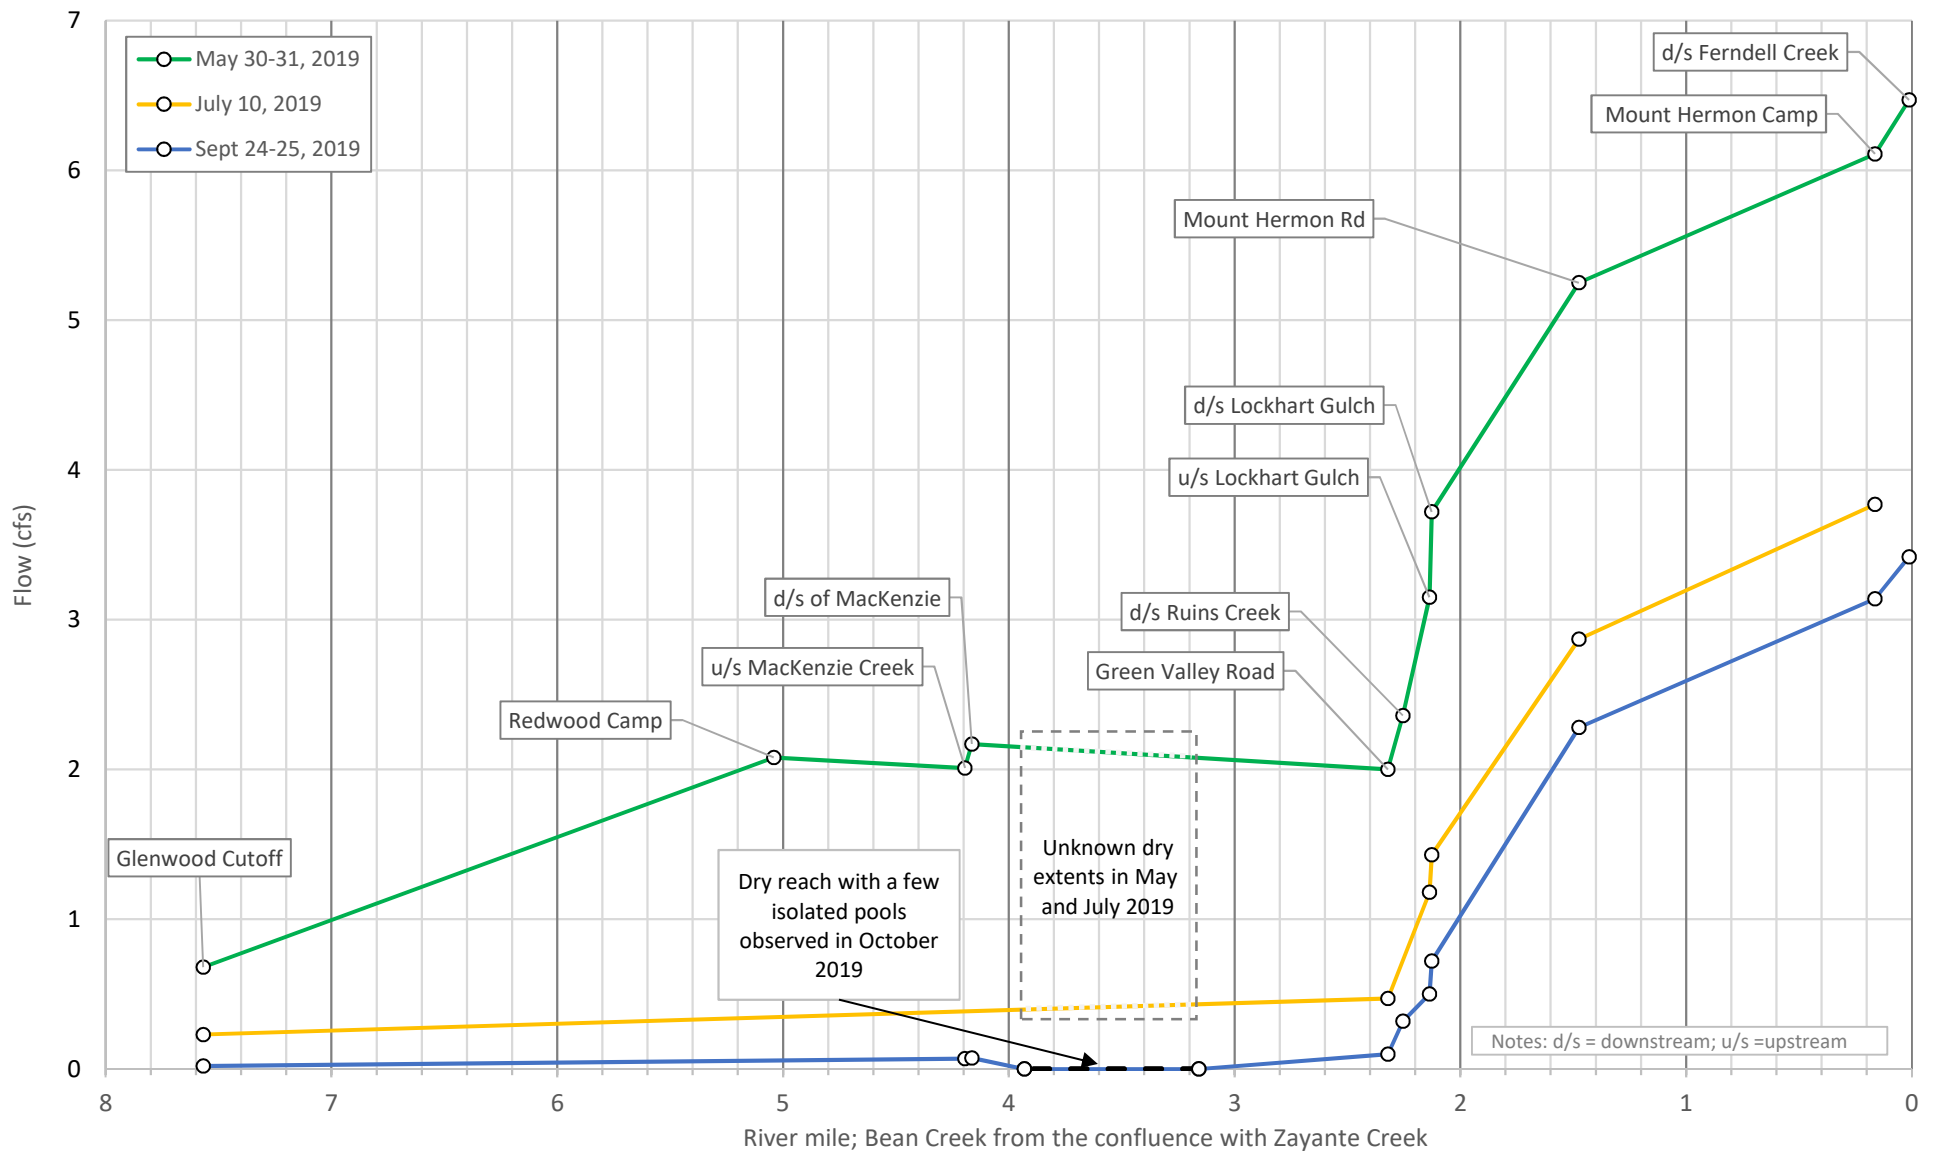
Figure 3. Bean Creek downstream changes in flow as measured during 2019, Santa Cruz County, CA Note location of dry reach.

In general, we found that flow increased along Bean and Zayante Creeks, with the exception of the one reach along Bean Creek, suggesting that there is inflow from groundwater within these watersheds. The study reach with relative downstream changes in flow can be seen in **Figure 3** for each of the three sampling events along Bean Creek. The changes in flow from the September event can also be seen in **Figure 4**. The observer's log from each of the sampling events can be seen in **Tables 1 to 3**. The findings of this study are consistent with previous observations within the basin, where the upper Bean Creek watershed and its tributaries are typically losing reaches that recharge the groundwater and streamflow in the lower watershed is enhanced by groundwater discharge from the Santa Margarita (Kennedy Jenks, 2015). We observed the greatest increases in flow downstream of the confluence of Ruins Creek with Bean Creek. This reach, in particular, is the primary gaining reach within the Santa Margarita Basin and is characterized by areas where the stream has cut into the Santa Margarita and springs in the streambed and along the sides of the stream are contributing groundwater discharge (Kennedy Jenks, 2015).

during the earlier sampling events. The results of this walk are compiled with the September sampling event (**Figures 3 and 4**).

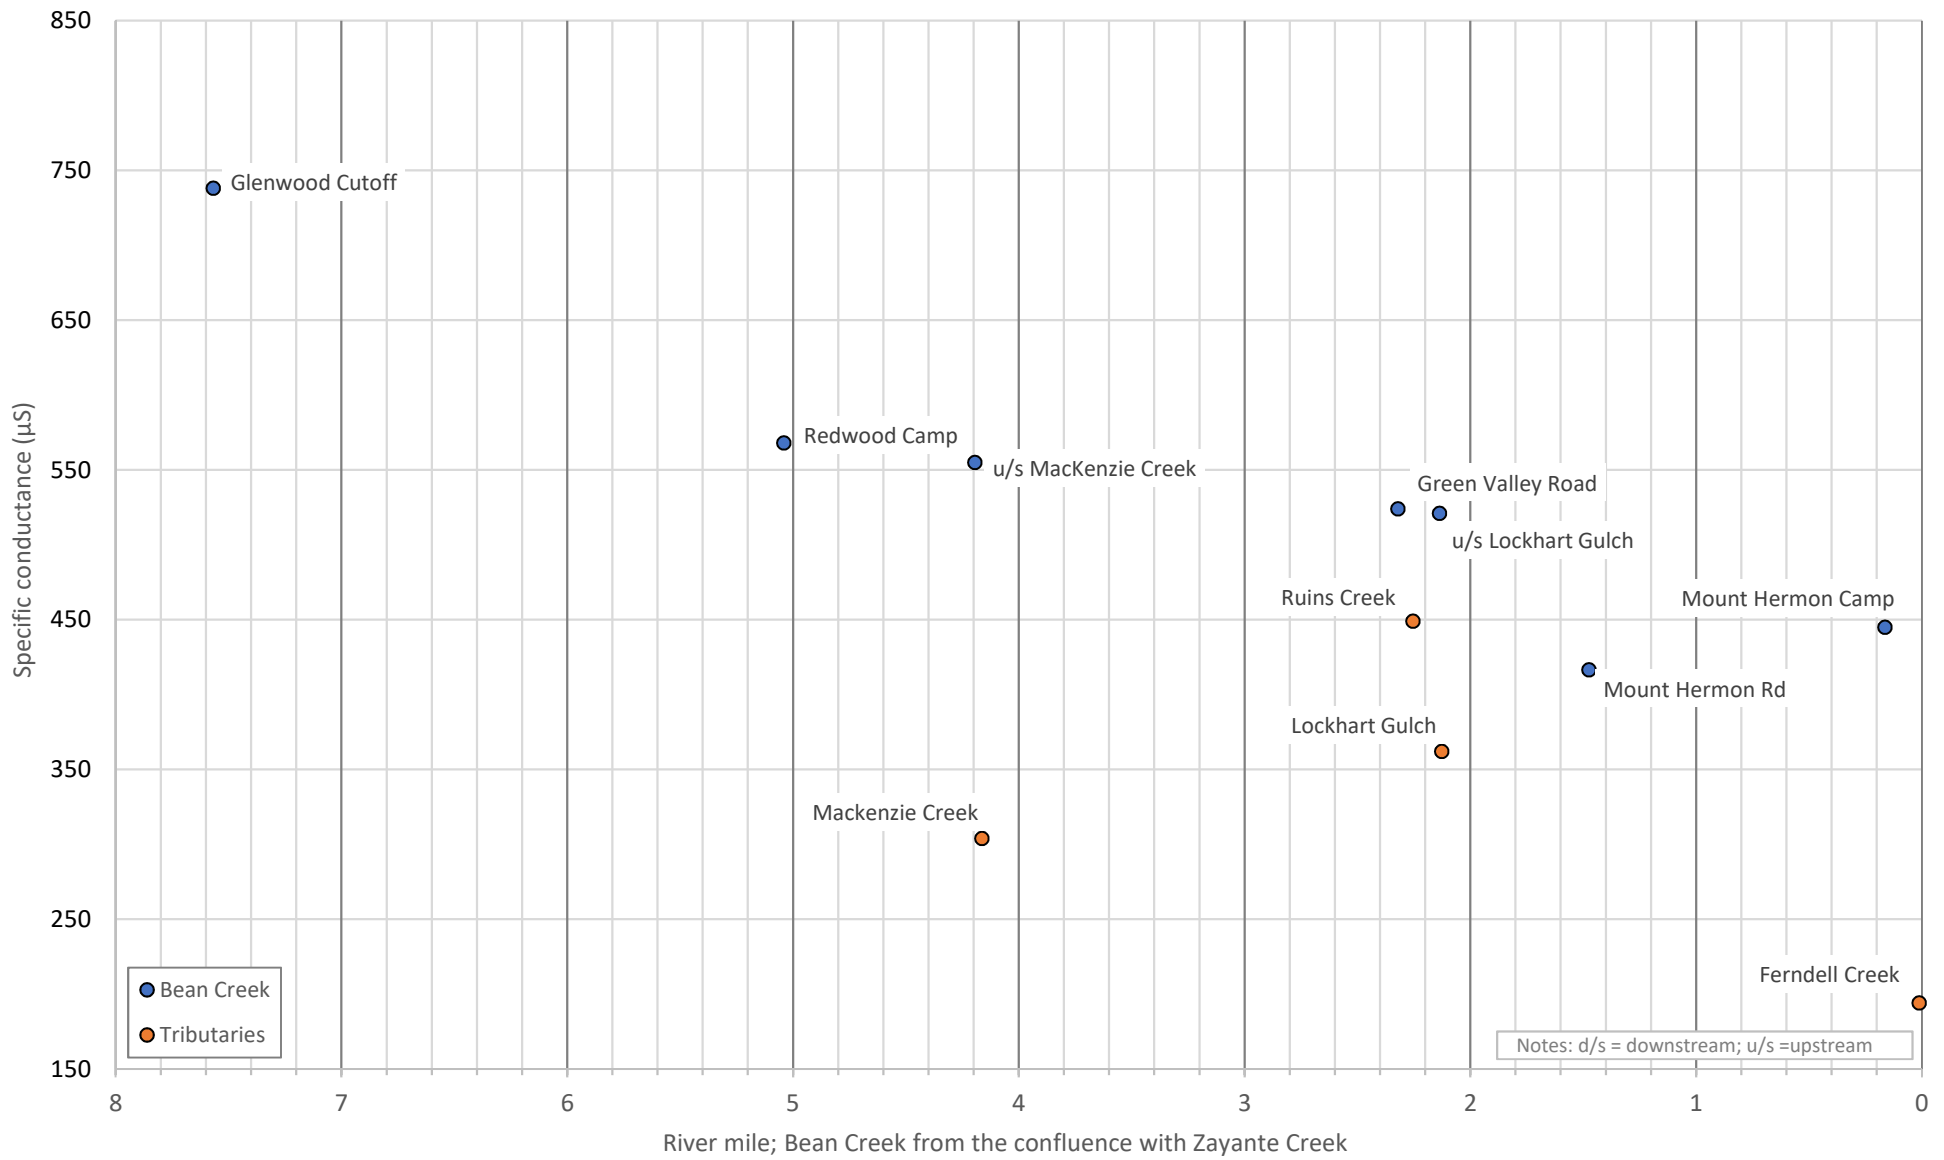
Figure 6. Bean Creek specific conductance from samples taken on May 30-31, 2019, Santa Cruz County, CA

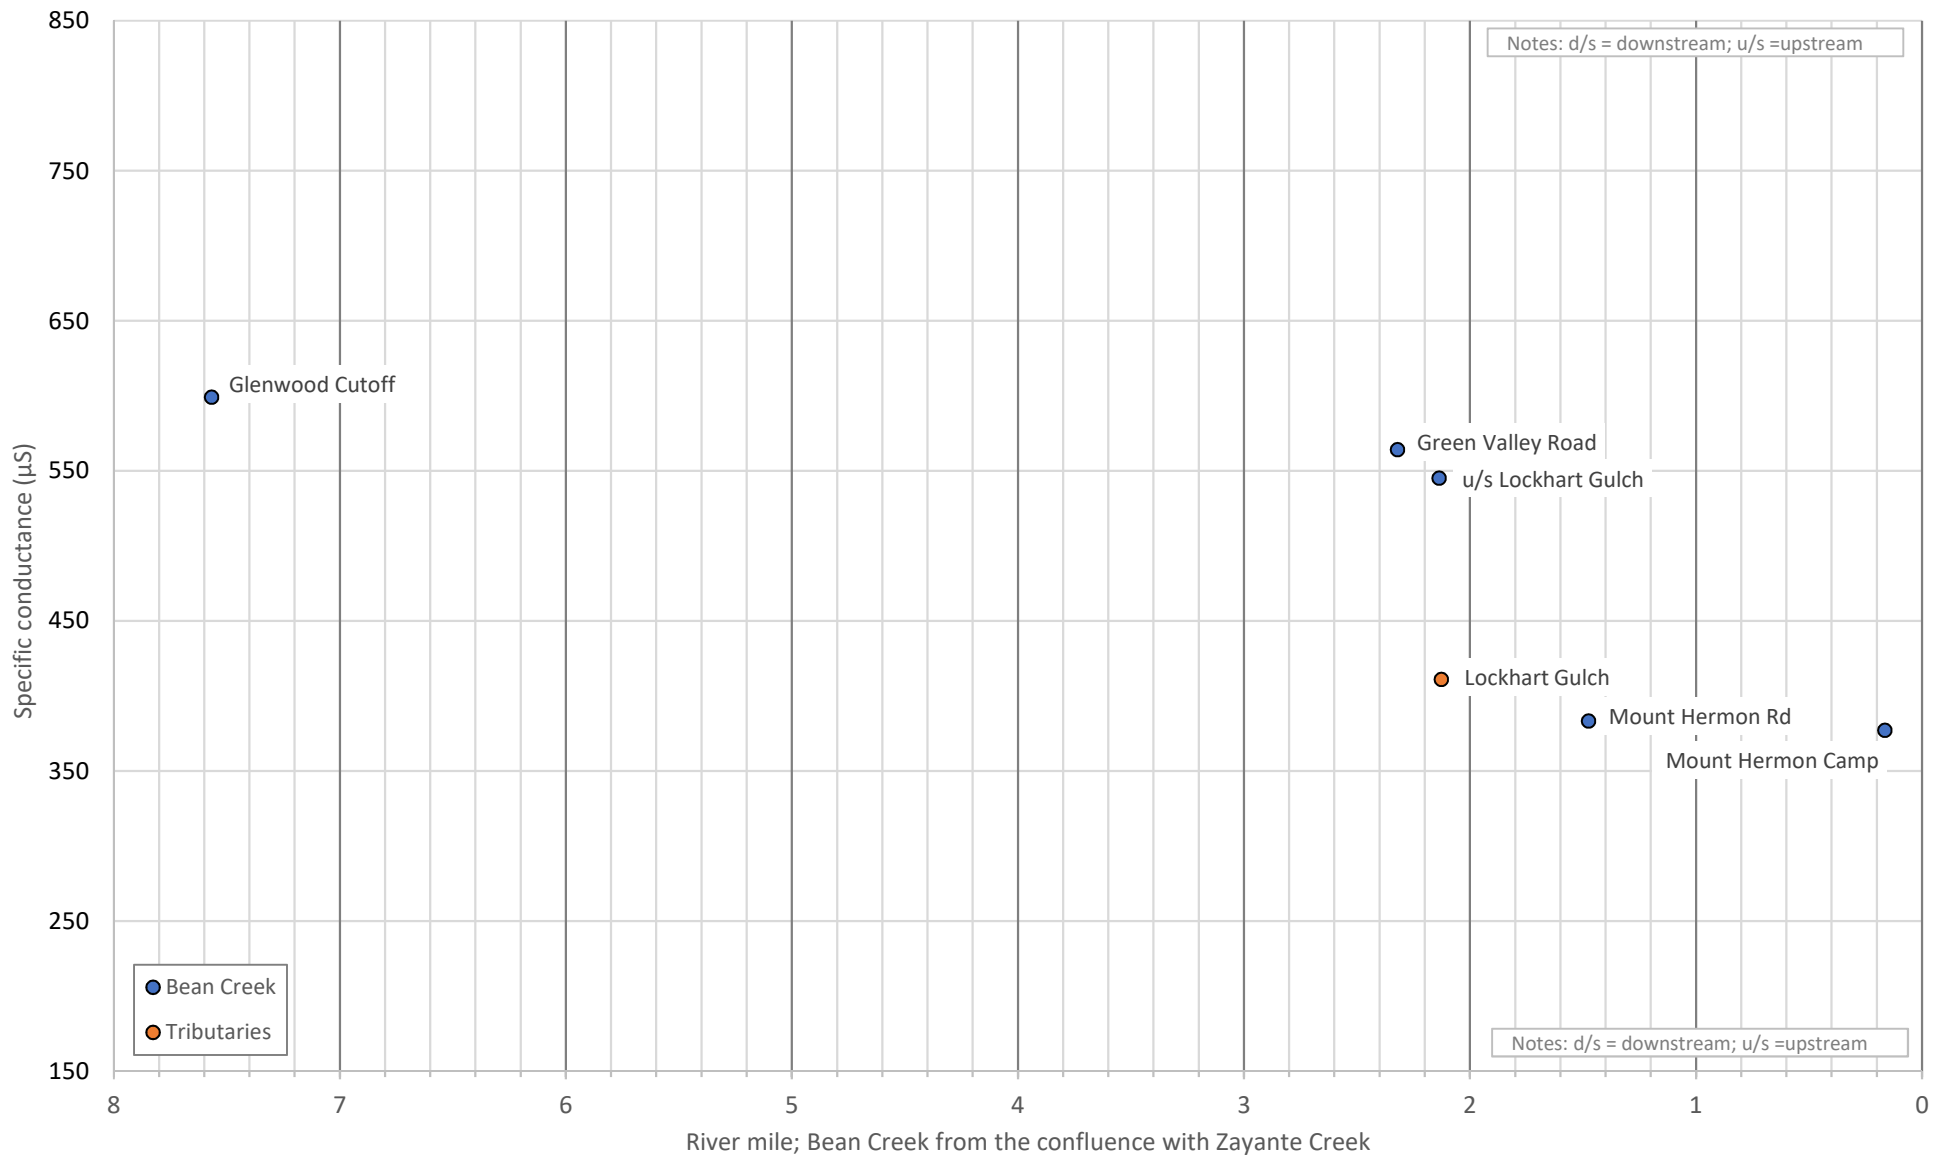
Figure 7. Bean Creek specific conductance from samples taken July 10, 2019, Santa Cruz County, CA

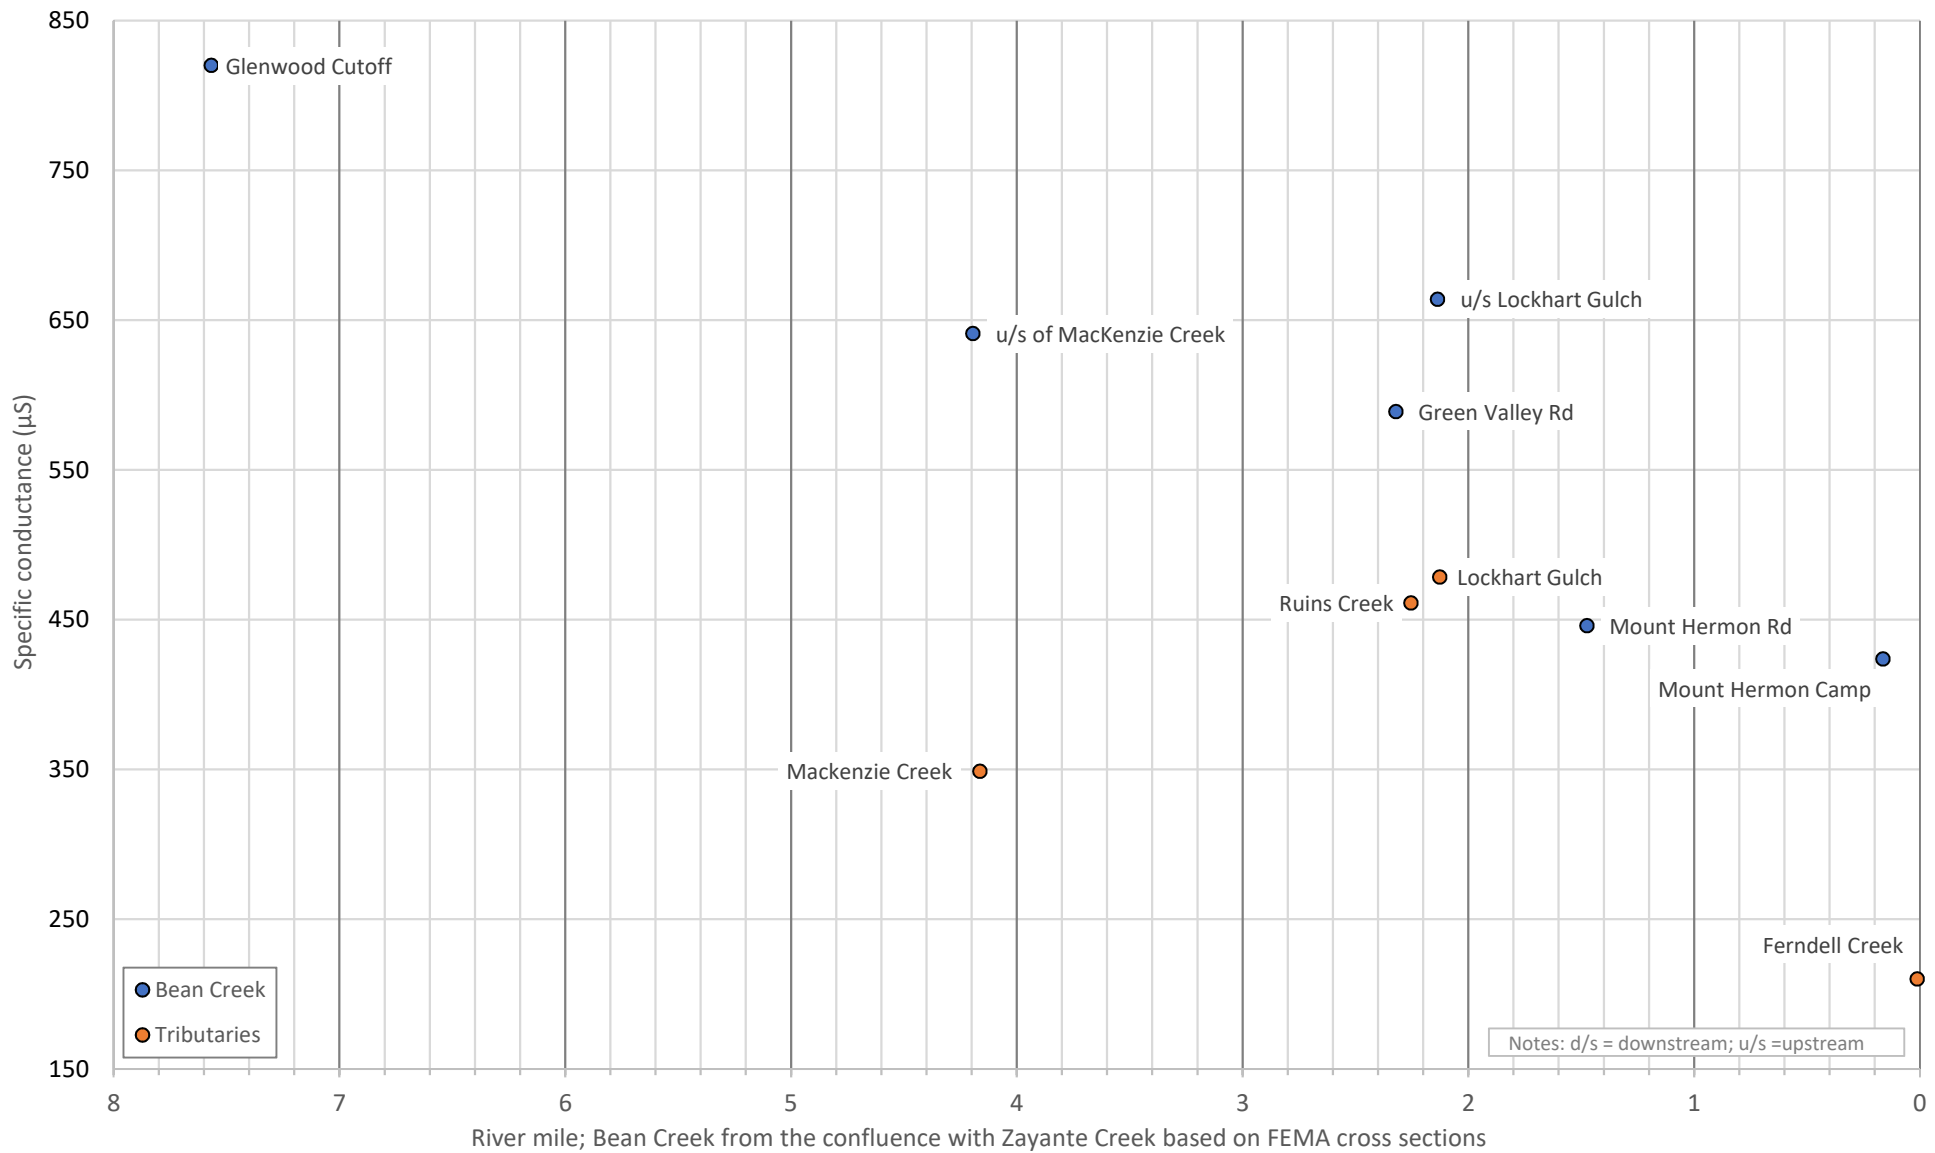
Figure 8. Bean Creek specific conductance from samples taken September 24-25, 2019, Santa Cruz County, CA

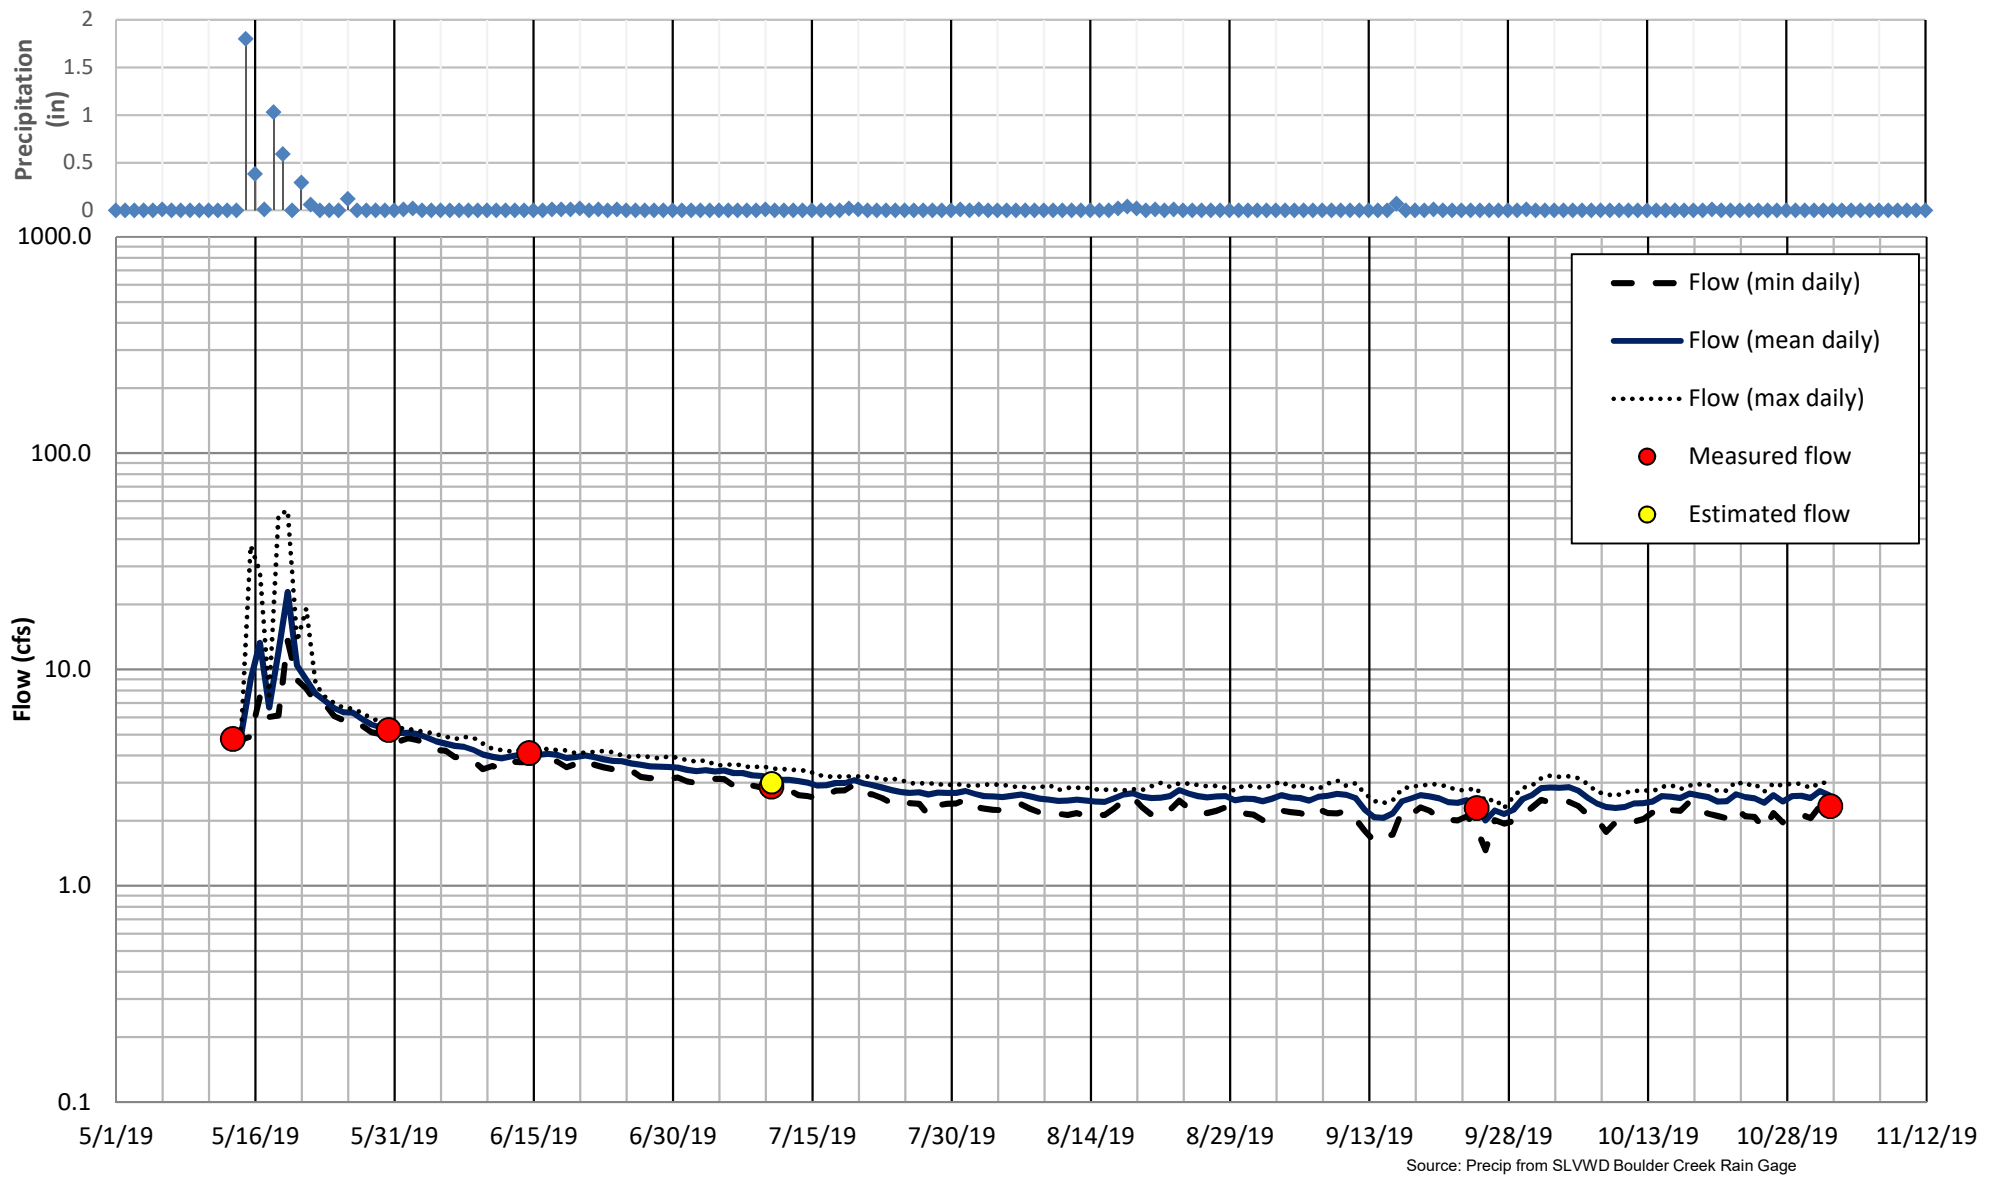
Figure 9. Bean Creek at Mount Hermon Road water year 2019 seasonal baseflow, Santa Cruz County, Ca

Flows increased at the site in response to the approximately 4.16 inches falling between May 15 to 22, 2019 (**Figure 9**). This rain event increased the 2019 summer flows through the first week or two of June. Flows decreased through the rest of the summer, following a typical pattern. We observed a daily fluctuation in flow of approximately 1 cfs throughout the baseflow season at the Mount Hermon Road gage. This fluctuation is consistent with the flow pattern observed downstream at the Bean Creek at Mt Hermon Camp gage (approximately 1 mile downstream of the Mt Hermon Rd. gage). This fluctuation could be examined in future gaging to evaluate the potential cause, such as diurnal fluctuation from evapotranspiration or possibly influence from upstream diversions. There are no major diversions upstream of this gage.

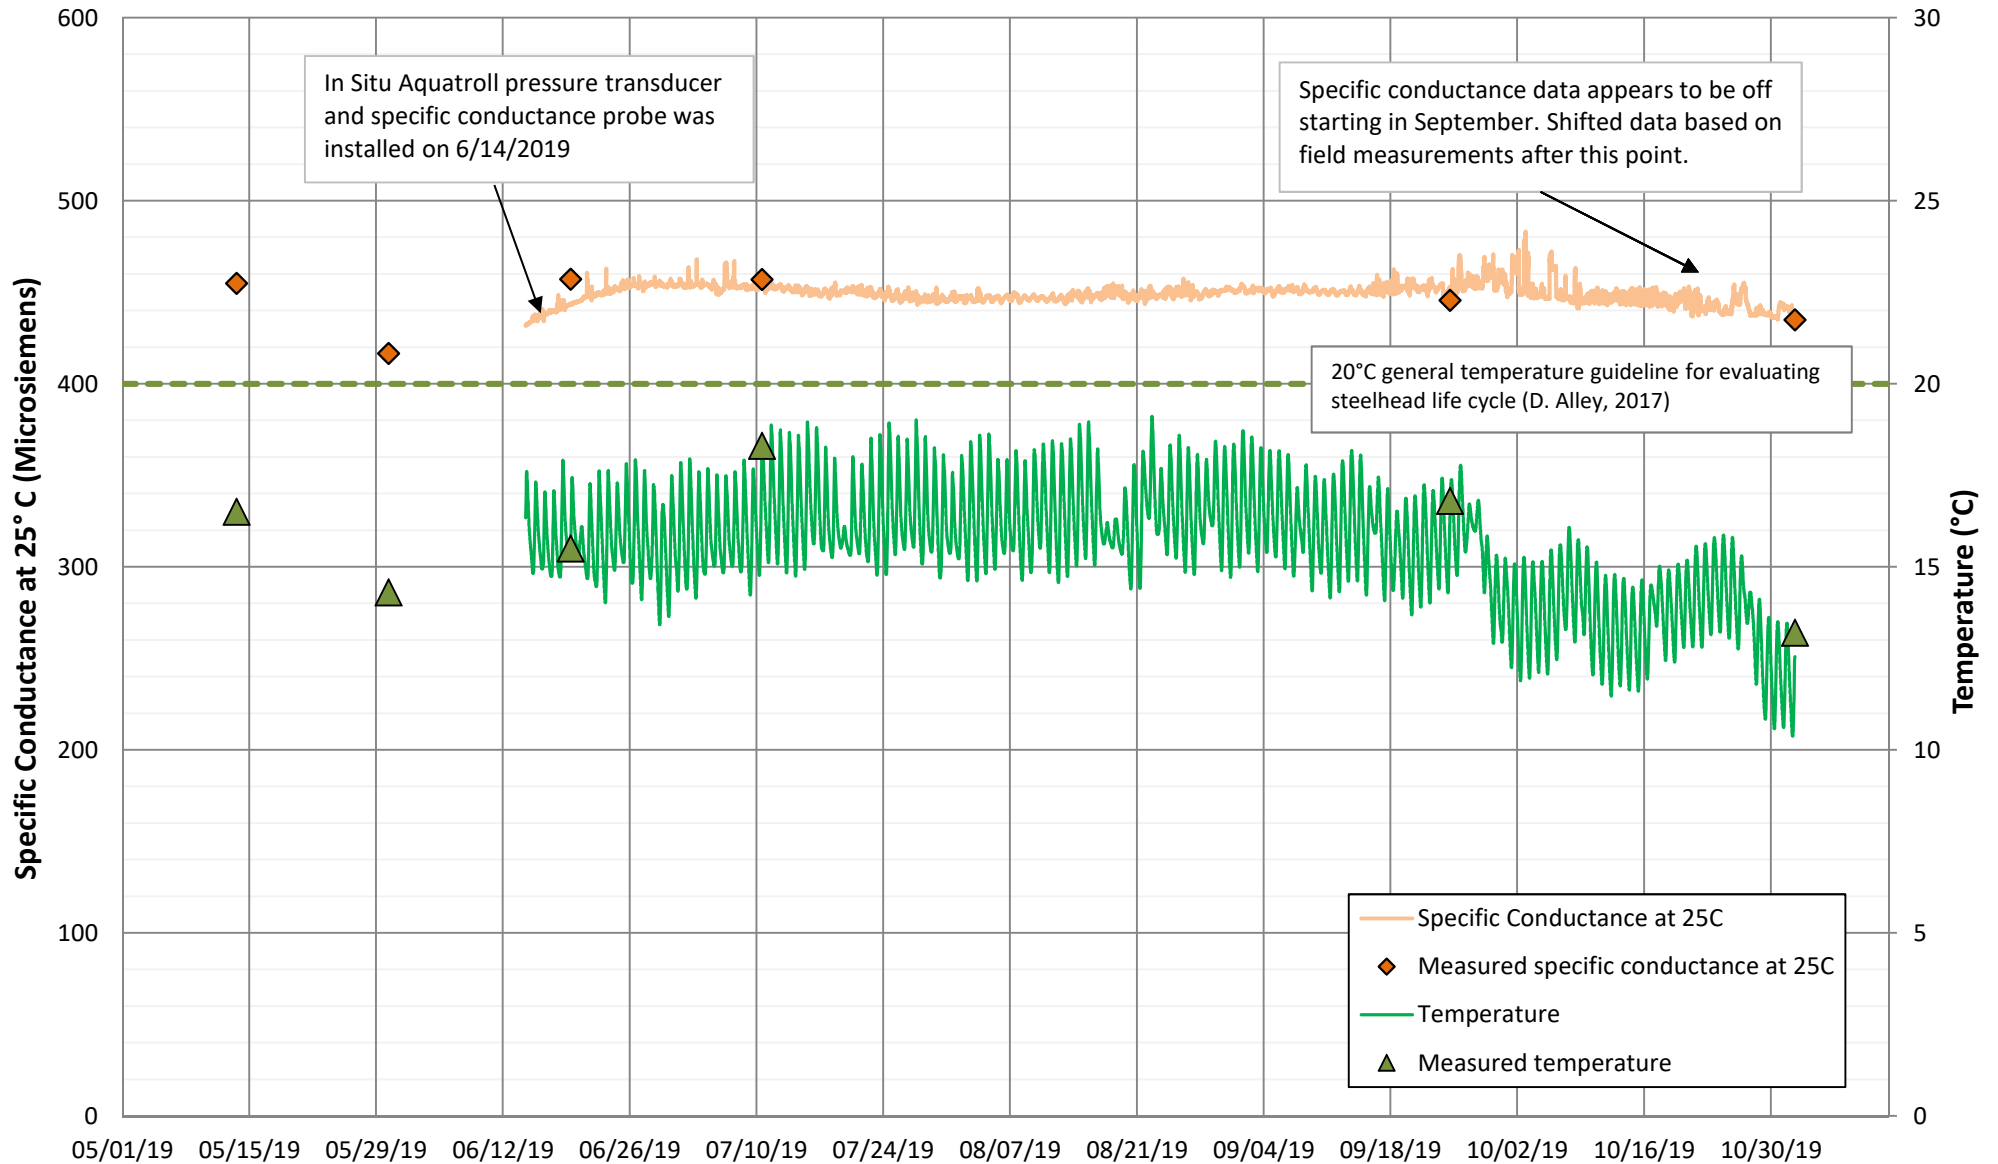
Figure 10. Specific conductance and temperature at Bean Creek at Mt. Hermon Rd. seasonal low flow water year 2019

Water temperature at the site reached up to approximately 19°C during July and August (**Figure 10**). This is below the 20°C general temperature guideline for evaluating the lower threshold for temperature stress for steelhead life (D. Alley, 2017). Specific conductance readings (normalized to 25°C) were relatively consistent around 450 $\mu\text{S}/\text{cm}$ throughout the gaging period (**Figure 10**).
