**SANTA MARGARITA BASIN
STREAMFLOW MONITORING AND
ACCRETION ASSESSMENT,
DRY SEASON OF 2020**

Report prepared for:
County of Santa Cruz, Environmental Health Services

Balance Hydrologics, Inc.

May 2021

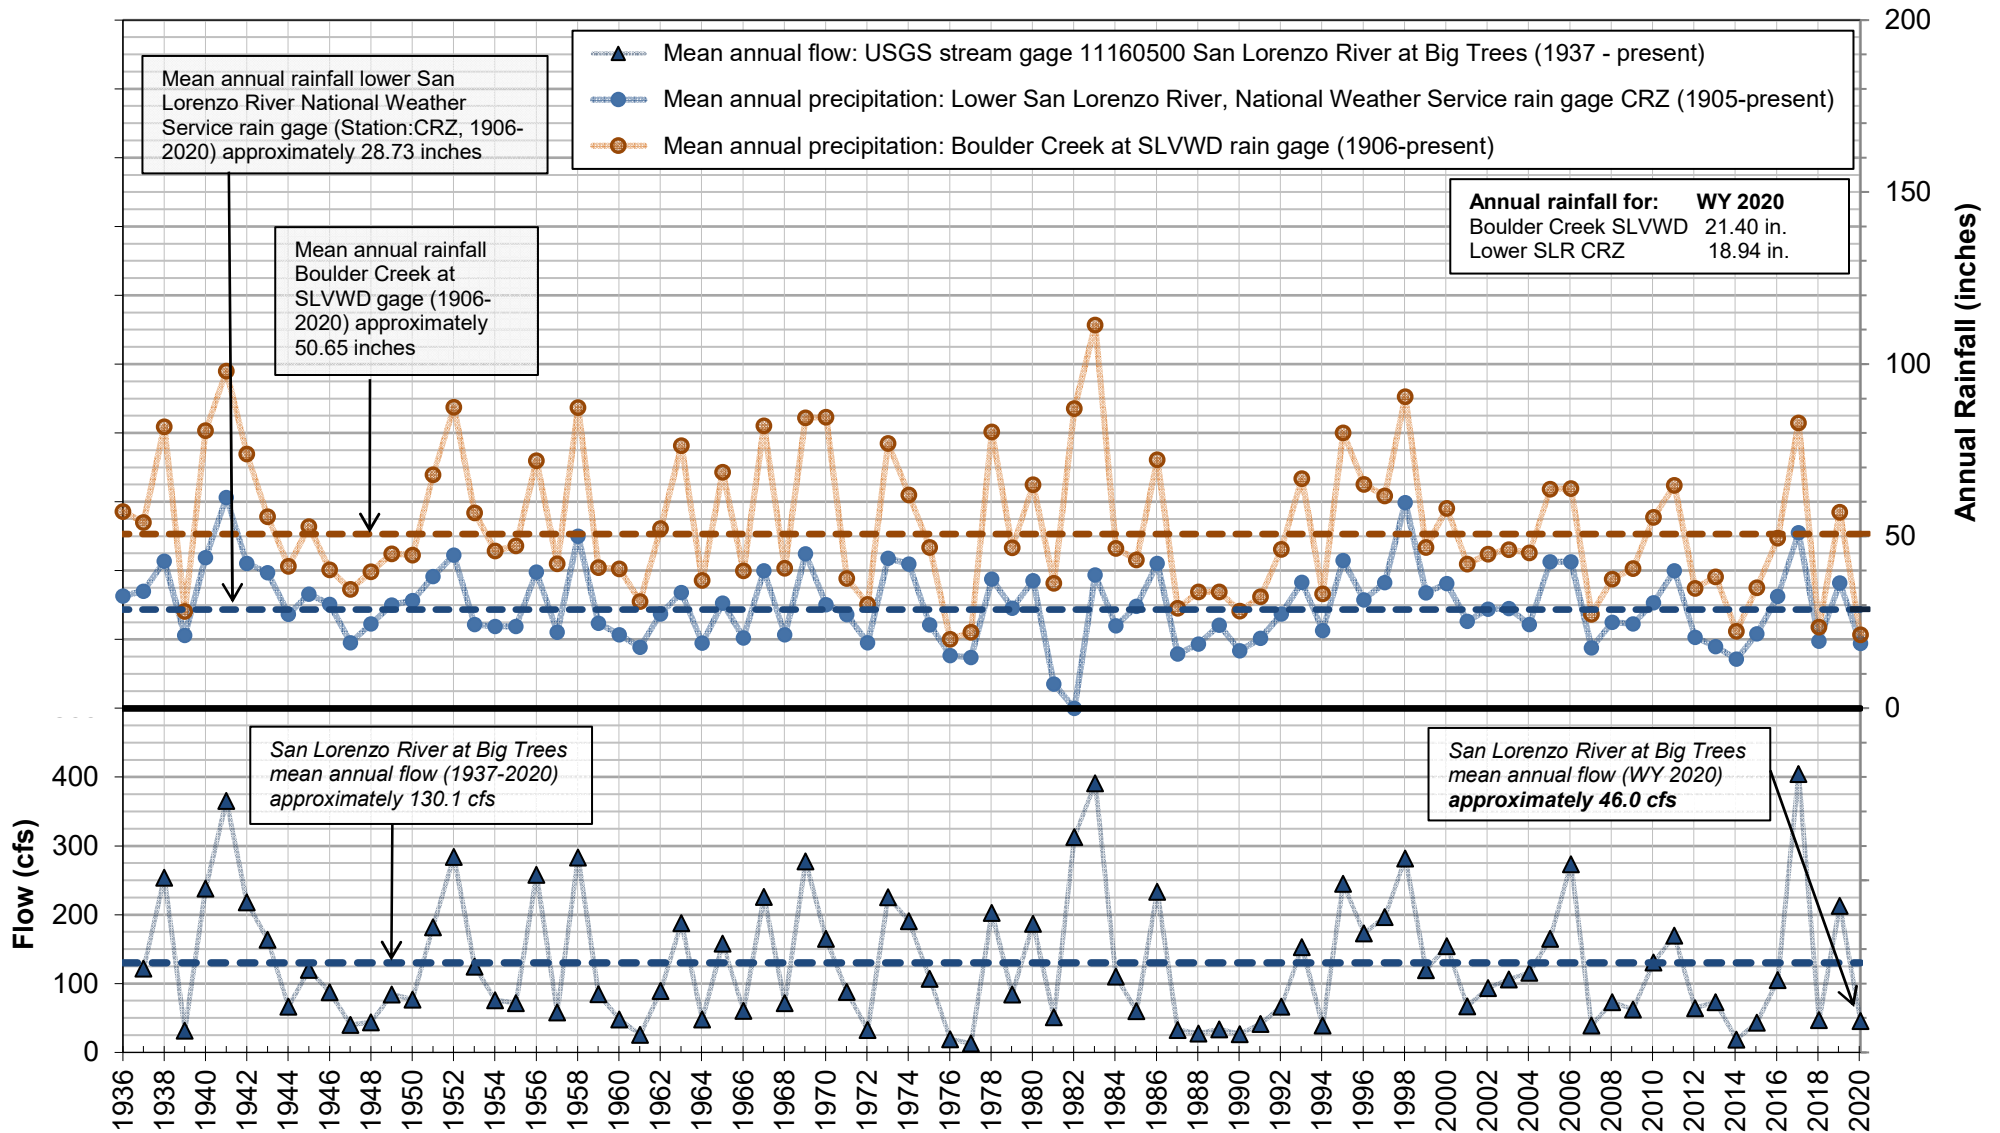
Figure 2. Comparison of historic annual rainfall in San Lorenzo Basin to annual streamflow at USGS Gage 11160500, San Lorenzo River at Big Trees, Santa Cruz County, CA

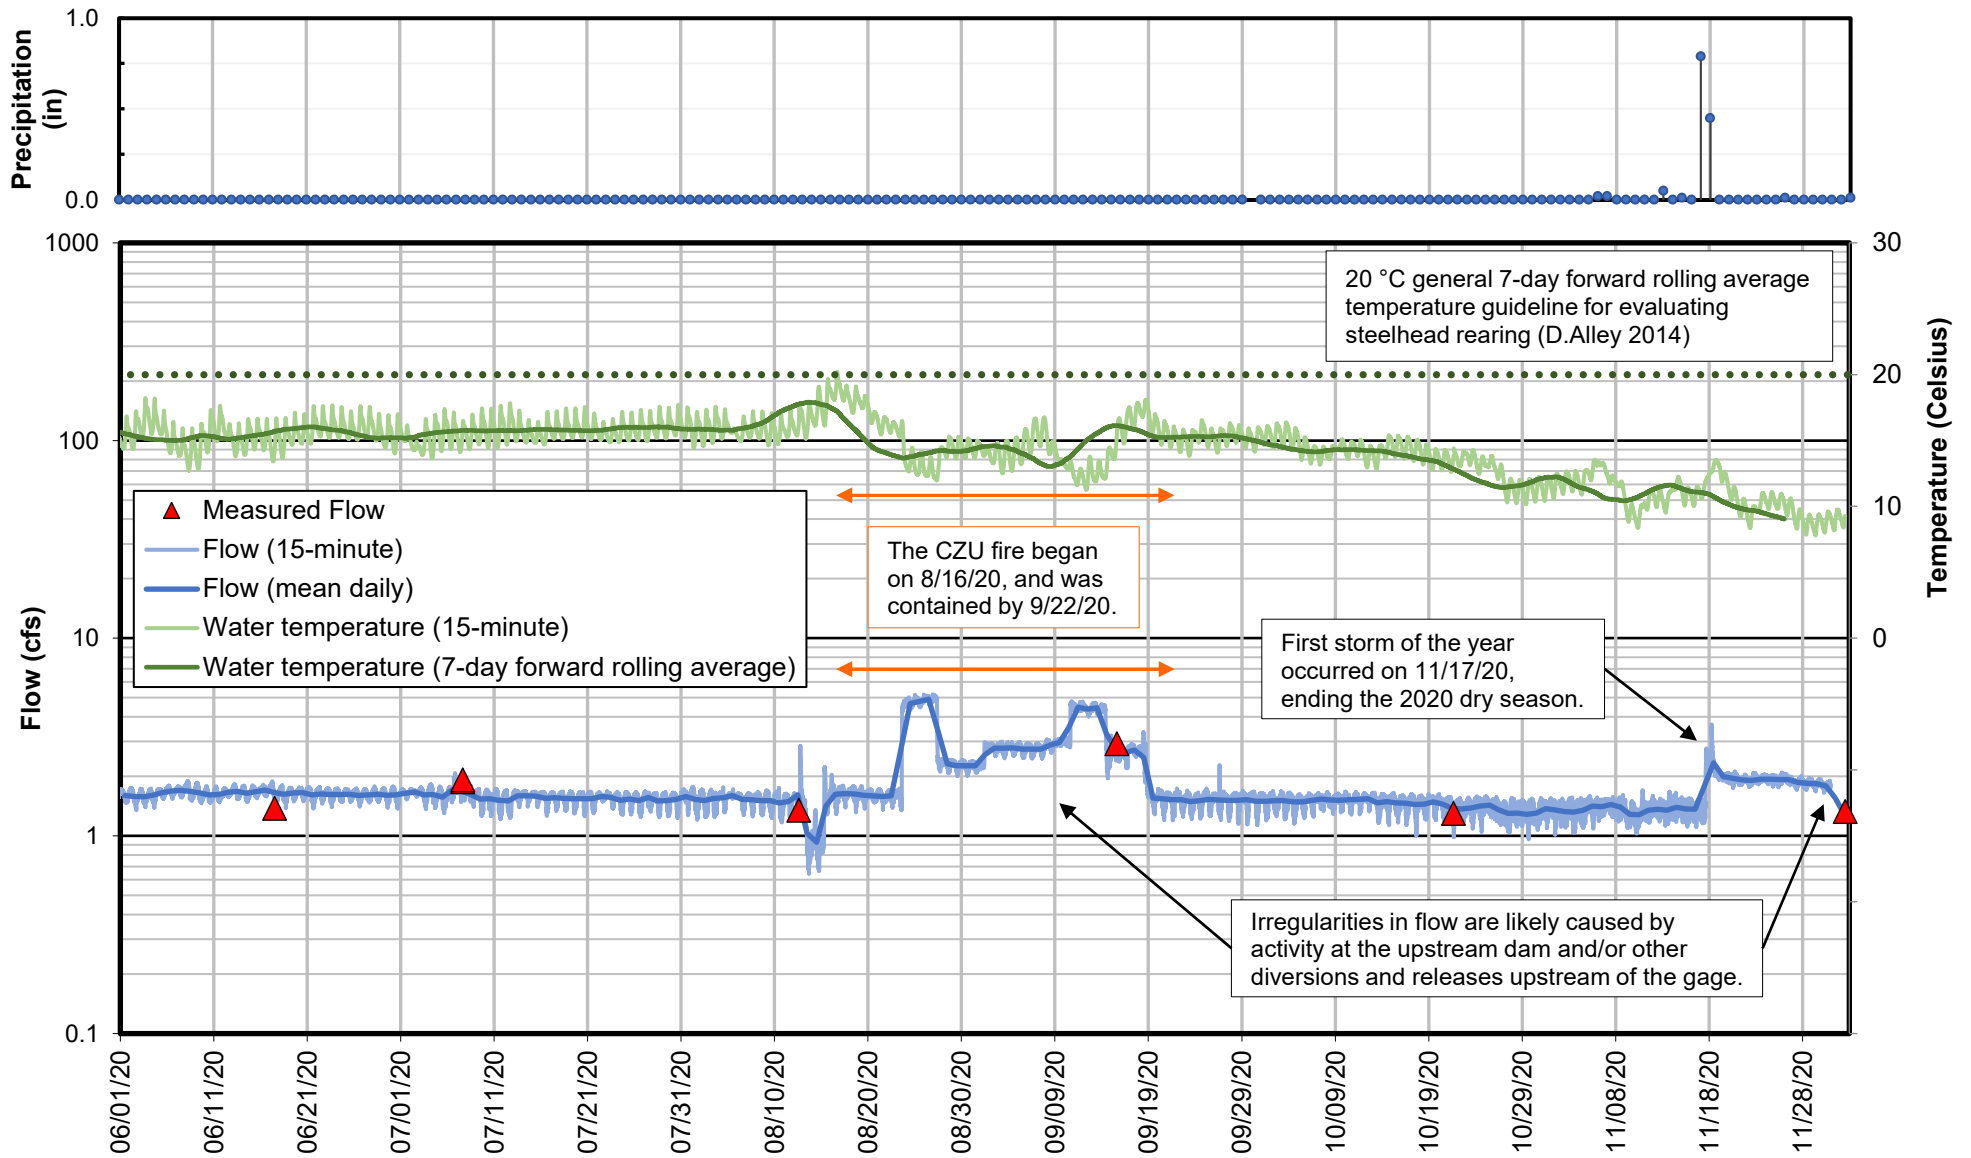
Figure 4. Flow and temperature at Newell Creek approximately 120 ft upstream of the San Lorenzo River, dry season 2020, Santa Cruz County, CA. Precipitation data from SLVWD downtown Boulder Creek gage.

The seasonal baseflow recession at the Newell Creek upstream of the San Lorenzo River gage was consistent at about 1.5 cfs from June through November, which is consistent with observed flow recessions during previous years (**Figure 4**). This site is downstream of the Loch Lomond Reservoir and is highly regulated. During the period of the CZU the flow increased up to 5 cfs, which is likely due to changes in activity and releases from Loch Lomond. The City regularly releases 1.0 cfs from Loch Lomond to promote aquatic habitat in Newell Creek and the river.

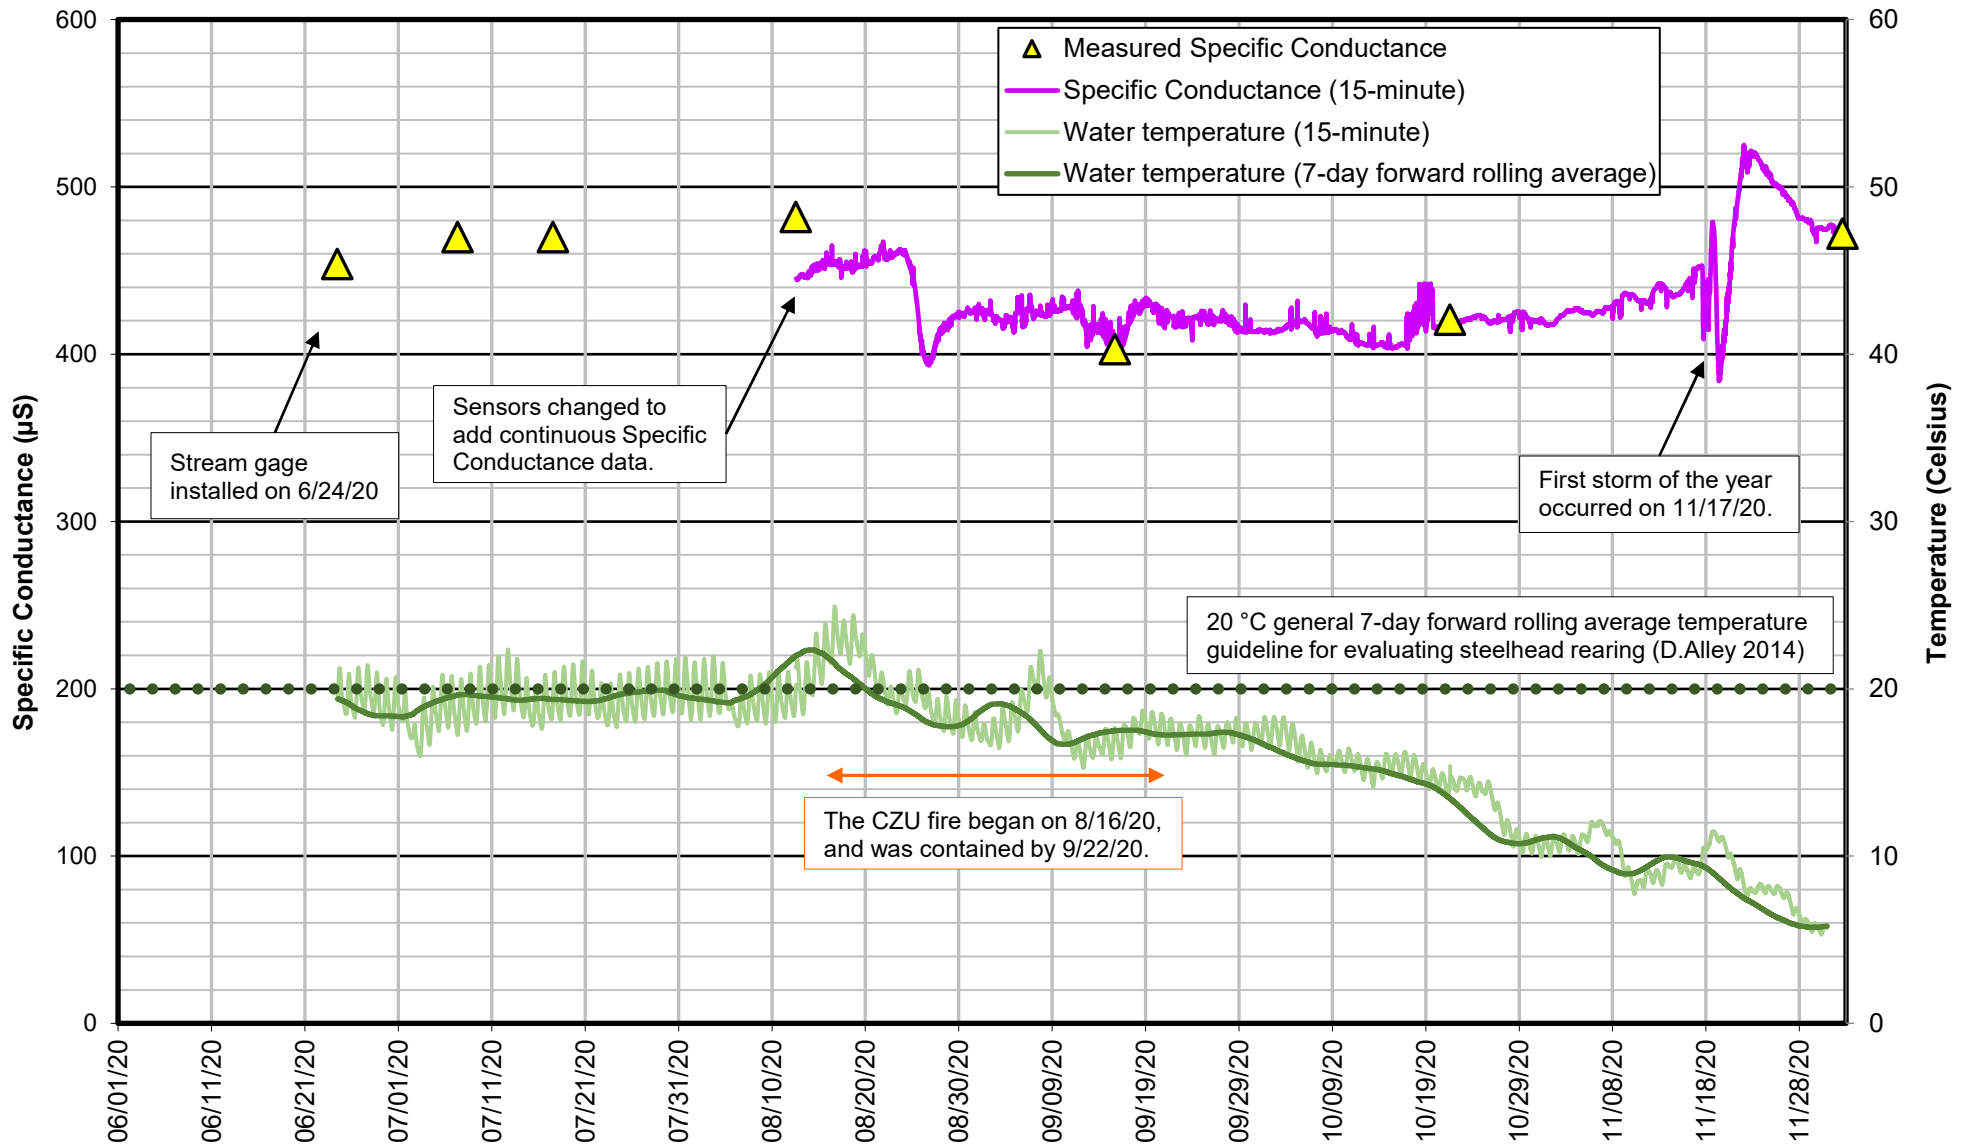
Figure 7. Specific Conductance and temperature at San Lorenzo River upstream of Love Creek, dry season 2020, Santa Cruz County, CA

Figures 7 -10. Measurements and observations for each gage are shown in **Tables 1 – 4** and a summary of daily mean flow for each gage are shown in **Forms 1 – 4.**

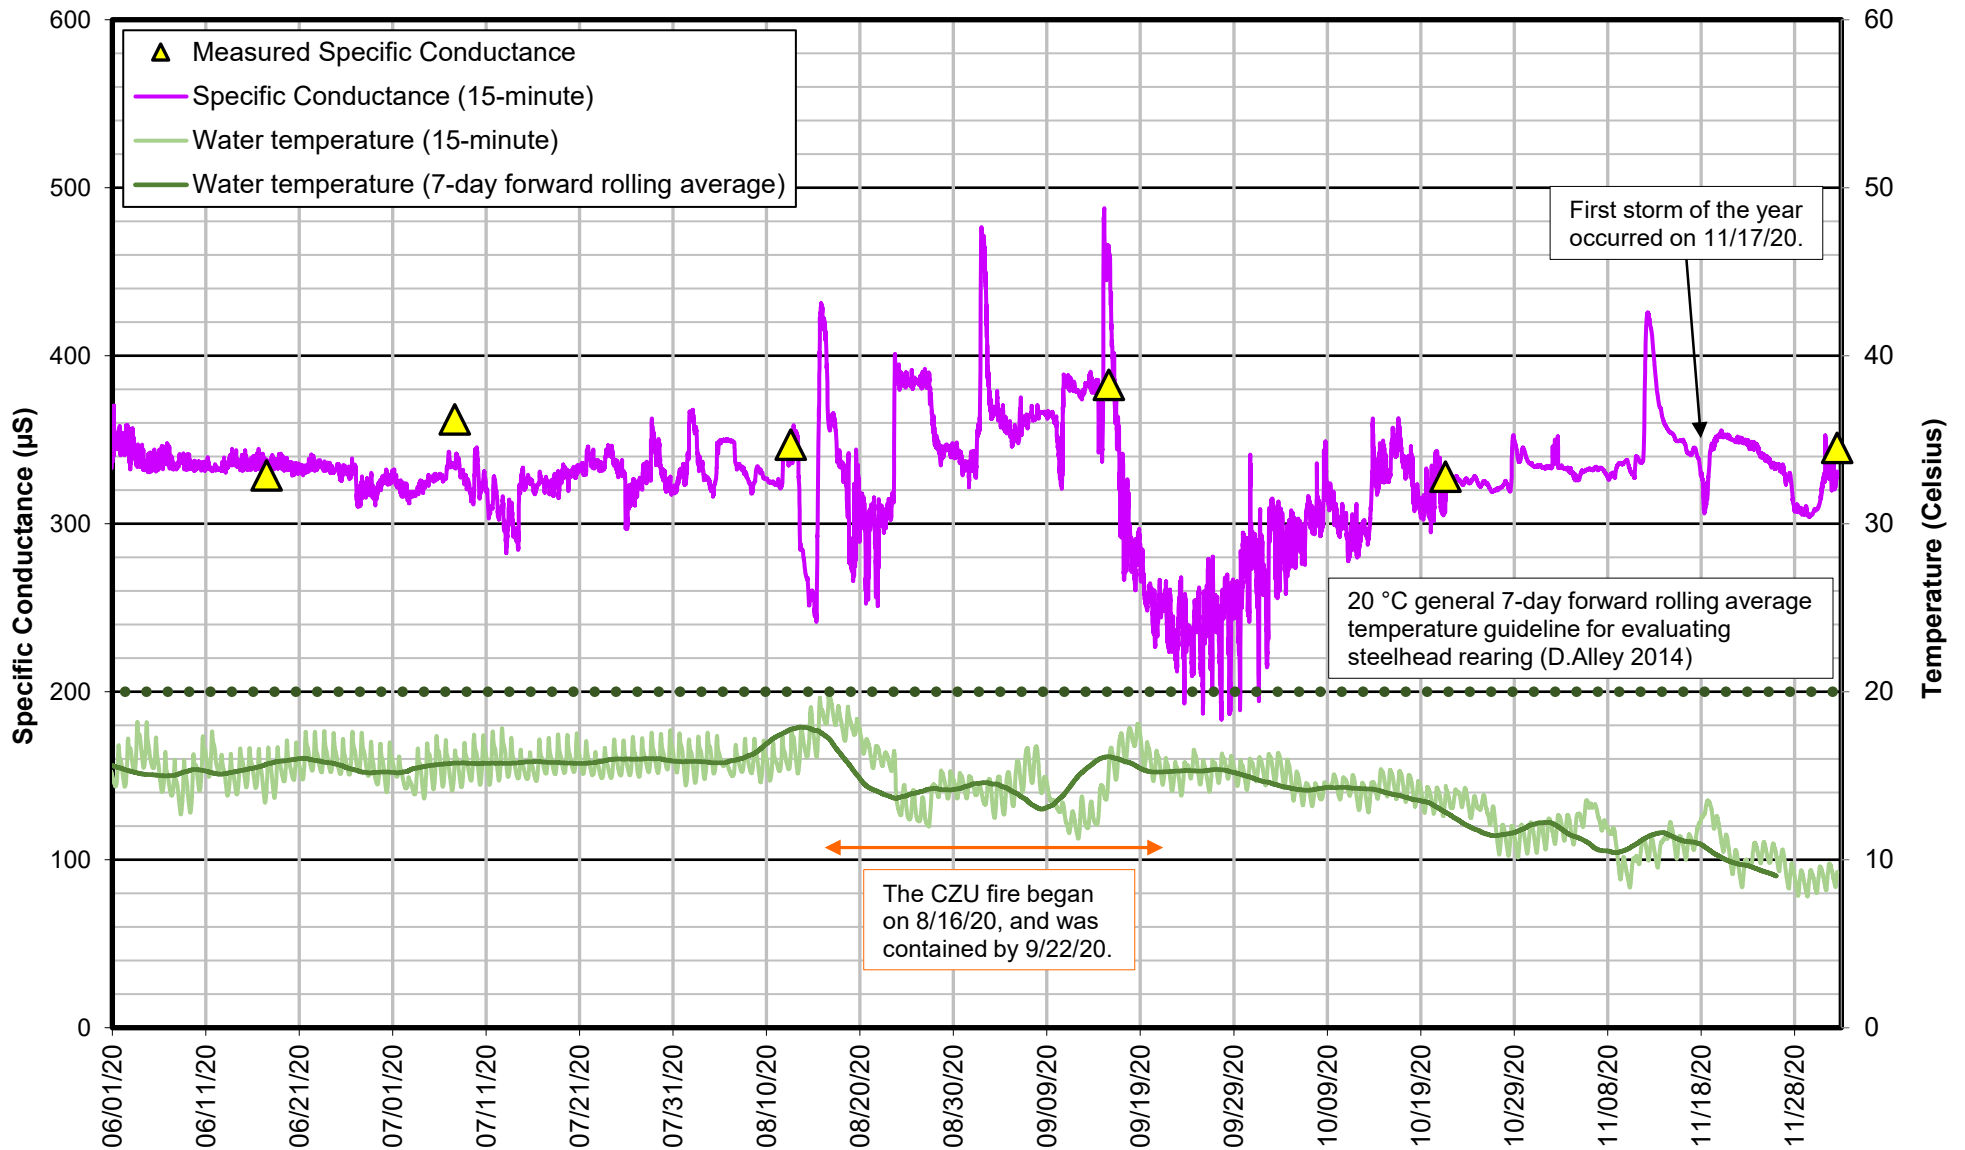
Figure 8. Specific Conductance and temperature at Newell Creek approximately 120 ft upstream of the San Lorenzo River, dry season 2020, Santa Cruz County, CA.

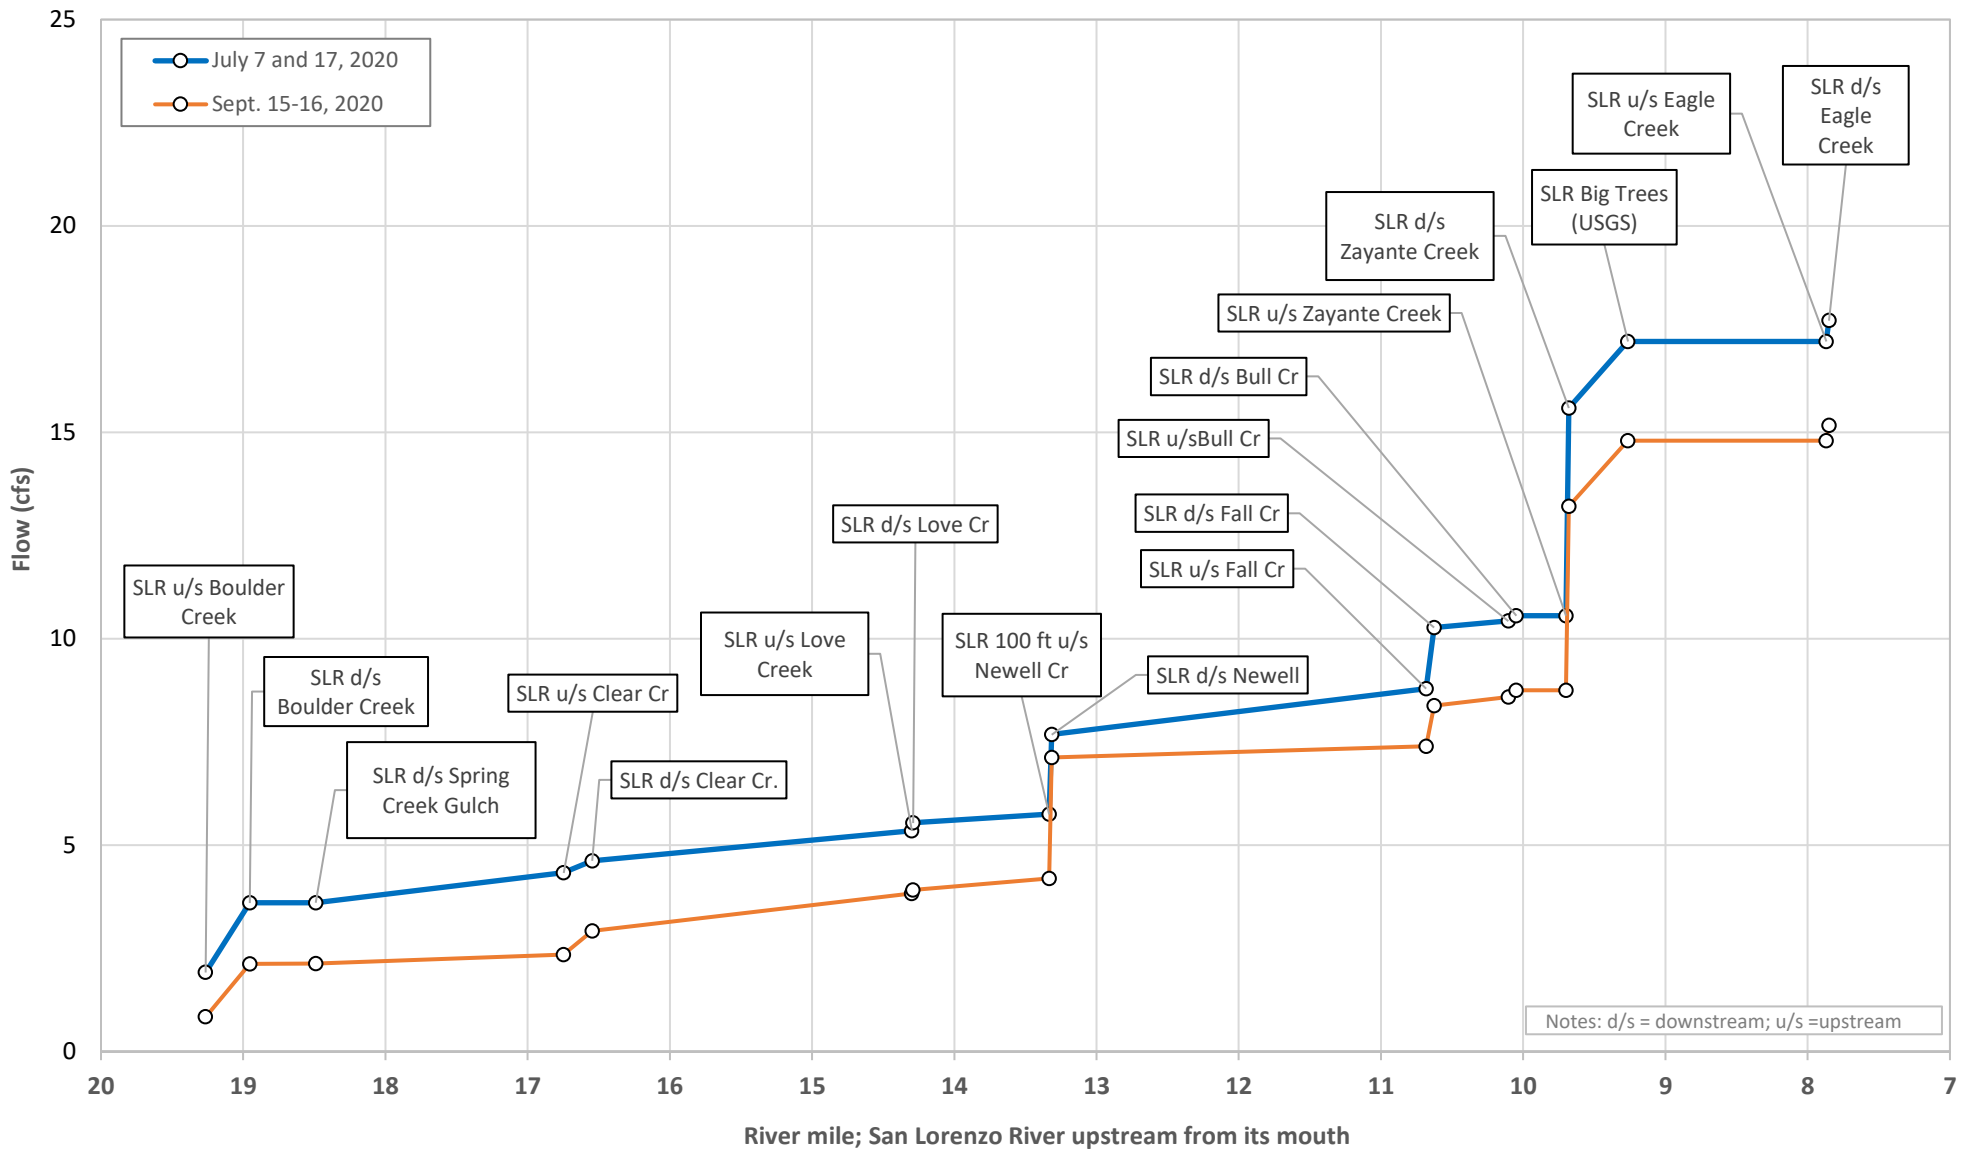
Figure 11. San Lorenzo River mainstem downstream changes in flow, dry season 2020 Santa Cruz County, CA

The accretion of flow showed a similar trend between the July and September 2020 sampling events, with a higher baseflow in July as expected earlier in the summer recession (**Figures 11-14**). The profile of accretion flow can be seen for the San Lorenzo River and Bean Creek during both events in **Figures 11 and 12**, respectively. The input of groundwater can be readily seen in each data set as a break in slope from horizontal of each line. If there were no groundwater interaction, then the flow would remain constant between tributaries assuming no diversions or losses to evapotranspiration. An up-trending slope from each set of points signifies accretion of flow apart from the tributary ('gaining reach'), likewise a down-trending slope indicates a flow loss in between each tributary ('losing reach'). The results can also be seen in map view for the July and September sampling events in **Figures 13 and 14**, respectively. Details of each measurement are shown in **Tables 5 and 6**, for the July and September events, respectively.

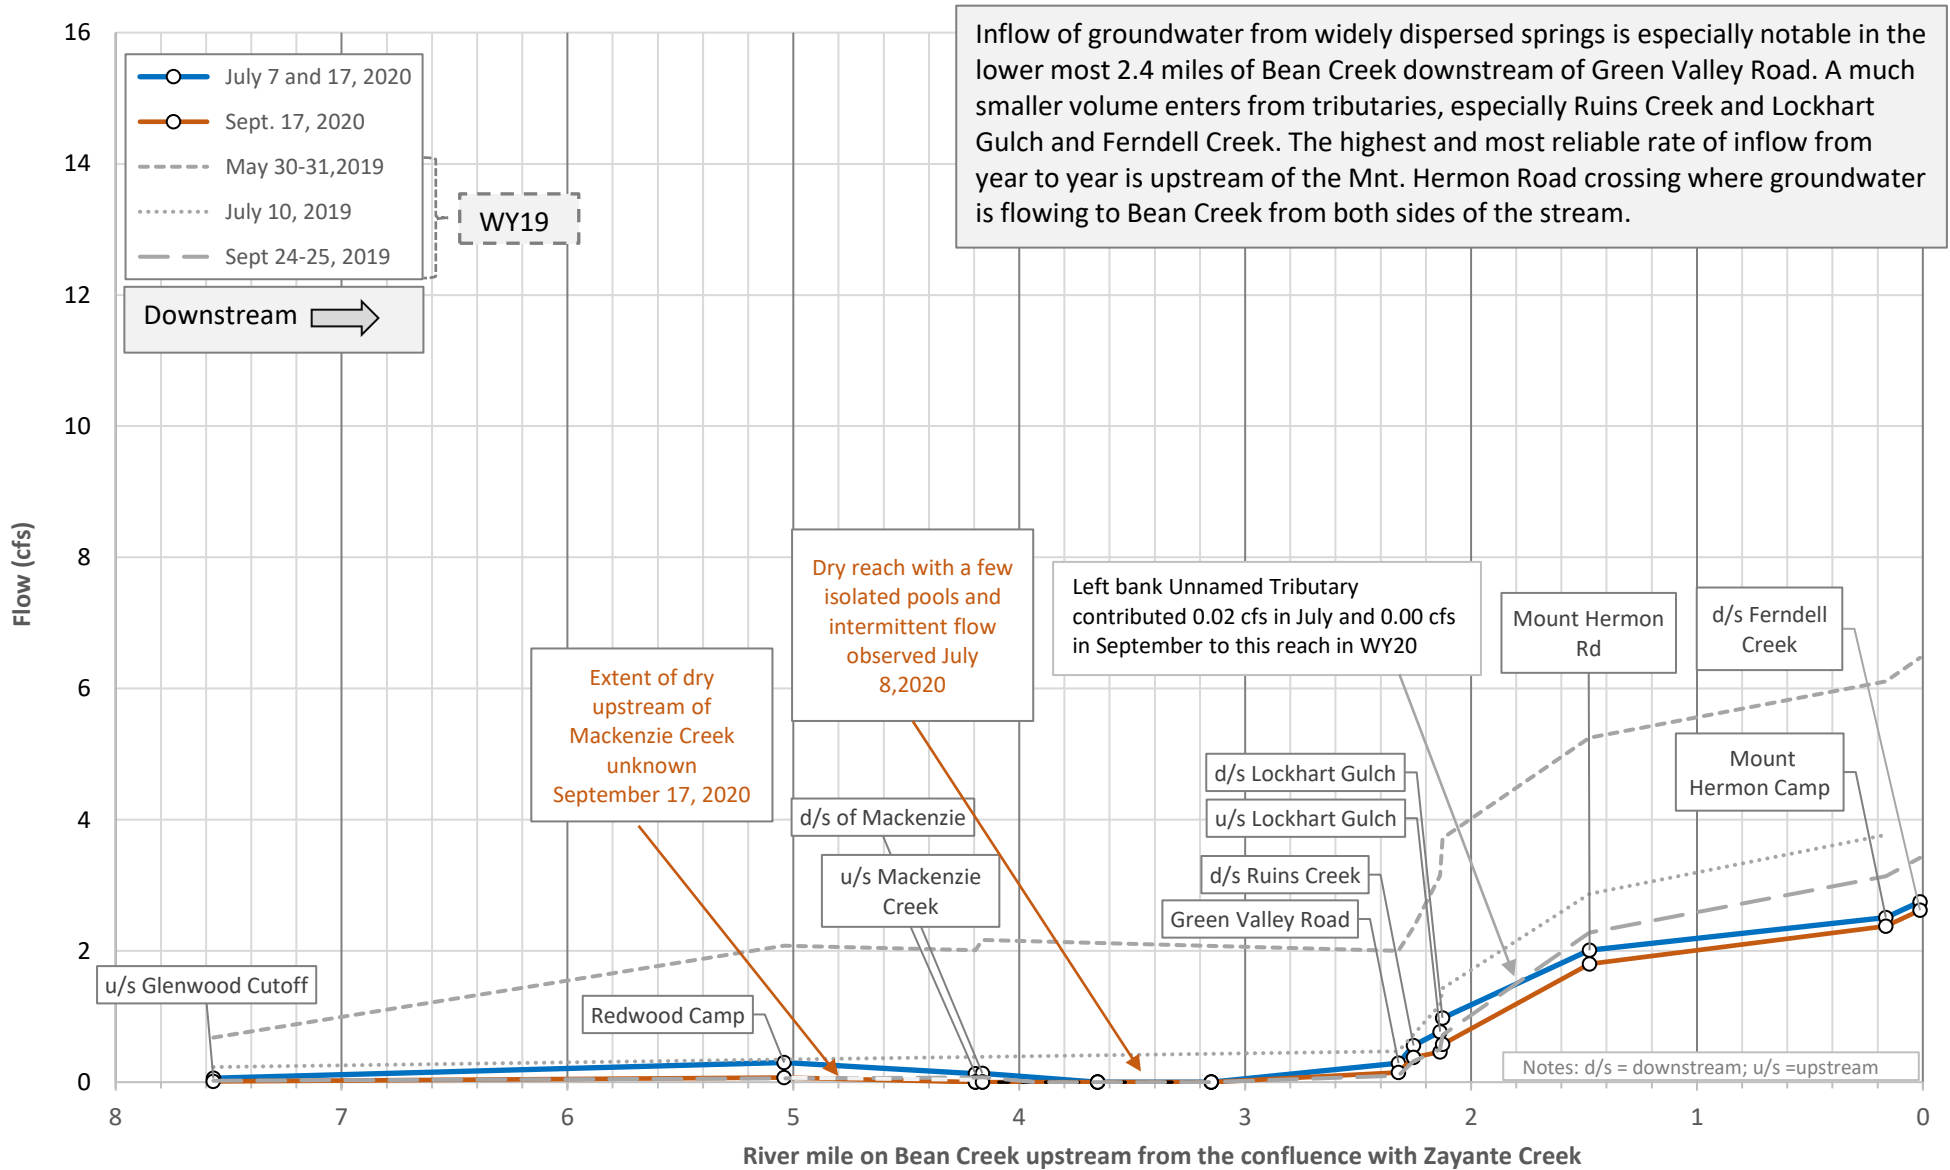
Figure 12. Downstream changes of flow in Bean Creek over the WY 2020 dry season and comparison with the dry season changes during WY 2019, a substantially wetter year. Santa Cruz County, CA The reach between Mackenzie Creek and Green Valley Road has been observed to go dry mid-summer.

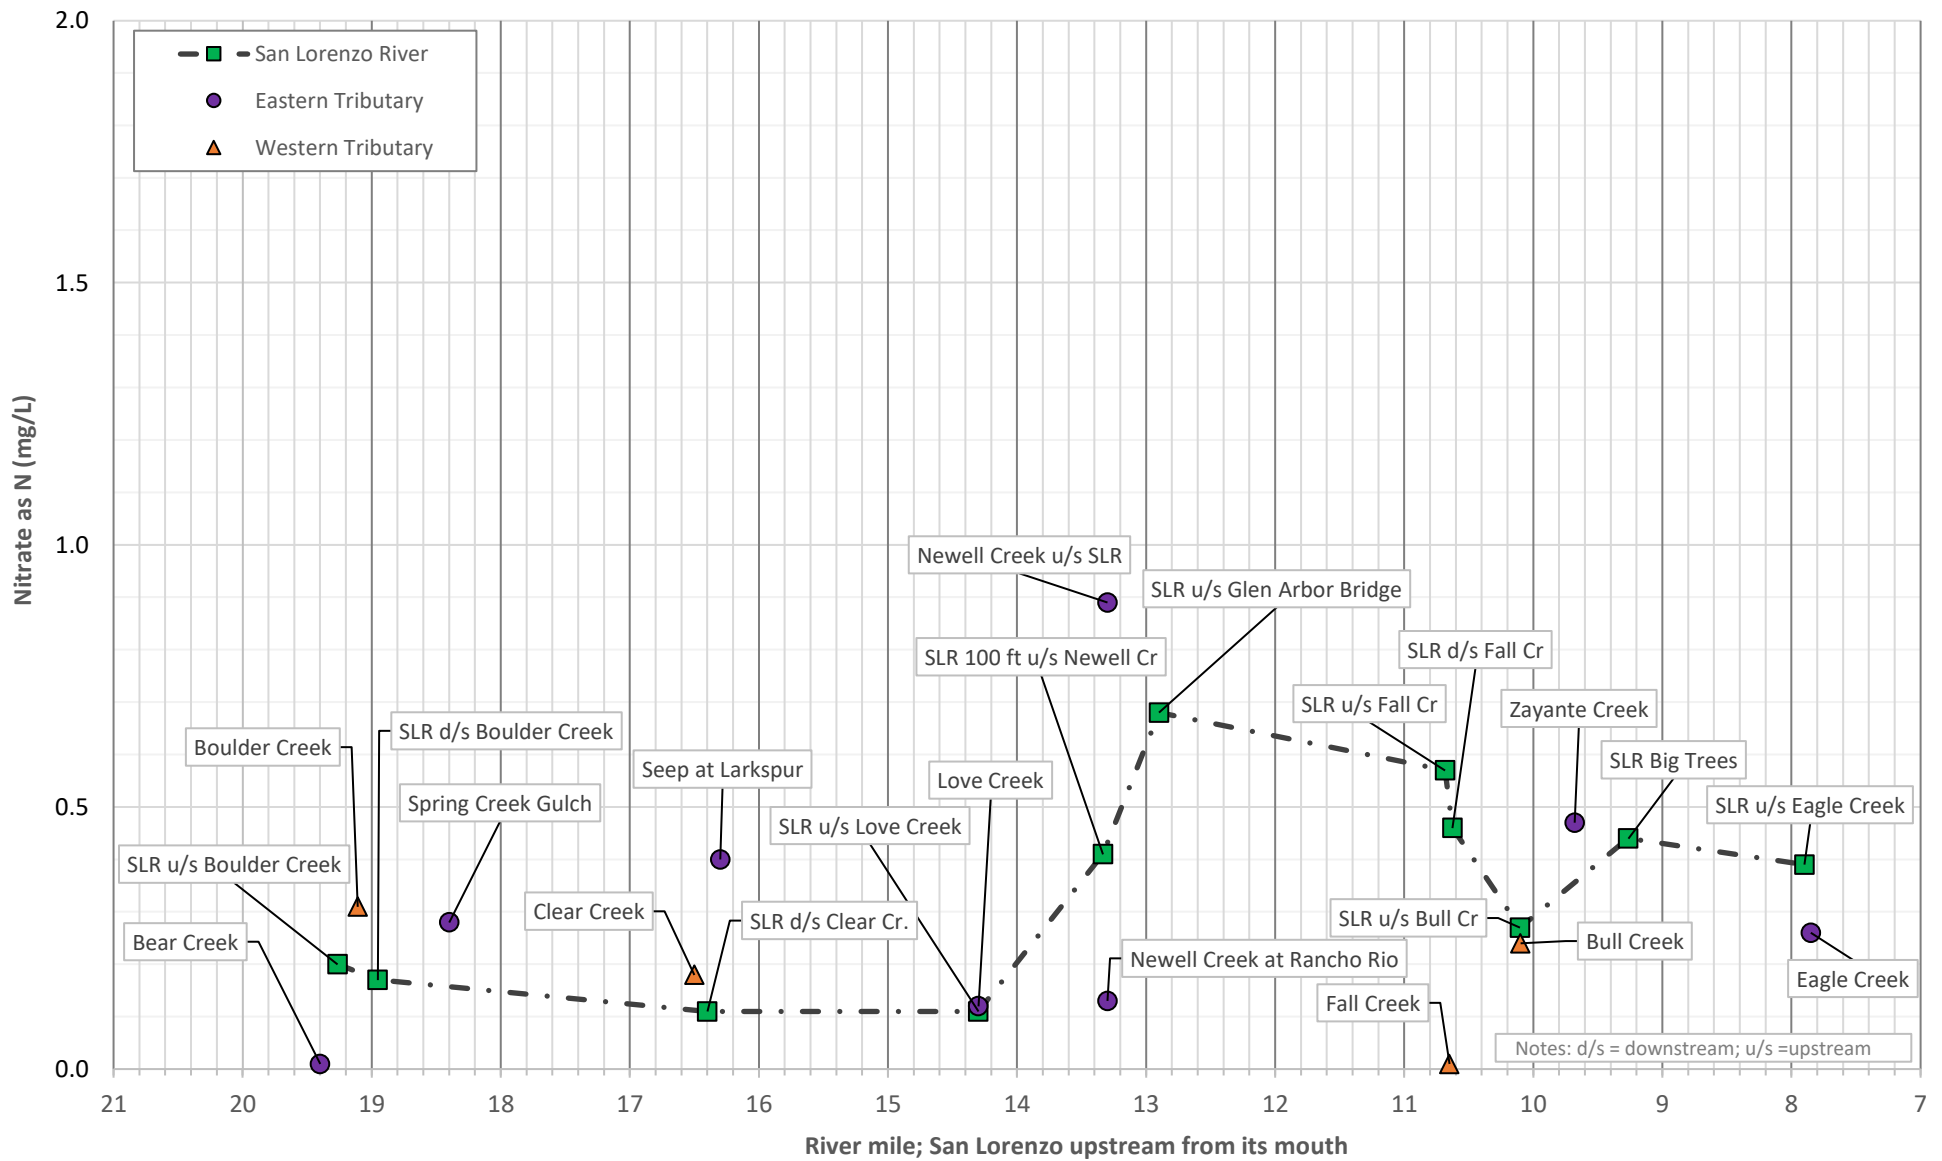
Figure 18. San Lorenzo River Nitrate as N from samples taken July 14, 2020, Santa Cruz County, CA

On July 14, 2020 water quality samples were collected throughout the Santa Margarita Basin at similar locations as the accretion flow measurements by Balance staff (**Figure 1, 1a, and 1b**). The results and additional observations are shown in **Table 7, Figure 17** shows a map of nitrate levels, and **Figures 18 and 19** show profiles of nitrate levels along the San Lorenzo River and Bean Creek, respectively.

As in previous years, the 2020 field work shows that considerable nitrate enters the river during a representative summer day as it flows downstream (**Figures 17 – 19; Table 7**). Along the San Lorenzo River concentrations increase through reaches where the Santa Margarita aquifer contributes directly to the river, from Love Creek at Ben Lomond downstream to Eagle Creek. And on Zayante Creek, discharge from the Santa Margarita raises nitrate levels from the Zayante Store (just upstream of the Santa Margarita outcrop) to Graham Hill Road, just above its confluence with the San Lorenzo River. Bean Creek also shows consistent downstream increases in reaches where it is incised through the Santa Margarita.

In general, nitrate levels on the San Lorenzo River on July 14, 2020 appeared to increase in the downstream direction from around 0.1 N-mg/L to 0.68 N-mg/L downstream of Newell Creek (**Figure 18**). This same pattern has been observed during previous water quality sampling events (Parke and Hecht, 2020 a).

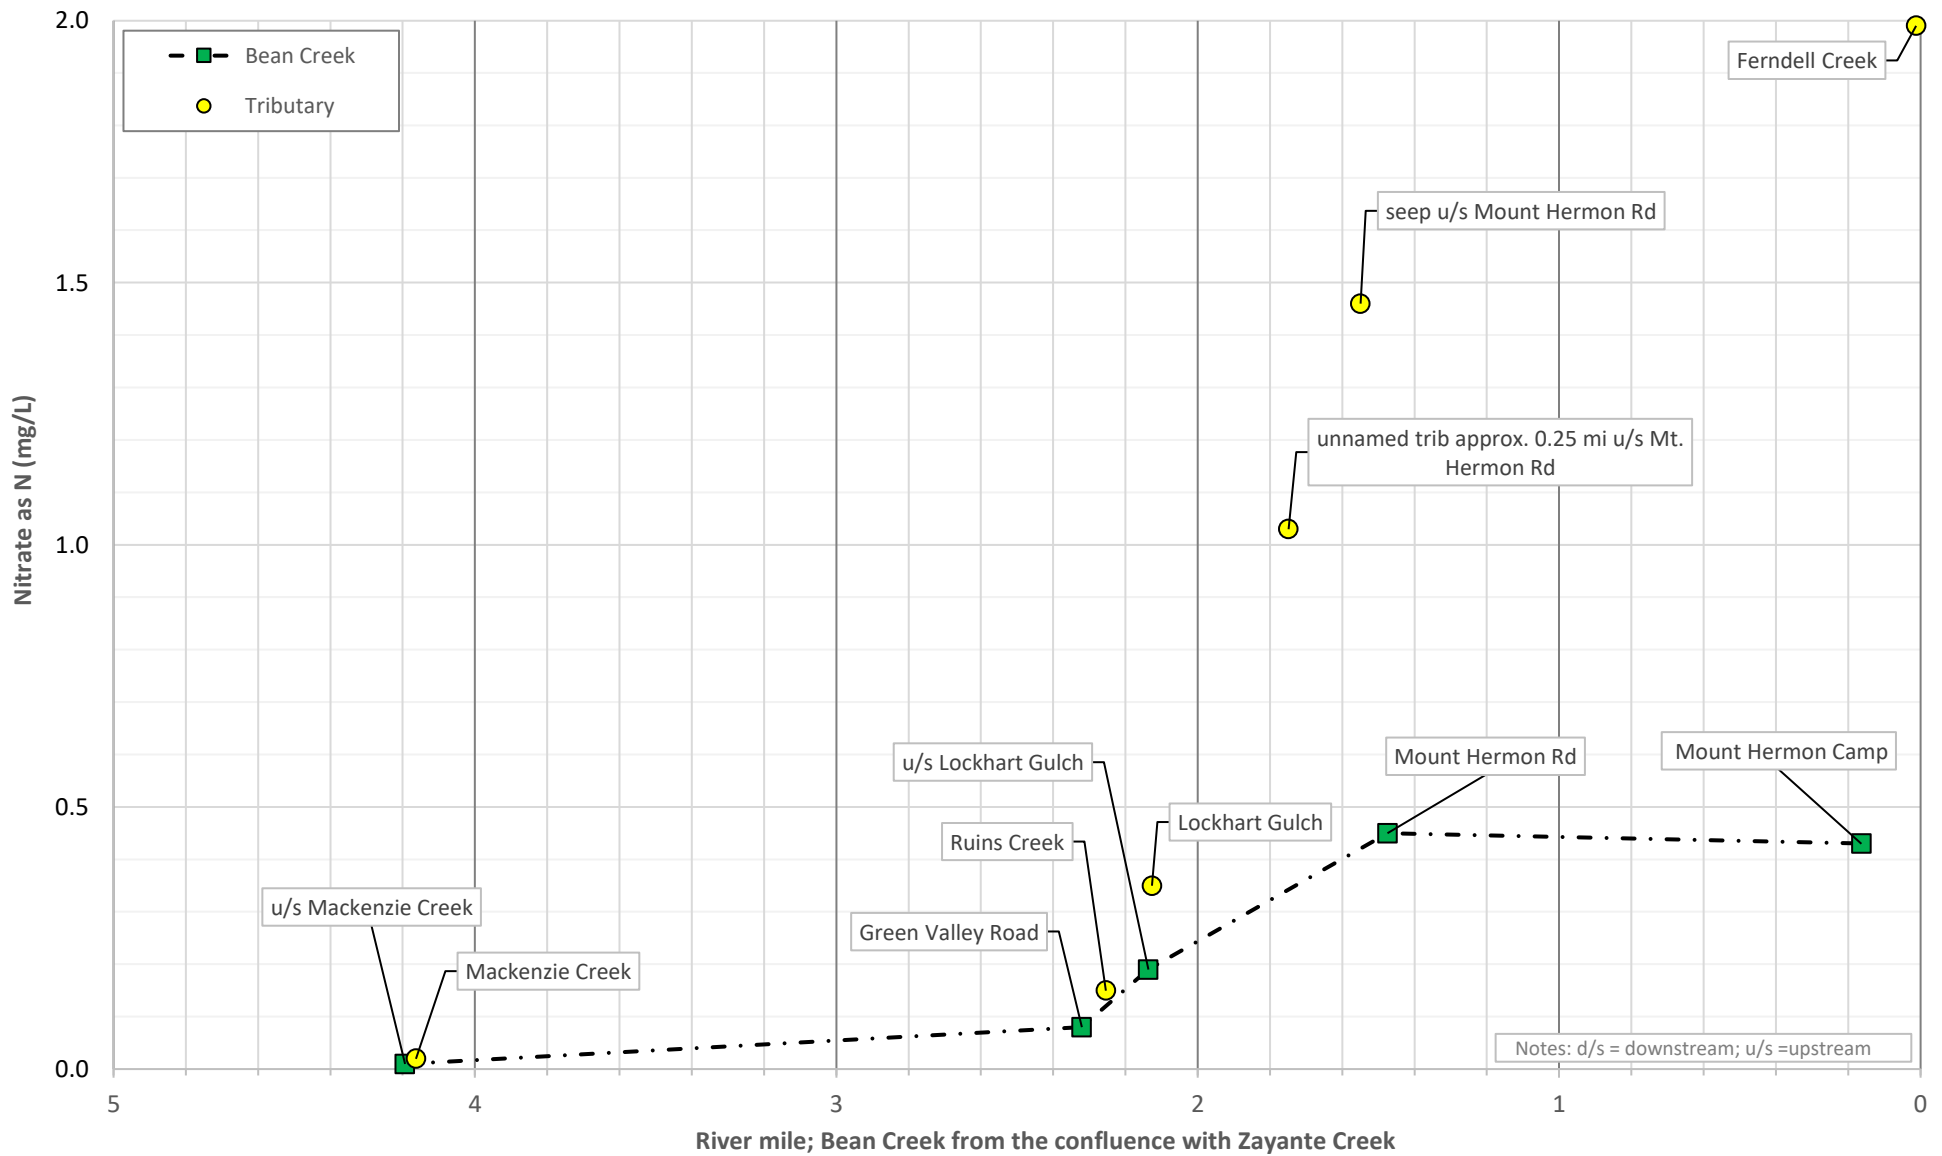
Figure 19. Bean Creek Nitrate as N from samples taken July 14, 2020, Santa Cruz County, CA
