Groundwater Quality

- 1. Groundwater Quality Background
- 2. Federal and State Water Policy Framework
- 3. Start Process of Developing Sustainable Management Criteria for Degraded Groundwater Quality

Groundwater Quality Background

Georgina King, Montgomery & Associates

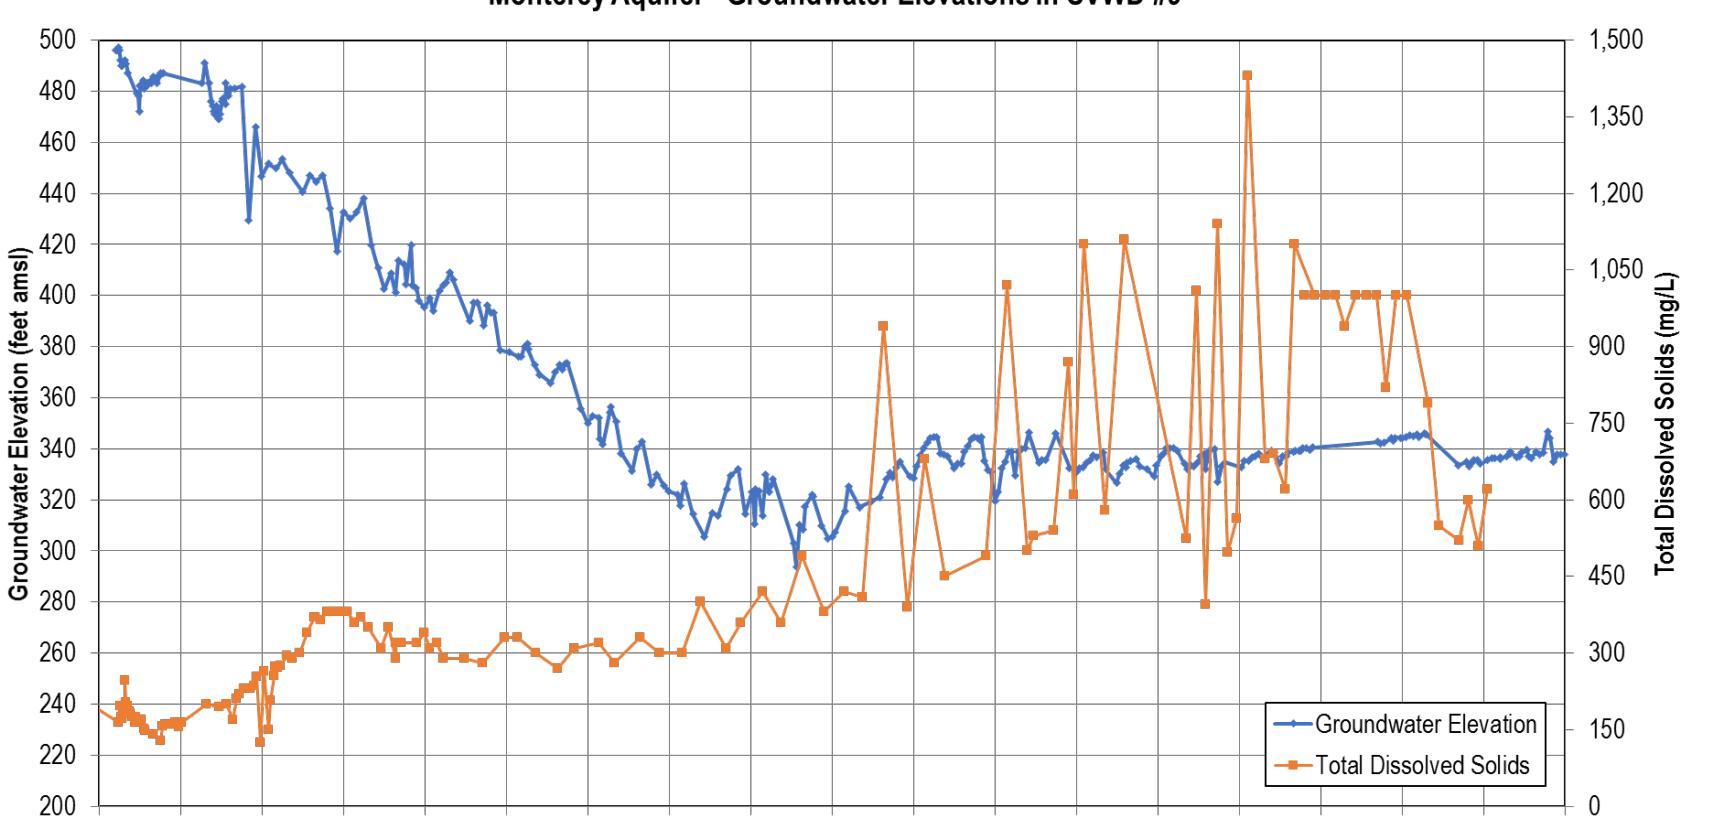
Monterey Aquifer - Groundwater Elevations in SVWD #9

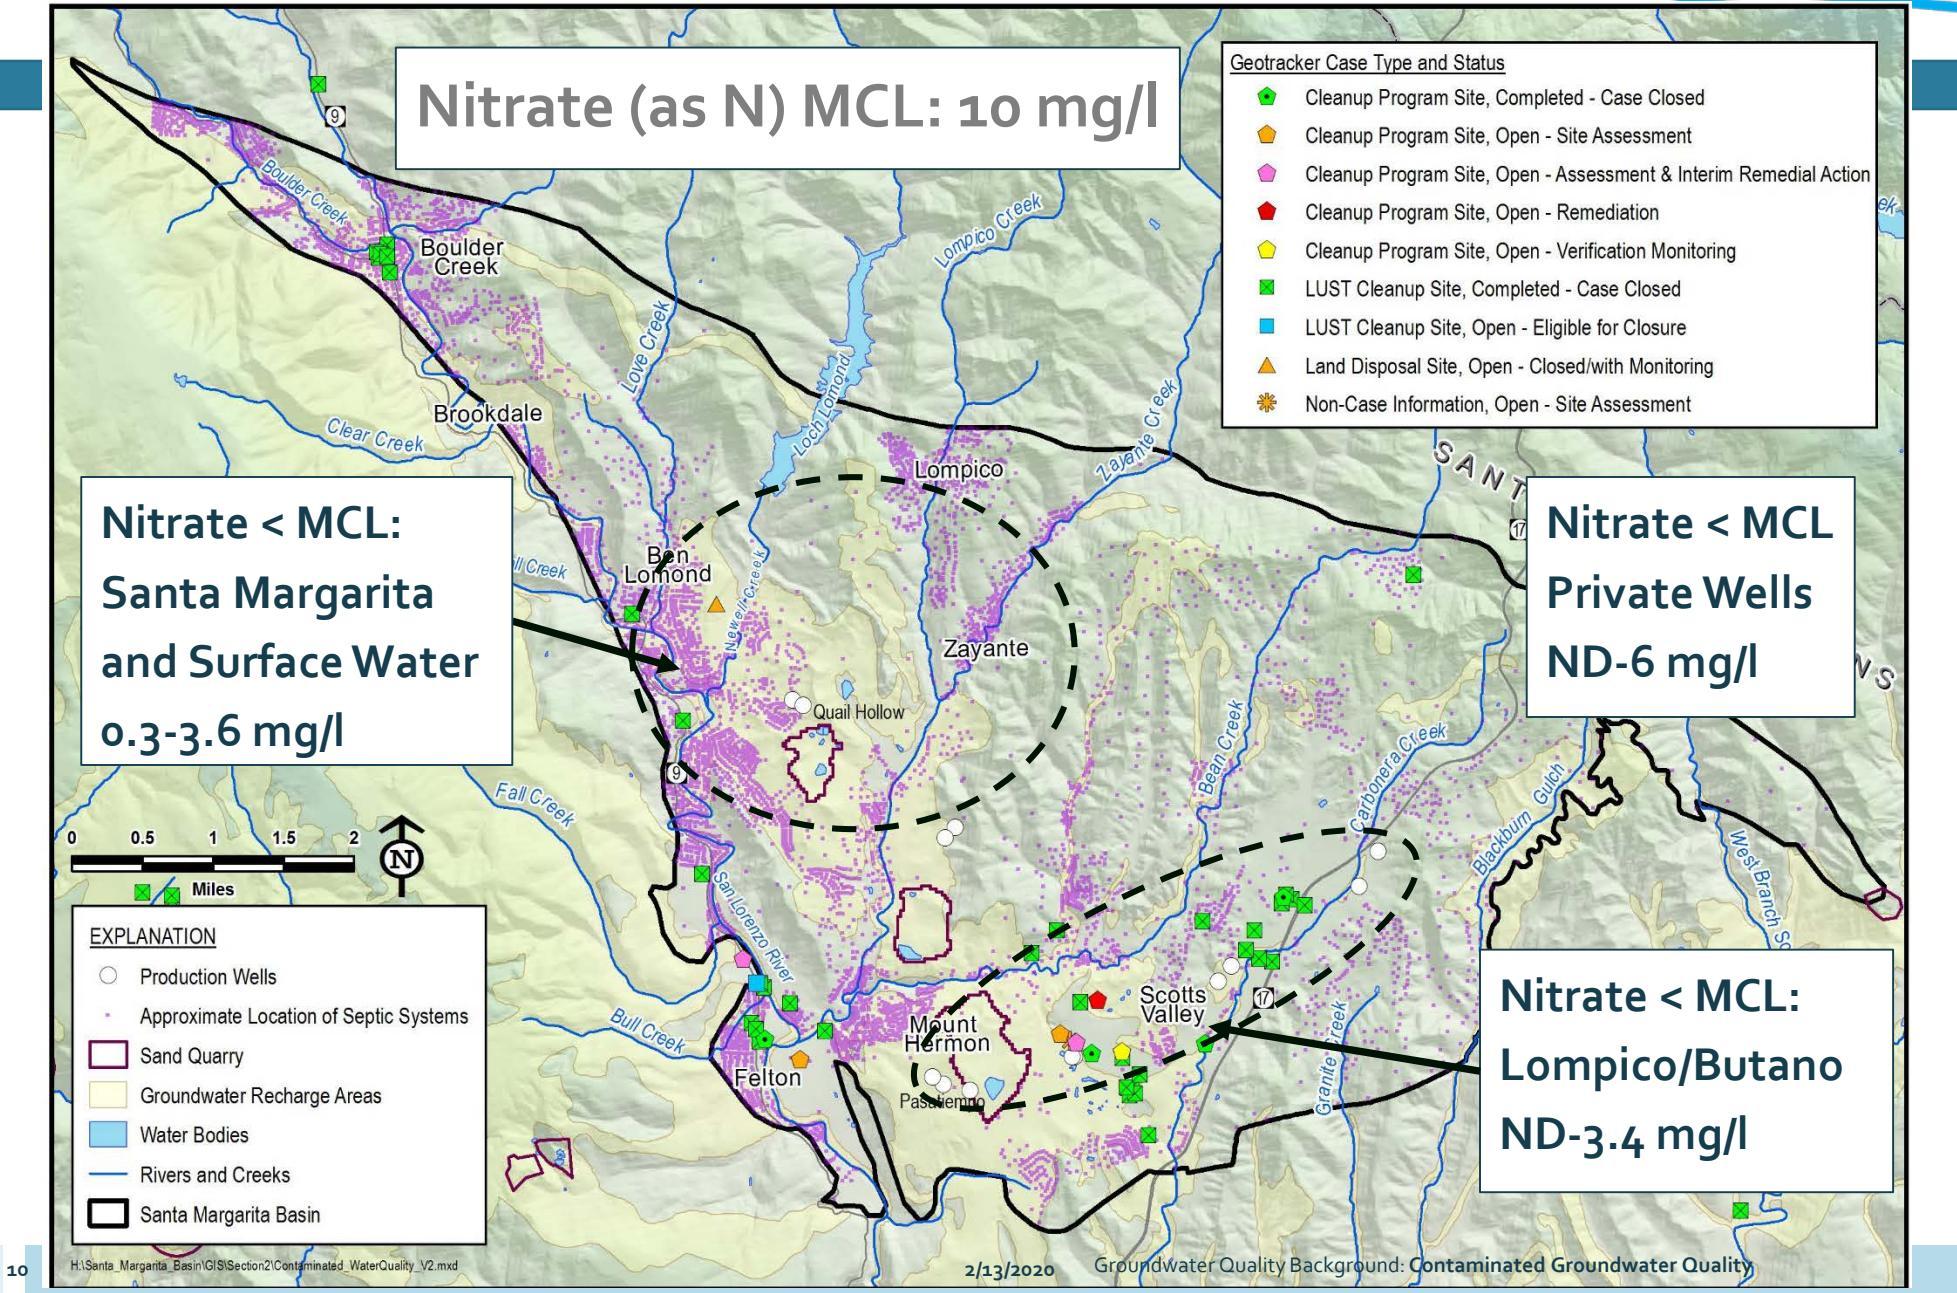
Groundwater Quality Background Nitrate Total Maximum Daily Load (TMDL)

- Nitrate in groundwater does not currently exceed primary drinking water standards
- Groundwater contributing to elevated nitrate concentrations in the SLR

TMDL has Nitrate as N target of 0.34 mg/L by 2020 at SLR at Felton Sept 2011 – Sept 2018 average nitrate as N was 0.48 mg/L

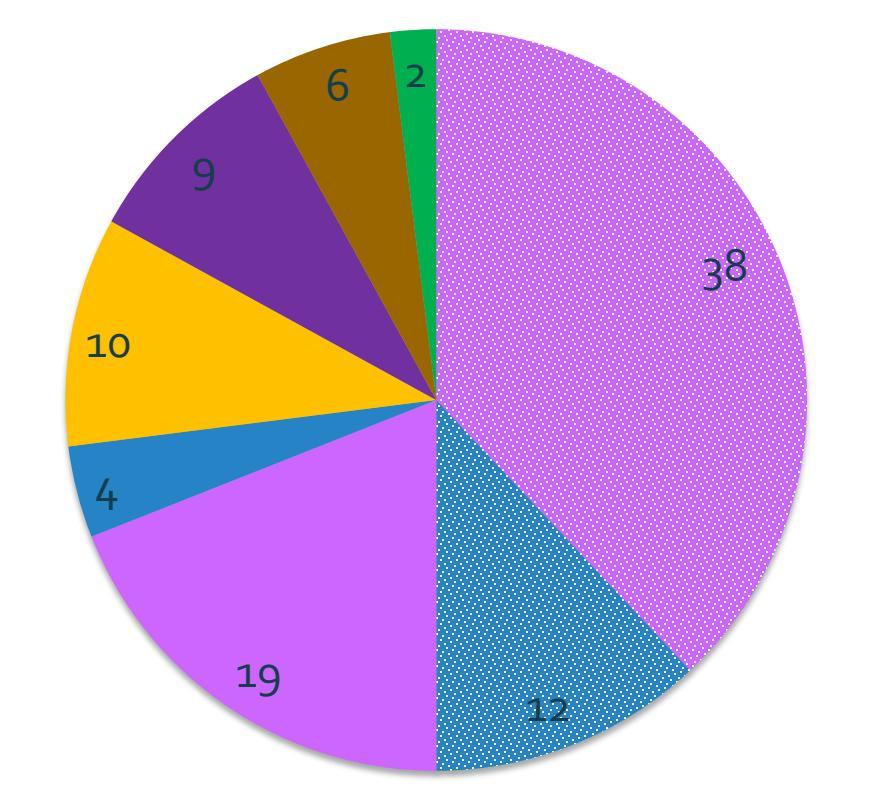
Nitrate to San Lorenzo River, County of Santa Cruz, 1995

- Septic Systems in Sandy Areas
- Natural Sources in Sandy Areas
- Septic Systems in Non-Sandy Areas
- Natural Sources in Non-Sandy Areas
- Sewer Discharge from B.C. Country Club
- Scotts Valley Nitrate Plume
- Livestock and Stables

Fertilizer

50% of nitrate sources are from sandy areas 67% of nitrate sources from septic systems are from sandy areas

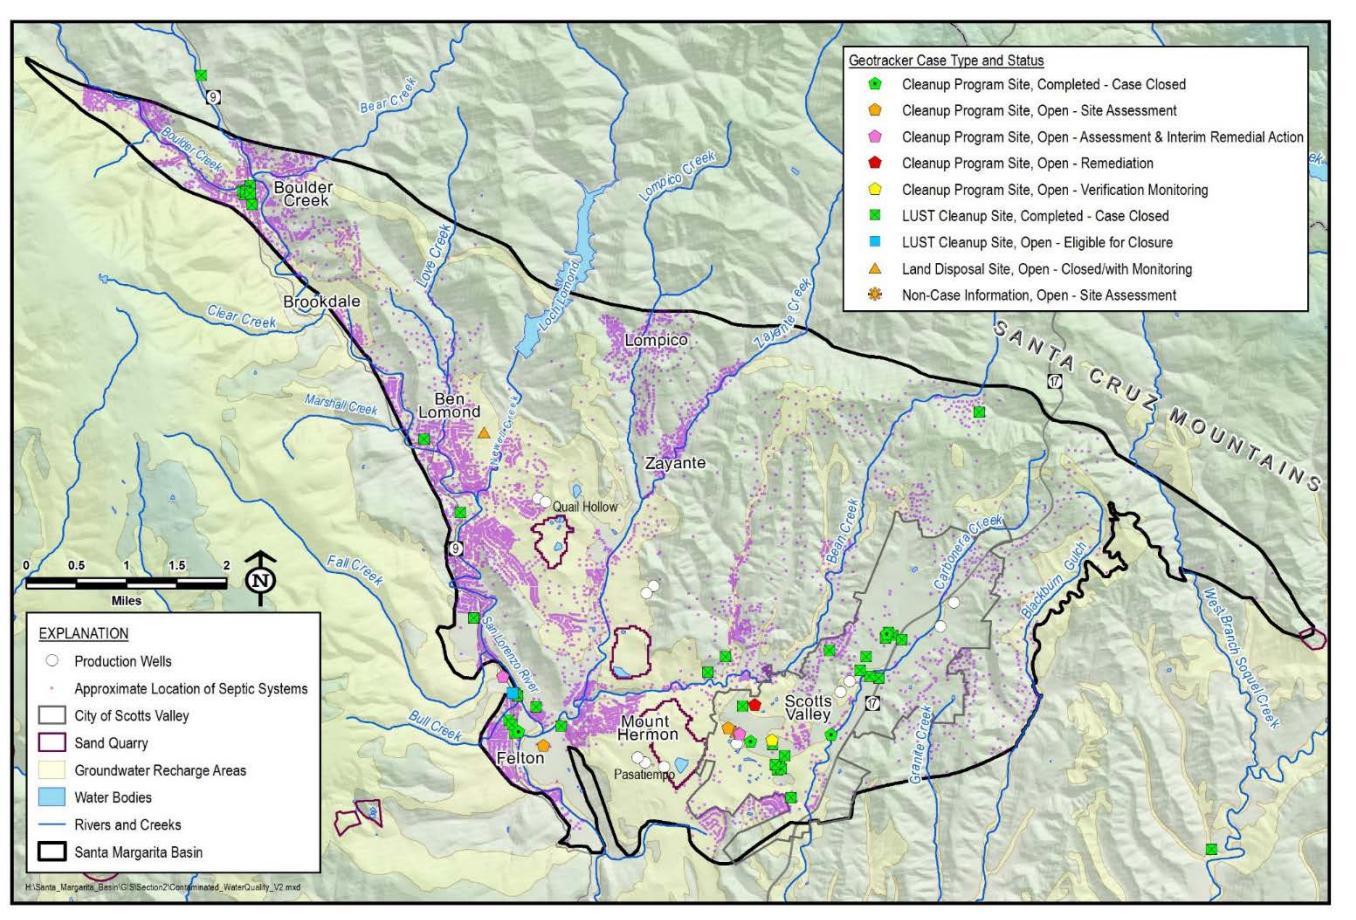
Green = completed cleanup

Still cleaning up:
Watkin-Johnson superfund site
Scotts Valley Dry Cleaners
King's Cleaners
Former Santa Cruz Lumber Company (orange symbol)

Ongoing monitoring

Ben Lomond Landfill

No gas stations currently leaking
